A116672

Inspection and Assessment of DVA Lifts

Department for Infrastructure

28 February 2020

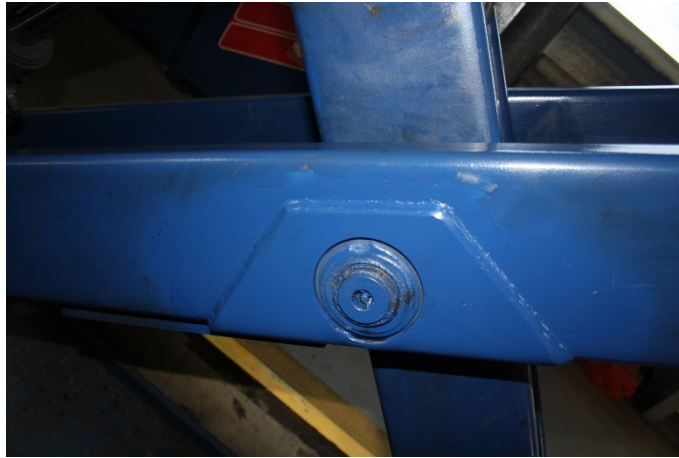
Typical outer box section – outside face with remedial steel plate

11. In many instances, remedial works in the form of steel plates have been recently welded to the outer face and underside of the scissor leg outer box. The steel plates are located at the position of the scissor leg pivot. This was observed in 68% of lifts.

WYG would recommend that all lifts exhibiting signs of fatigue are taken out of service and replaced. We would not advocate any short-term localised repairs due to the presence of fatigue in the scissor legs around the pivot. Consideration could however be given to replacement of the scissor legs, bearing bushes and pivots to bring the lifts temporarily back into service until new lifts are available. This is subject to all other parts of the scissor lifts being inspected, evaluated and certified by MAHA and an independent inspector as safe to use.

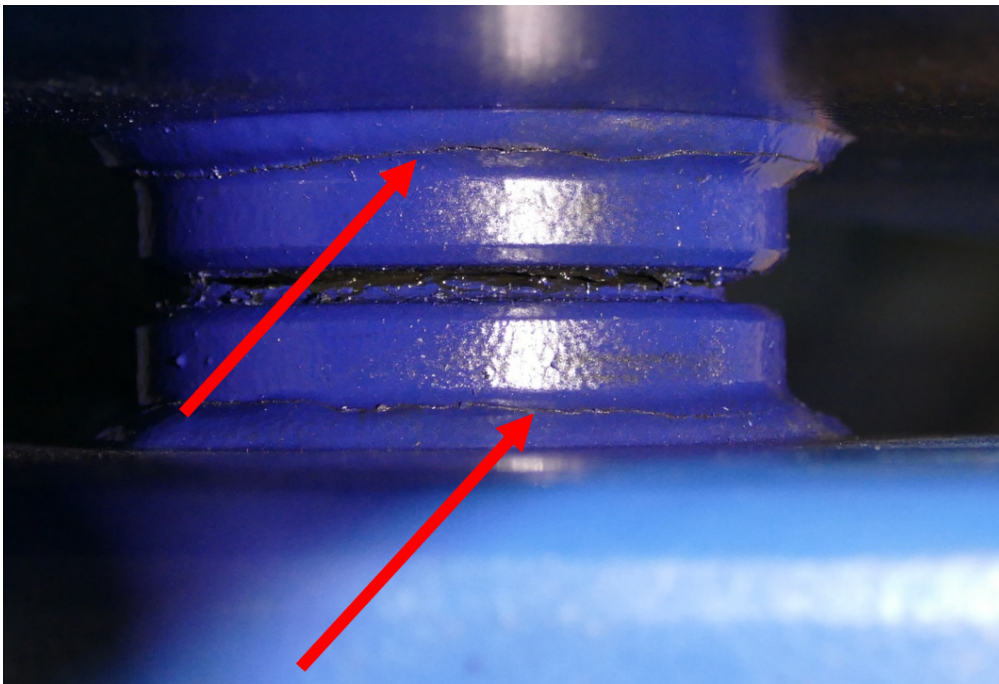
8. Cracking was observed in most of the welds securing each boss to the inner face of the scissor legs box sections. This was observed in 94% of lifts.

Typical cracking in boss

WYG believe that the defects outlined in section 3.1 points 1 and 2 are as a result of fatigue.

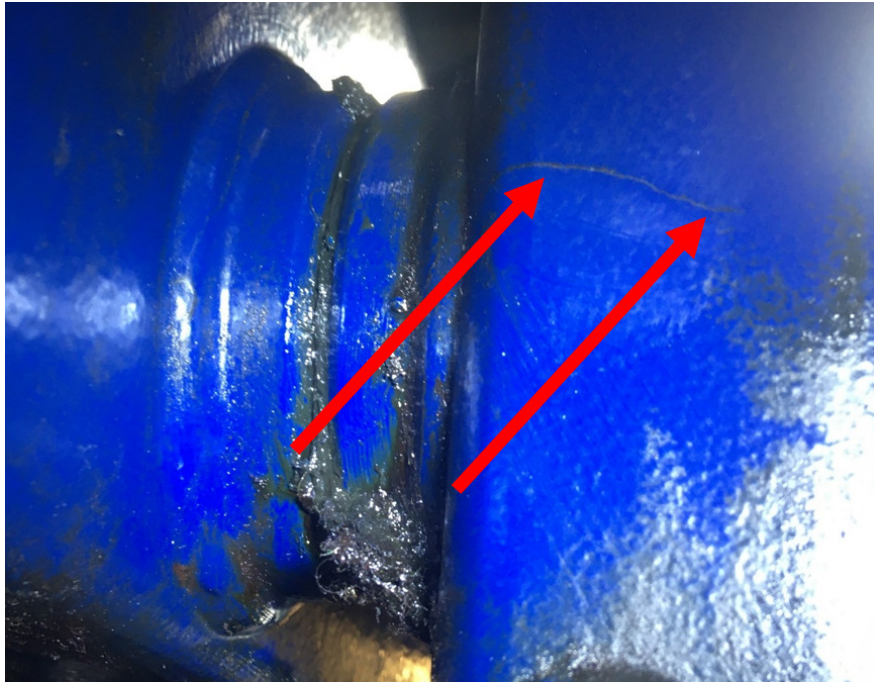
9. In some instances, the cracking described in point 1 was observed to propagate into the underside of the rectangular hollow section scissor legs. This was observed in 25% of lifts. However it was not possible to quantify the exact number of legs affected due to the presence of remedial steel plates, as discussed in point 4.

Cracking observed to underside of box section

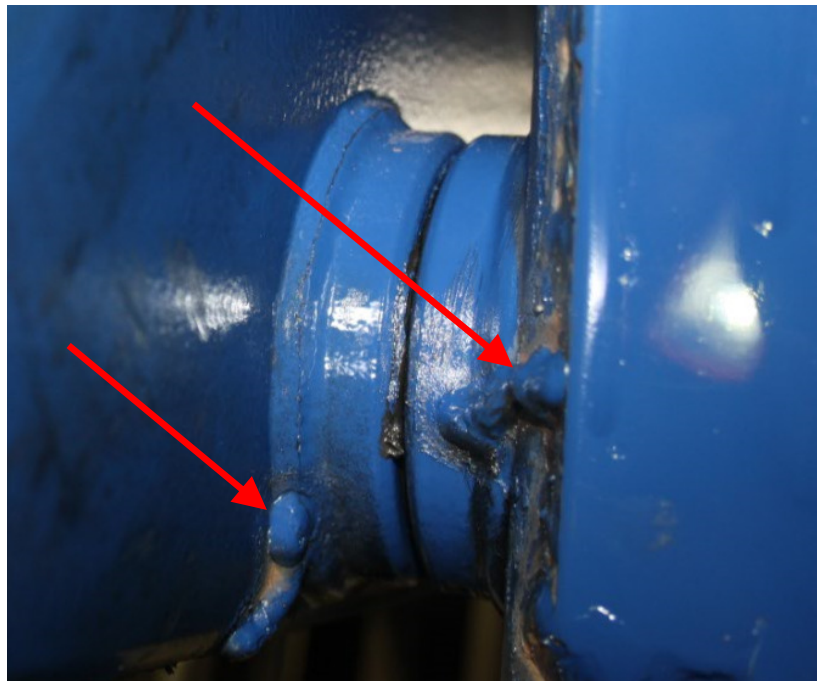
10. In some instances, remedial welding has been undertaken around the boss, presumably as an attempt to cease the propagation of the cracking noted in points 1 and 2. This was observed in 42% of lifts.

Localised site welding observed to boss

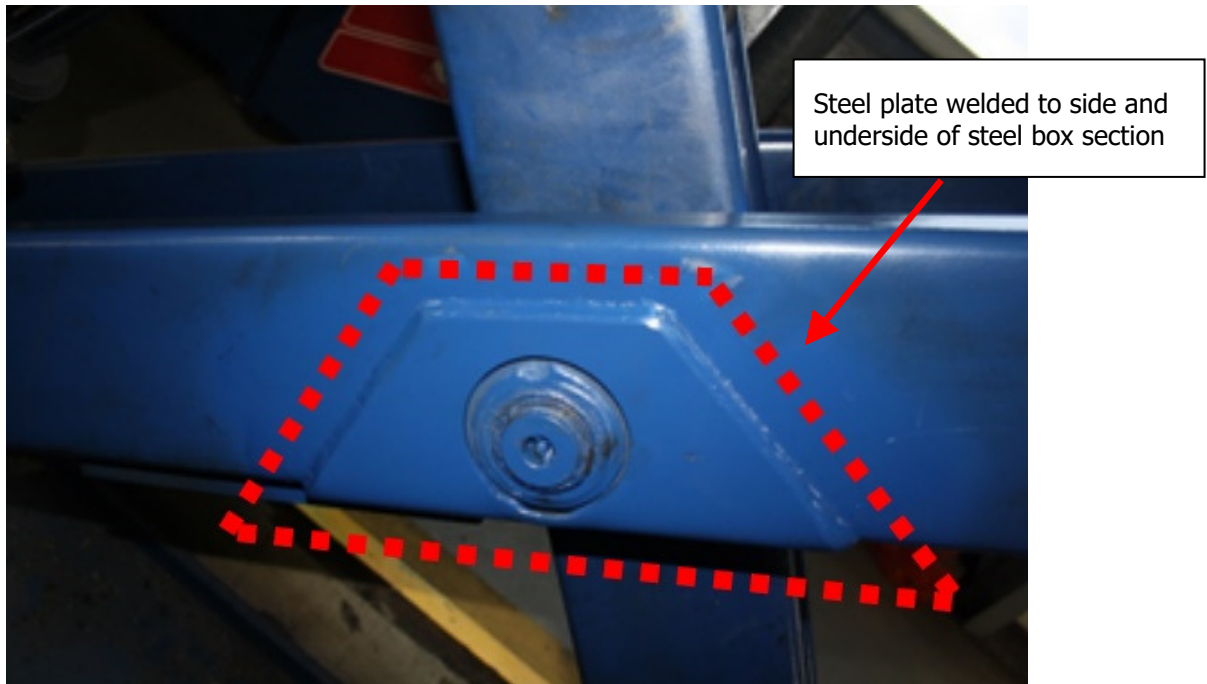
Typical remedial steel plates welded to outer face of outer box section

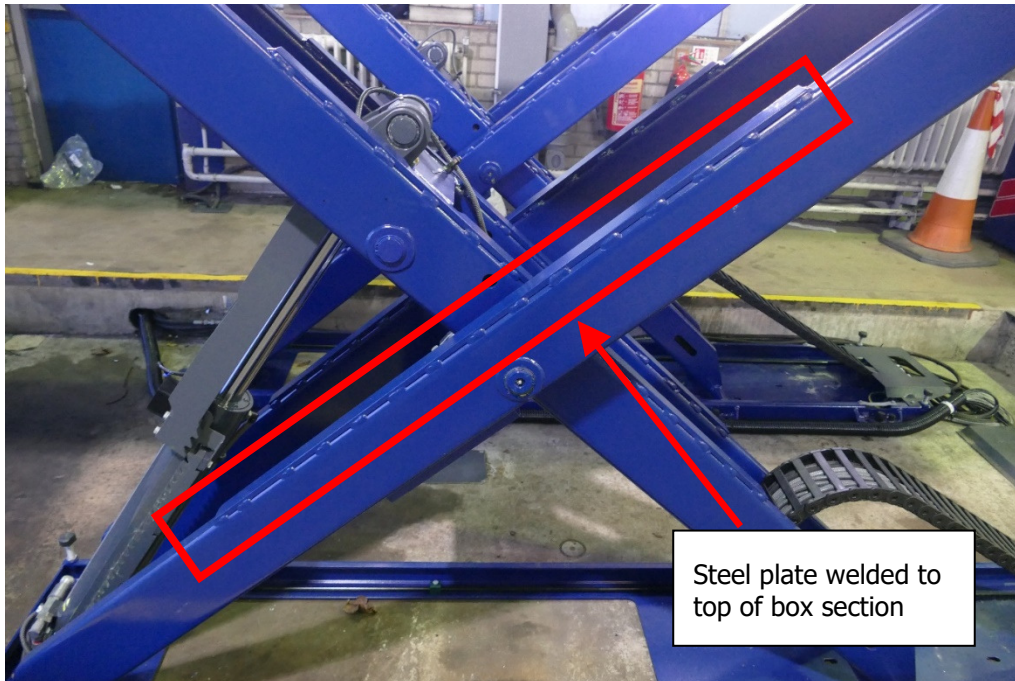
- The addition of 1200mm long x 40mm wide by 10mm thick plates welded to the top of the 150mm x 50mm rectangular hollow section scissor legs over the pivot using hit and miss fillet welds.
- The fillet welds securing the bosses to the scissor legs also appeared to have a larger throat thickness. However this could not be measured due to the narrow gap between the scissor legs (approximately 30mm).

1200mm x 40mm x 10mm plate hit and miss welded to top of scissor legs

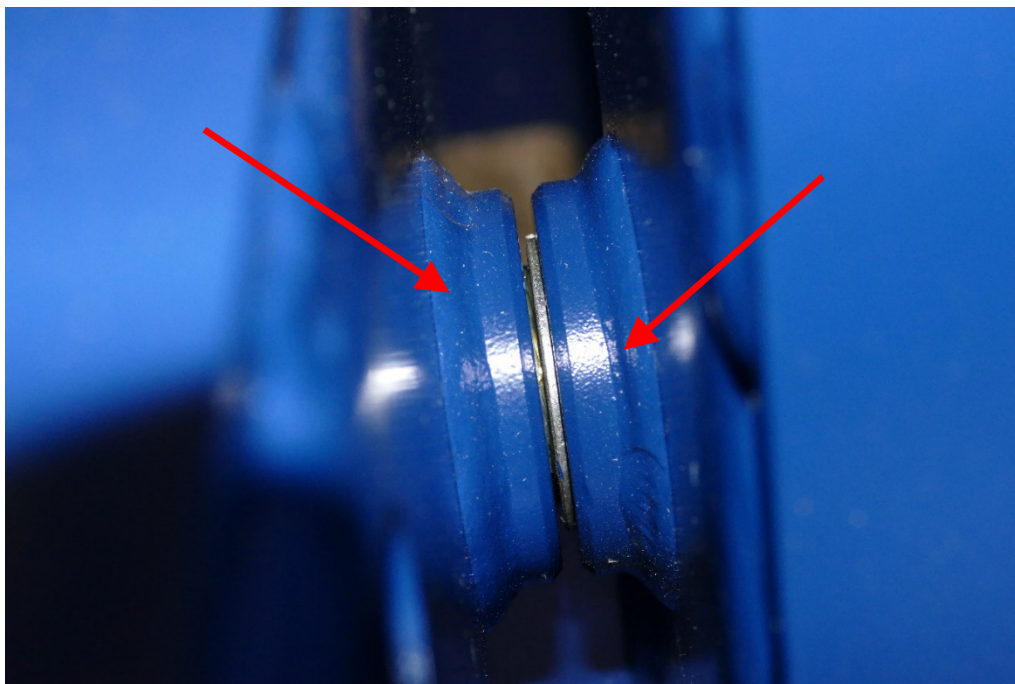
Larger weld around boss
