# Cavity Wall Insulation Research Project 2019

Research study prepared for the  
Northern Ireland Housing Executive

Research study prepared by Consultancy, Investigation and Training (CIT)  
for the Northern Ireland Housing Executive

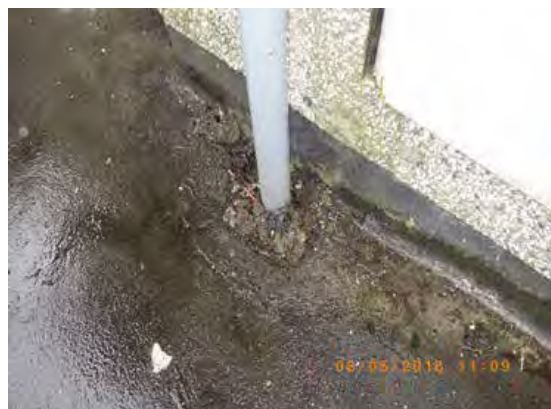
Figure 6.1 Blocked drainage

The drainage to the front elevation on the floor above this property is blocked causing the water to overflow resulting in some staining to the walls and roof section. If not remediated the risk of damaging the render will be greater with the potential for excess water ingress to the cavity and potential compromise of both the CWI installation and inner wall areas.

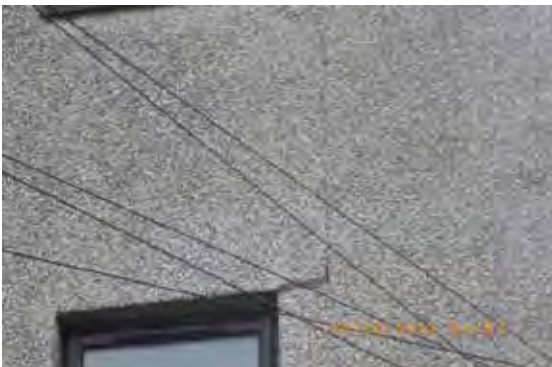
The render covering on the rear of the property is damaged with a crack running down the wall. If not remediated, the risk of further damage to the render will be greater with the potential for excess water ingress to the cavity potentially compromising both the CWI installation and inner wall areas.

Figure 6.5 Crack running down the rear elevation

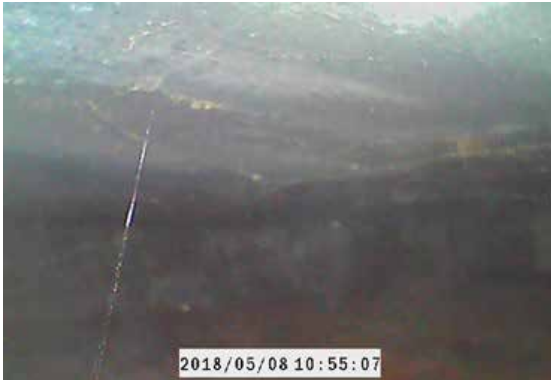
For these reasons the CWI has been compromised. The debris must be removed because it could be a conduit for moisture to travel across the cavity to the inner wall, representing a risk of compromising the inner wall and resulting in the formation of damp. Voids in the insulation could increase the risk of condensation forming on the inner wall due to the cold bridging effect.

Figure 6.12 Voids and debris in the cavity

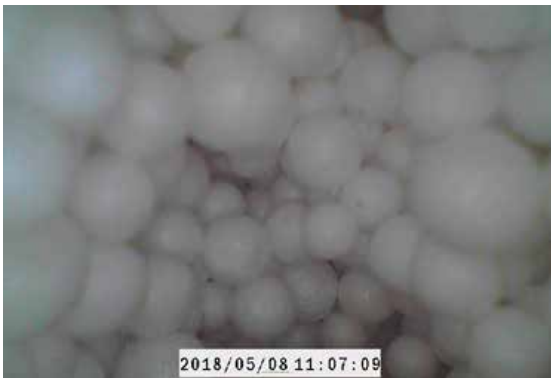
Figure 6.13 Voids in the CWI

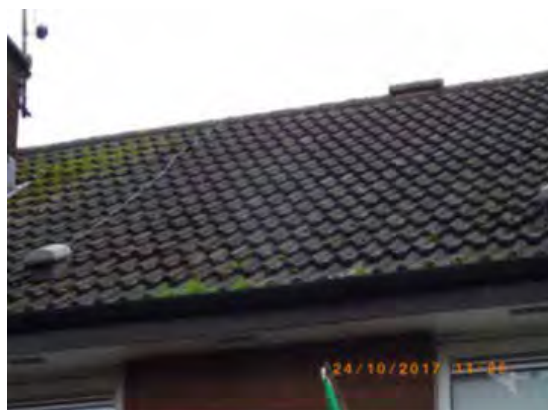
The guttering is in a relatively good condition but has vegetation growth in both the front and rear sections which if not removed, would increase the risk of water overflowing onto the external wall area accessing the cavity with the potential to compromise the inner walls.

Figure 6.15 Vegetation growth in guttering (front) elevation.

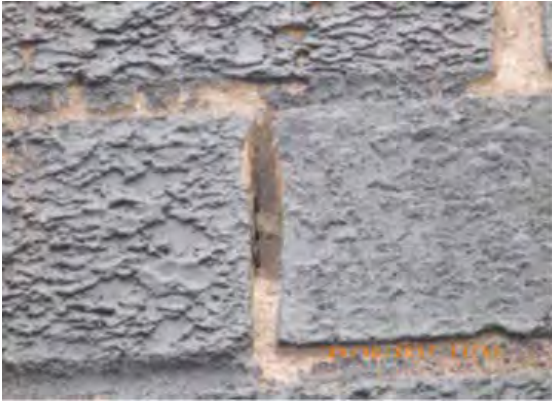
The brickwork mortar joints on the side and rear elevations of the property show evidence of erosion. Weathering and lack of maintenance are contributors to this condition which if left un-remediated will allow excess water to access into the cavity, potentially compromising both the CWI installation and inner wall areas.

Figure 6.18 Mortar erosion (side) elevation

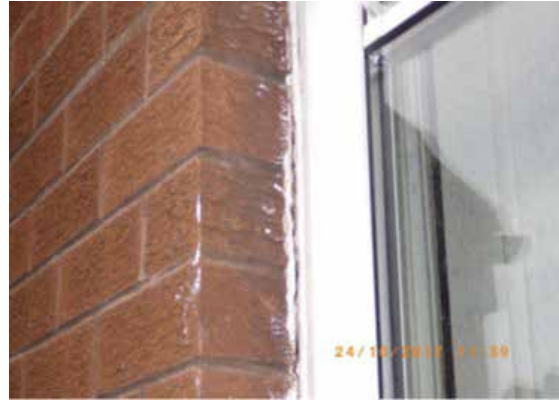
Perimeter seals on all ground floor windows on the front elevation and all ground floor windows and door on the rear elevation are defective and require remediation. The perimeter seals have either eroded or are missing and if left un-remediated will allow water to access into the cavity, potentially compromising both the CWI installation and inner wall areas.

Figure 6.20 Perimeter seals (window)

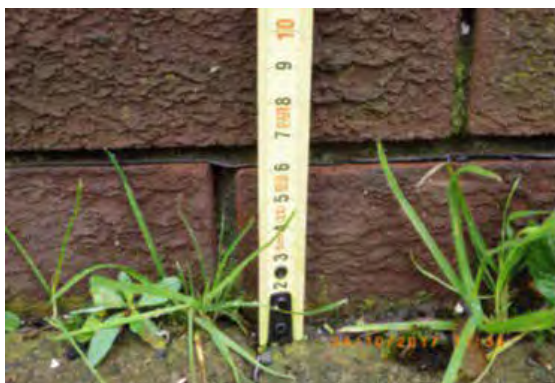
The DPC level on the front, side and rear elevations is below the recommended 150mm level. As a consequence, accelerated soaking of the outer leaf brickwork could occur and cause excess moisture to access into the cavity, potentially compromising both the CWI installation and inner wall areas.

Figure 6.22 DPC level below 60mm

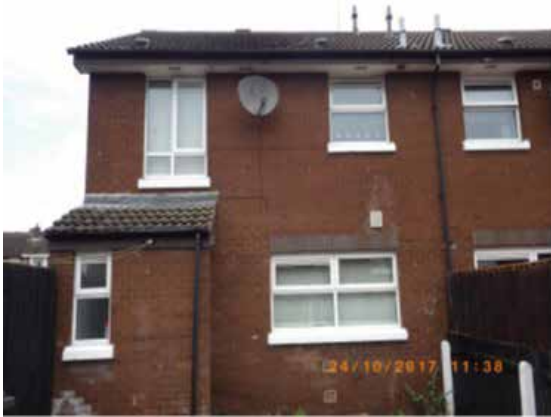
Figure 6.26 Rear elevation

Assessment of the drilling pattern identified that the injection holes were too far apart on all elevations, resulting in a failure of the CWI material to distribute evenly into the cavity and achieve the required density fill. This CWI installation is non-compliant with the requirements of the system designer's manual and the issued system Agrément Certificate.

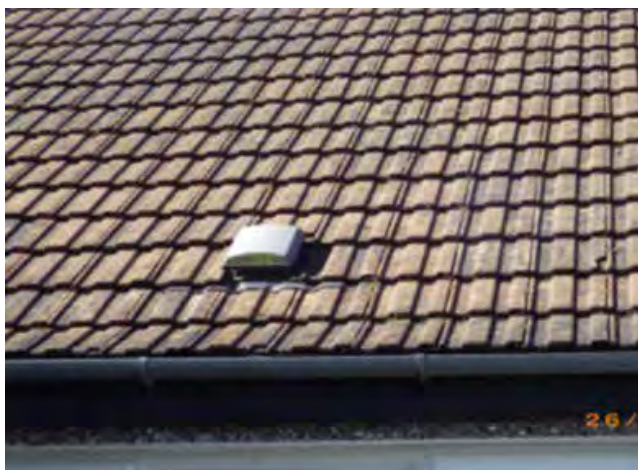
The pitched roof of the property is in a generally good condition with no defects or maintenance-related issues identified during the survey. There is one broken tile on the front elevation, but this is not currently having a detrimental effect on performance or causing the condition to deteriorate.

Figure 6.27 Broken roof tile

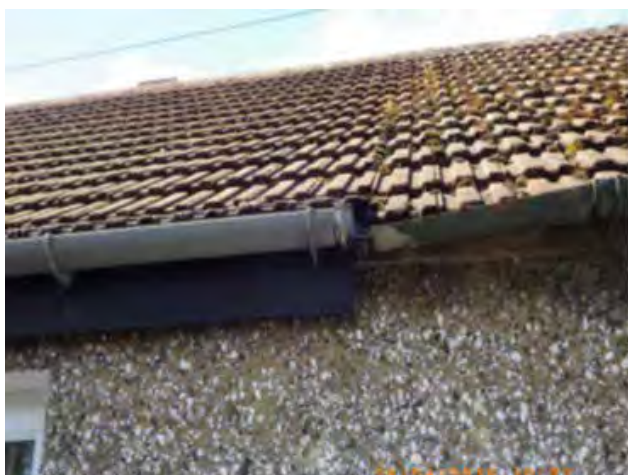
Figure 6.28 Broken guttering joint

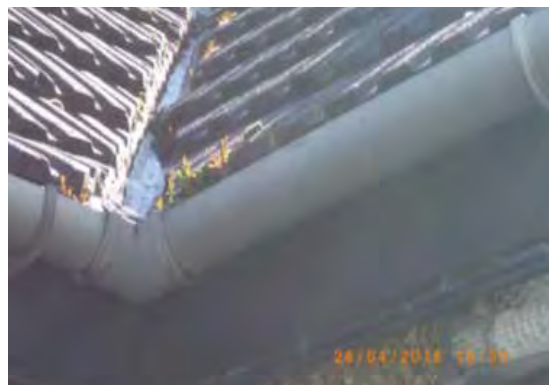
The guttering is in a relatively good condition but has vegetation growth in the rear sections which if not removed would increase the risk of water overflowing onto the external wall area and accessing the cavity with the potential to compromise the inner walls. The guttering joint between the adjoining property has failed and if this is not remediated water volume flowing onto the render will increase and have the potential to compromise the inner walls.

Figure 6.29 Blocked guttering

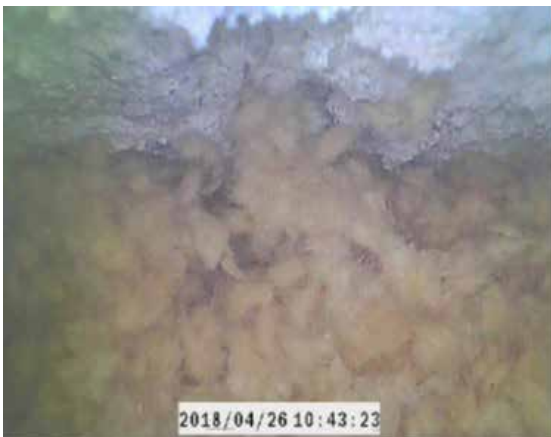
The cavity was assessed by way of intrusive borescope inspection at nine different intervals (three on each elevation) on all accessible elevations. On the front elevation two of the borescope inspections identified voids in the CWI and one with an inadequate fill. On both the side and rear elevations only one of the borescope inspections identified a void in the CWI, with the other two inspection points compliant with requirements. Voids in the CWI could increase the risk of condensation on the inner wall due to the cold bridging effect.

Figure 6.32 Void in the CWI

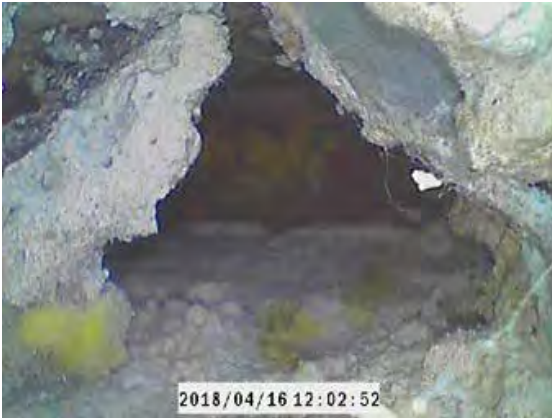
Figure 7.6 Void in the CWI installation

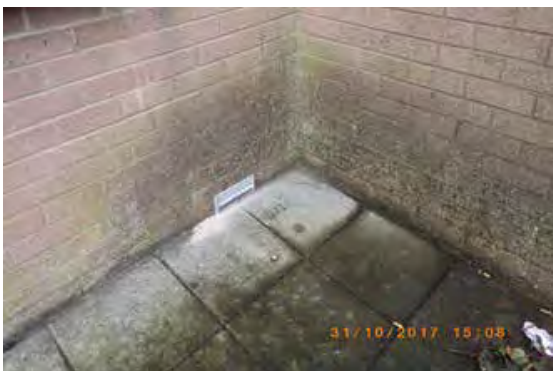
Figure 7.20 Compromised DPC

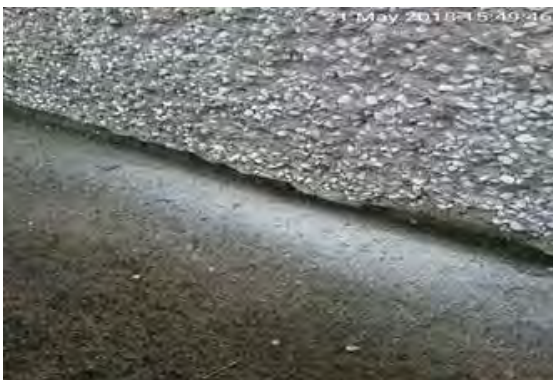
Figure 7.21 Non-compliant DPC level

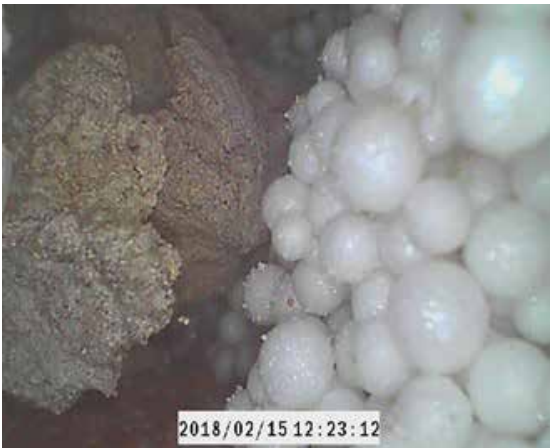
Figure 7.23 Debris in cavity and void in CWI

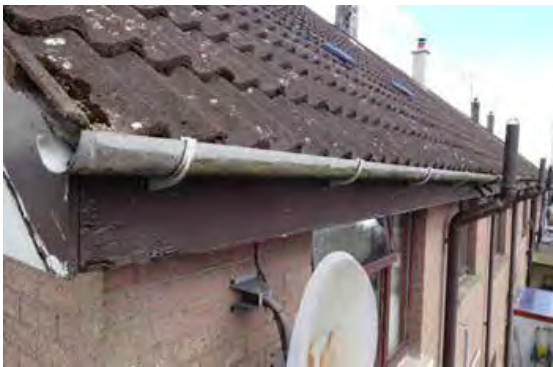
Figure 7.50 Damaged guttering

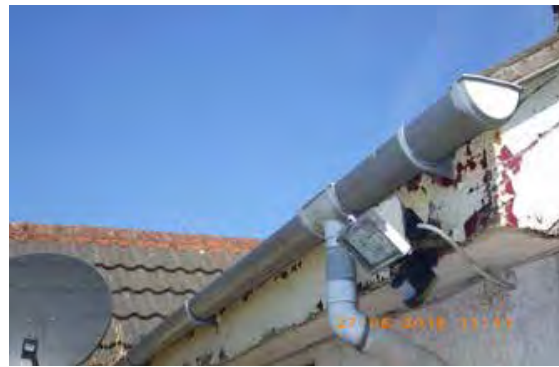
Figure 7.52 Damaged soffit and fascia

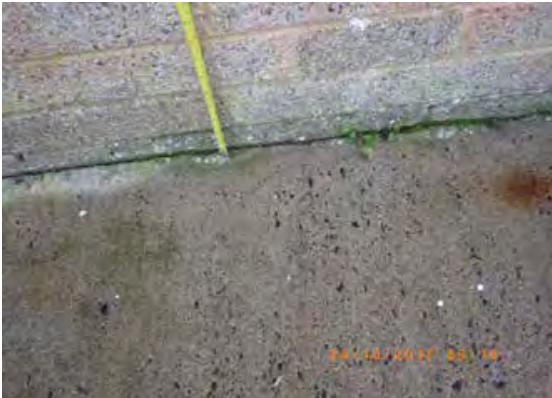
Figure 7.54 Non-compliant DPC level (below 150mm)

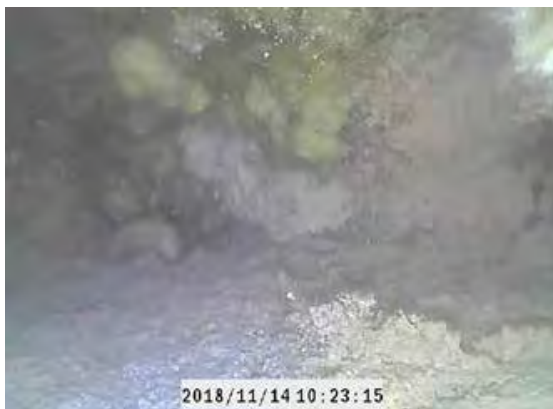
Figure 8.3 Voids and debris in the fibre CWI

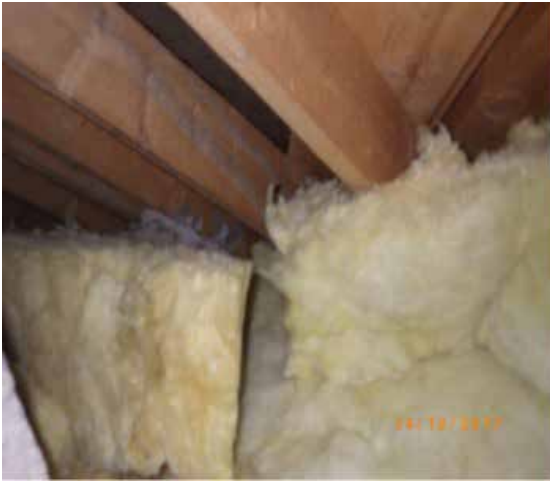
Eaves blocked with loft insulation (22%) (ref: figure 8.23 & 8.24). Where eaves are blocked with insulation (this can be either loft insulation or CWI) the insulation will reduce the air flow into the loft space which will increase the risk of condensation on underside of the roof. Over time this will allow water droplets to fall onto the ceiling below compromising the boards and loft insulation. The moisture forming on the underside of the roof may also affect the rafters, joists and the electrical wiring in the roof.

Figure 8.23 Eaves blocked with loft insulation
