Director of Engineering Memorandum
DEM 128/10 Revision R04
DEM TITLE: Management of Existing Vehicle Restraint Systems

Author :	Stephen Bradshaw
Version :	4
Implementation Date:	To be effective from the 'Date Issued'
Date issued to users:	March 2017

Appendix 3: Damage Examples

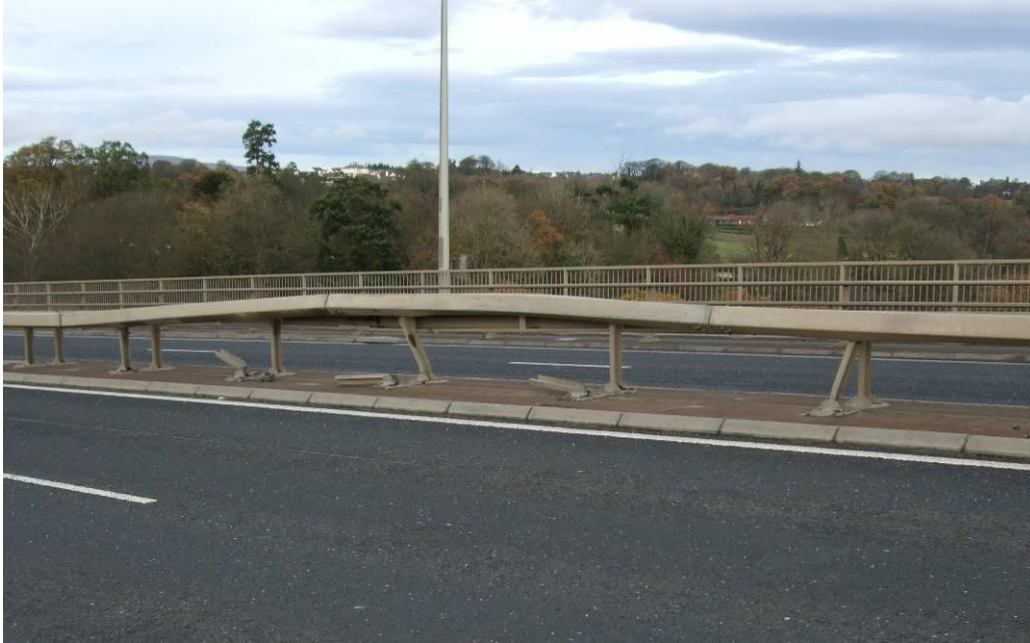
1. Damage: Barrier no longer reasonably functional.

Rail is bent/pushed more than 450mm out of line, and height is outside tolerances or three or more posts are broken/bent over and separated from the rail.

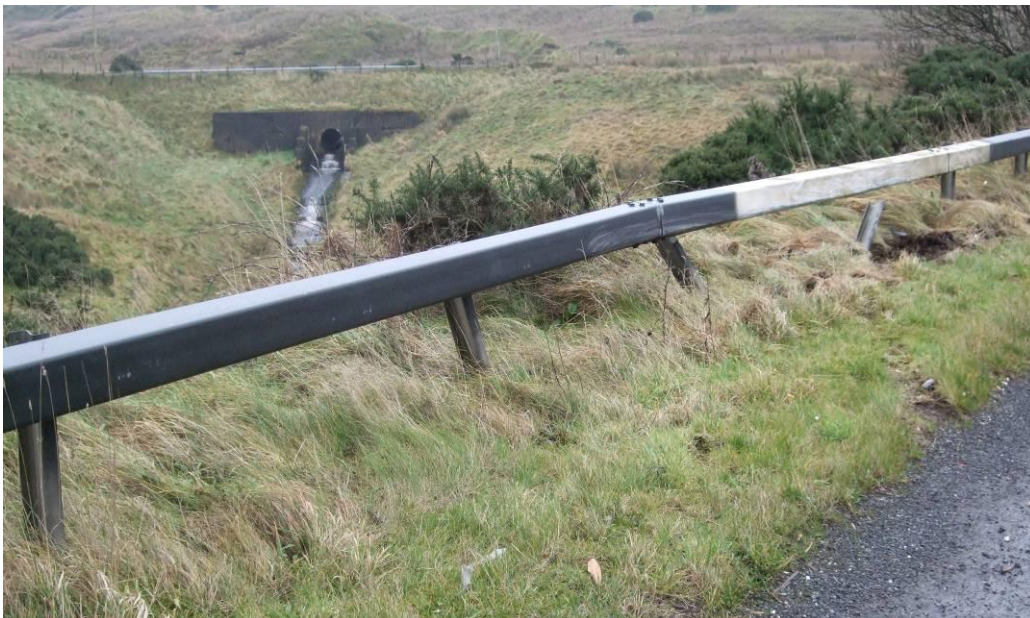
Rail element remains intact, no tears and joints remain undamaged. (Note however the posts will fall within the hazardous category.)

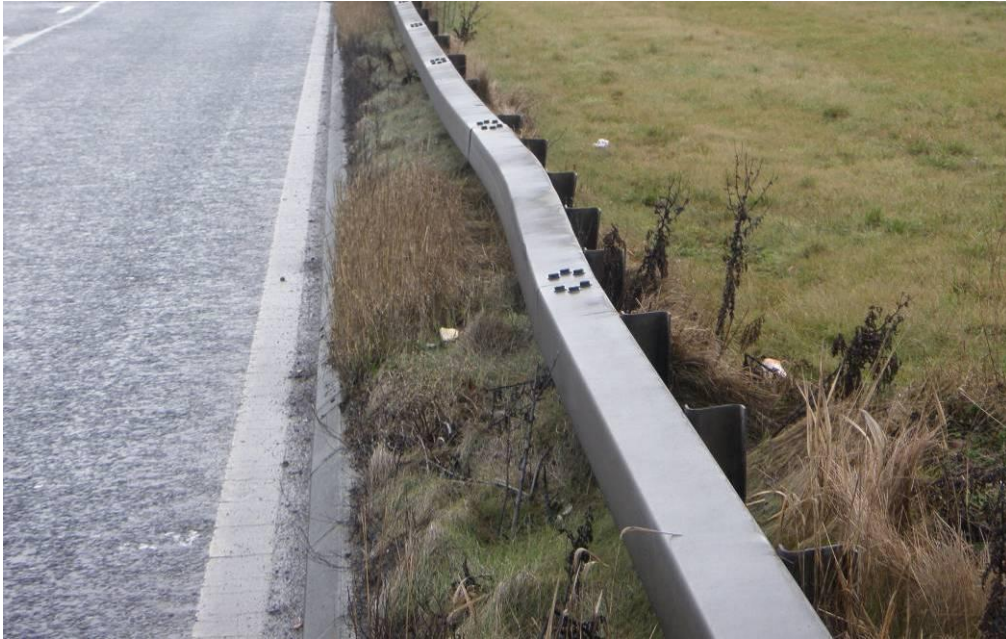
2. Damage: Barrier should function adequately under the majority of impacts.

Rail is bent/pushed out of line less than 300mm, rail element is intact (no tears or damaged overlaps).

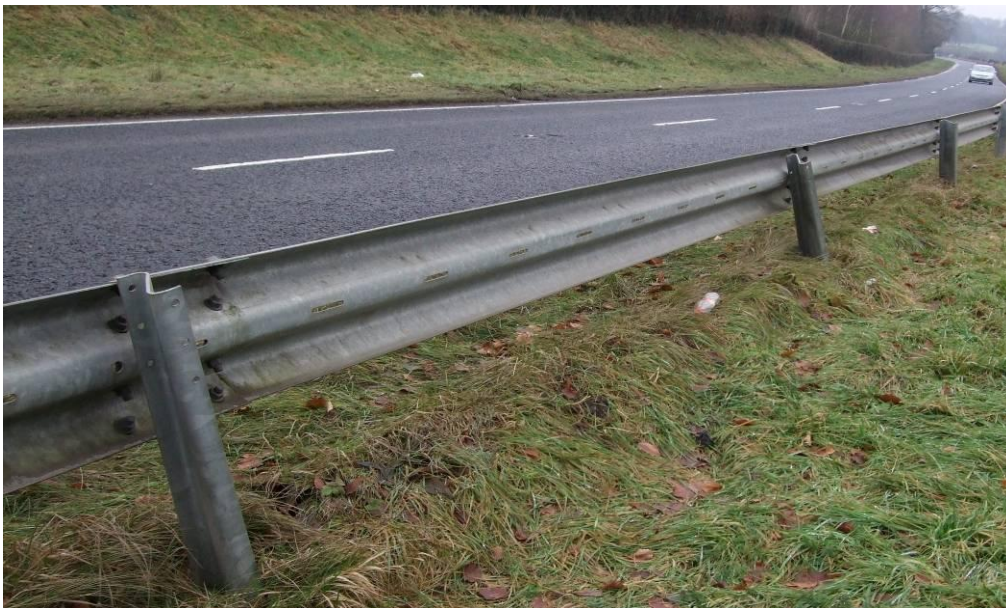
Rail element is still intact, no tears and joints remain undamaged, only 2 posts damaged.

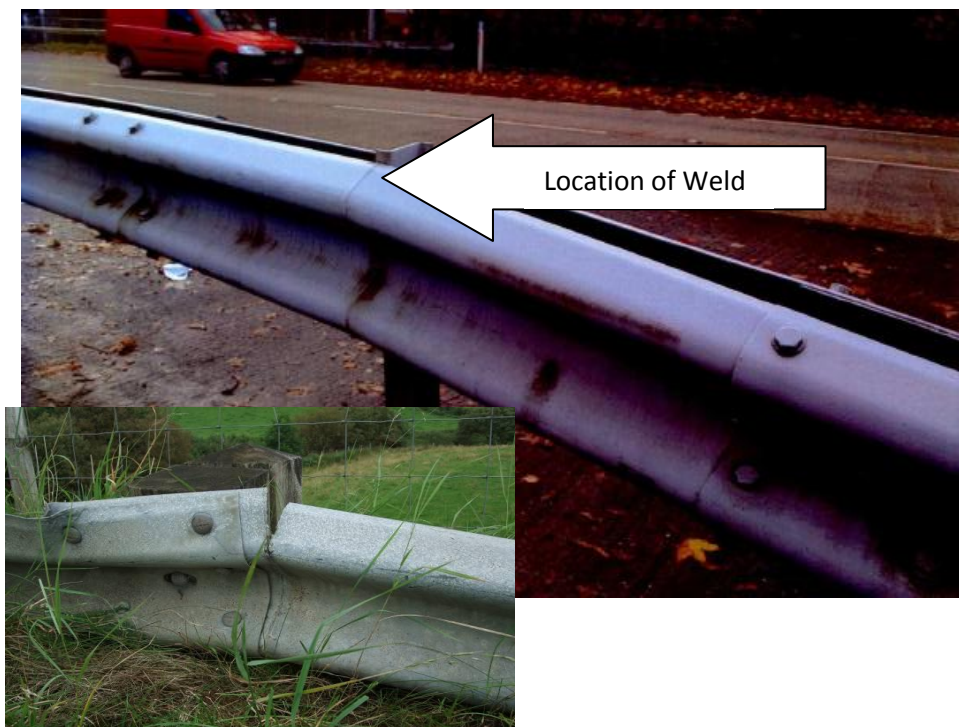
Welded angle beams – Note: Weld split on

If an existing VRS incorporates the welded angle beam as part of the terminal detail, this component must be replaced with a standard rolled angle beam or current standard terminal. If the VRS under consideration has wooden posts, a full VRS replacement shall be undertaken, refer to Section 6.

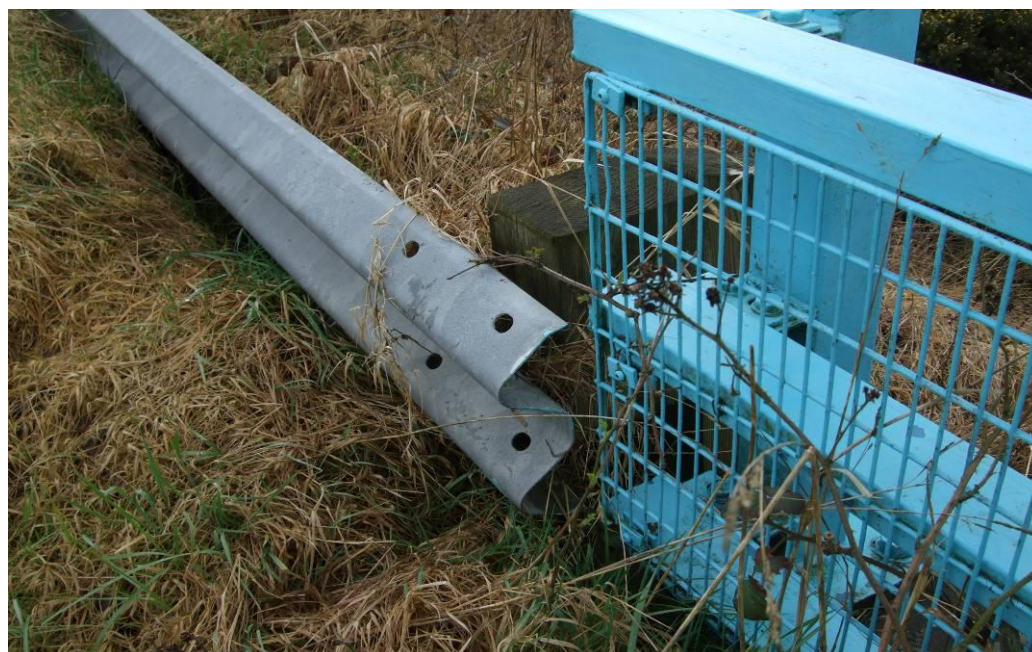
***Beam is not attached to post
No connection to parapet
Barrier and parapet misaligned***

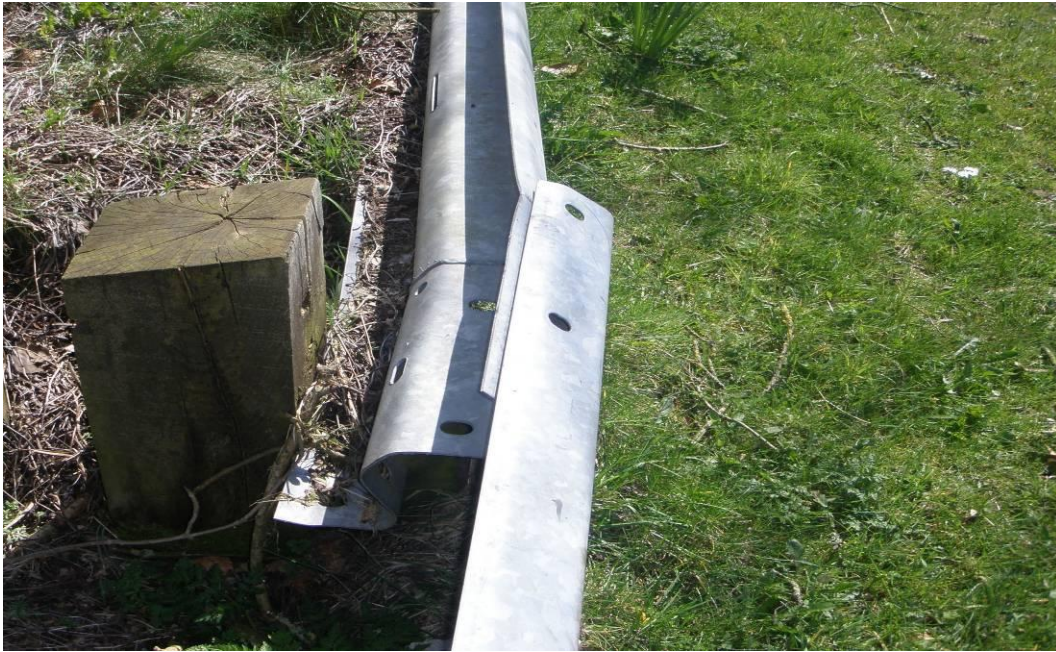
Wooden post, blocked out piece missing, barrier not connected to post, top of rail low, all bolts/fixings missing.

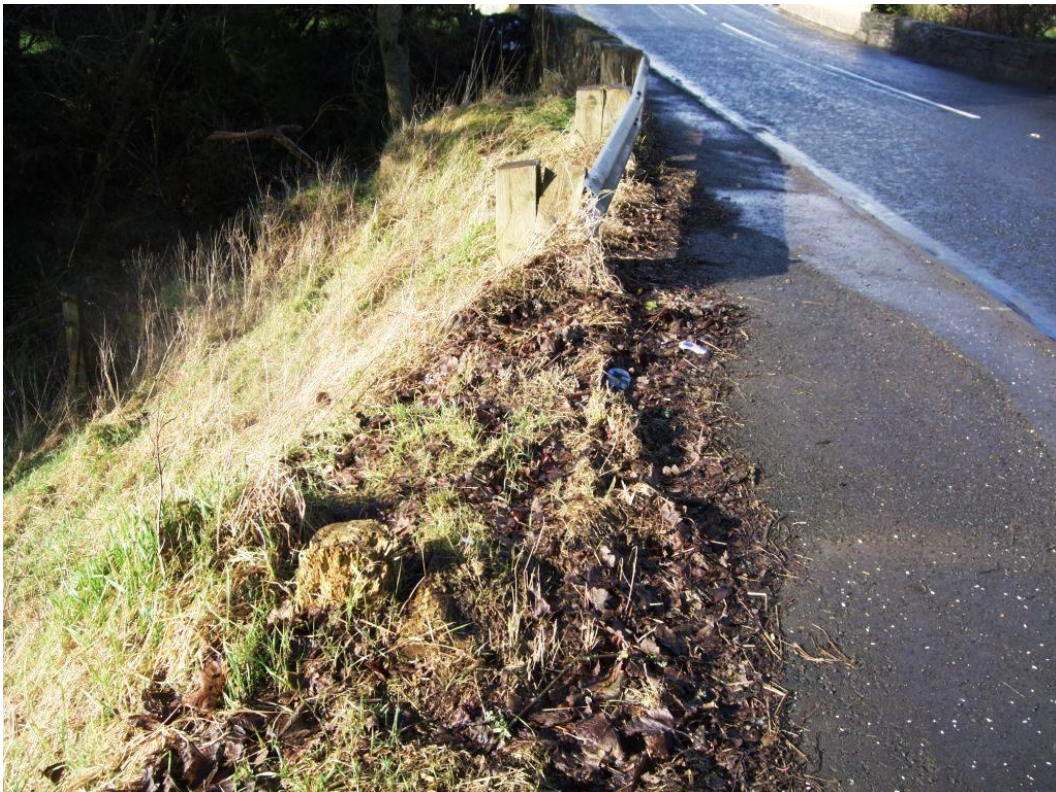
No Approach Terminal, Rotten Wooden Posts, Hazard within working width, insufficient length of hazard protection.
