Linen Green, Moygashel

Feasibility Report

Dfl Rivers

Project Number: 60507602

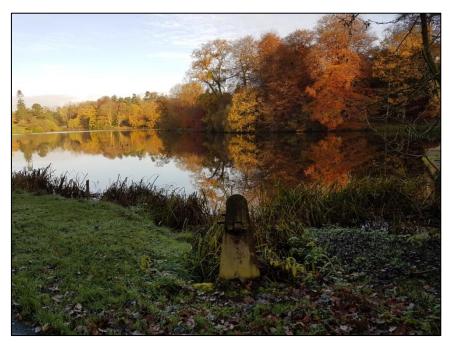
An abandoned mill race which was originally fed from the Park Lake is still present along the side of the hill from the dam to the Linen Green on the west side of the development. There remains a connection from the Park Lake however the flows are controlled by means of a sluice. A small flow was observed in the mill race immediately downstream of the dam however this escaped a short distance downstream through a gap in the bank to the main river channel. It is assumed that this flow originates due to seepage and leakage through the sluice inlet structure. Beyond this point the water in the channel is stagnant with algae growth observed.

Picture 3.4 Mill Race Inlet Sluice

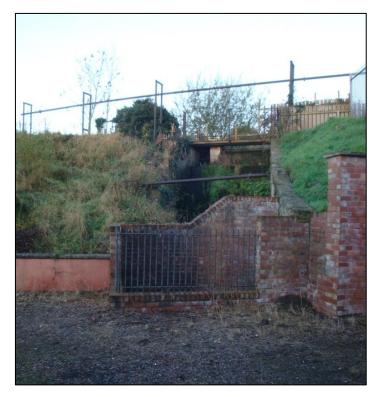
It is thought that this mill race now acts primarily as a land drain and may receive surface water drainage flows from adjacent developments. Survey work has suggested that multiple connections exist between the mill race and the Linen Green culvert however these have not been proven. A sluice arrangement is present near the southern end of the mill race which also includes a spill weir which would regulate the level should flows be conveyed. Again, the sluice gate is closed and the small flow observed down the cascade is probably from seepage and leakage through the gate. A 900mm diameter precast concrete pipe exits a chamber at the bottom of the cascade through a vertical grille.

Picture 3.5 Outlet Sluice, Overflow and Cascade at Linen Green

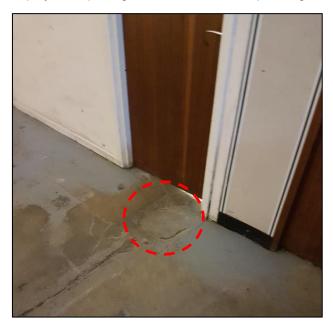
During a site visit on 15th November 2016, contact was made with employees who work in the Print Press who said that the building (which is located on the line of the culvert) has flooded numerous times in the past 25 years with flooding having occurred more than once annually. It is understood that the flooding is a result of surcharge of the system, including poorly sealed redundant floor gullies inside the building, with employees reporting that "water bubbles up through the floor".

Picture 6.1 Redundant sealed floor gully inside Print Press building

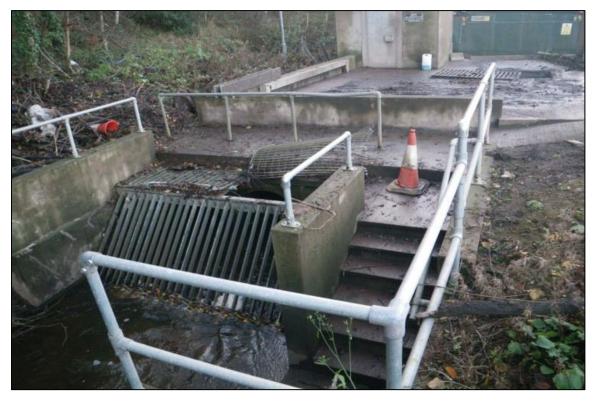
A primary cause of the flooding is believed to have been the blockage of the grille on the culvert inlet structure to the north of the Transport NI depot. This grille is reported to have been inspected on 30th November as part of Dfl Rivers maintenance process with the removal of debris occurring. It was further inspected on 5th December following the issue of a yellow weather warning in anticipation of Storm Desmond and was reported as being in a satisfactory condition.

Picture 6.2 Inlet to culvert showing platform removed (Dfl Rivers Flooding Incident Report)

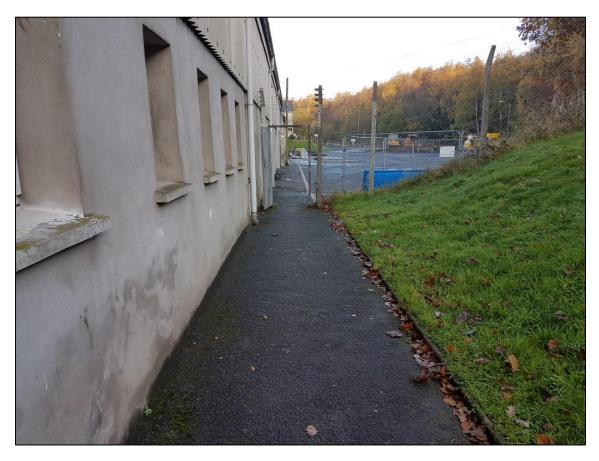
Flood waters at the Transport NI depot were reported to be of depth approximately equal to the height of the window sill along the eastern side of the garage. Site measurements were taken during a walkover survey which show that this was a depth in the order of 1.1m; see Picture 6.3 below.

Picture 6.3 Windows along eastern side of Transport NI Garage

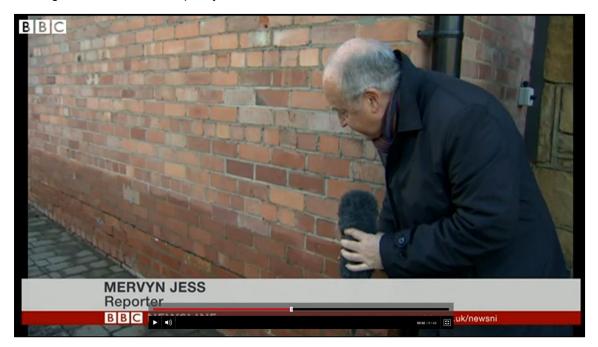
Picture 6.4 and Picture 6.5 below, taken from regional media coverage, illustrate that the flood waters reached depths in the region of 500-600mm within the Linen Green complex. It should be noted that these levels are only an indication of the depth of flood waters. Flow levels may be exaggerated via the wake of vehicles passing through the flows, although the depth of flow would suggest that vehicles would have been unable to pass. It is more likely that levels would be exaggerated through soaking of the wall i.e. the capillary action of the materials involved would draw water into drier areas.

Picture 6.4 Screengrab from BBC News footage showing depth of flooding at east end of "The Weaving Sheds" building (BBC)

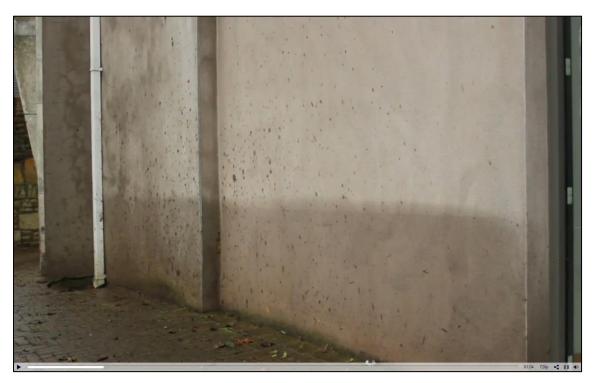
Picture 6.5 Screengrab from Belfast Telegraph footage showing depth of flooding at northern end of "The Warehouse" building (Belfast Telegraph)

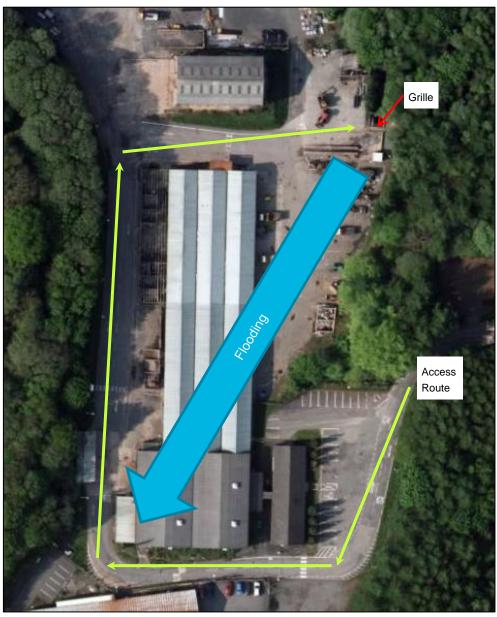
Figure 9.1 Grille Access

The report of the incident provided to AECOM by Dfl Rivers highlights that flooding was occurring at the Transport NI prior to 3am which was confirmed when a Dfl Rivers Engineer visited the site at approximately 3:30am. Several attempts were made to access and clear the grille however these were unsuccessful due to the resulting flooding. Access to the grille was normally gained by going around the Transport NI buildings (see Figure 9.1) however given the topography, flood waters had effectively cut off this route.

Provision of a pedestrian access route from the higher land to the east is proposed to allow access to the screen to be gained should flooding occur within the Transport NI depot. The current access route (as highlighted in Section 9.1) involves personnel going around the buildings and having to cross the culvert or path of the overland flows and potentially introduces the risk of the structure being cut-off as happened during the December 2016 event. It is noted that this area contains a wooded embankment so it may be necessary to include stepped access.

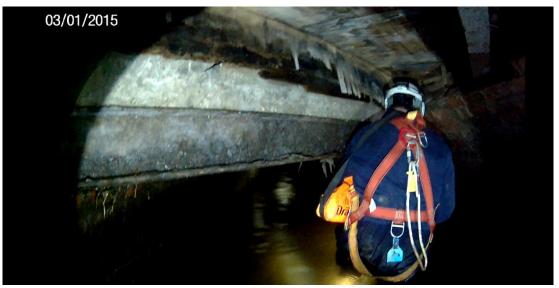
The investigations have revealed that parts of the culvert are in a very poor condition with major structural issues, some of which appear to have been recently caused during redevelopment works on the Linen Green site. Obstructions and debris lead to a reduction in the capacity of the culvert which is likely to have been a key factor in the flooding that occurred on 6th December 2015.

Picture 9.1 Obstruction across culvert upstream of manhole U4304/05

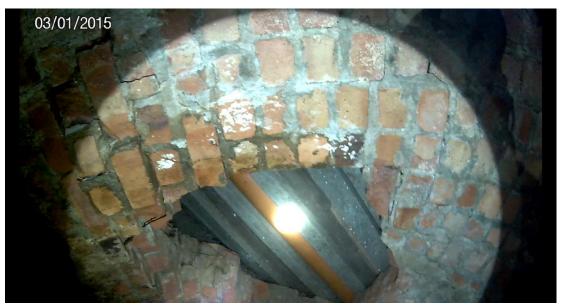
Picture 9.2 Missing bricks in roof of culvert near manhole U4304/06

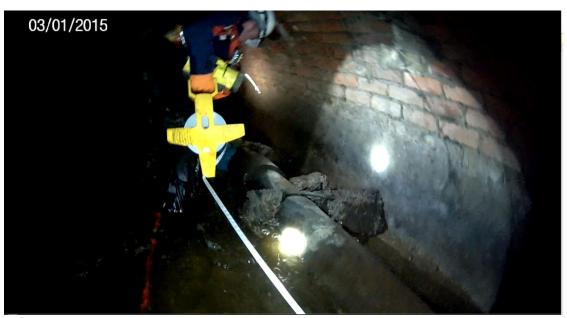
Defects encountered include debris, siltation, holes, poor connections, missing bricks, and a redundant water main in the base of the culvert from U3404/05 to U3404/01 which include valves and

Picture 9.3 Obstruction (water main) along culvert between manholes U4304/02 and U4304/03
