York Street Interchange

Placemaking & Active Travel Review

Annex A – Active Travel | Baseline Review
(Stage 1)

October 2022

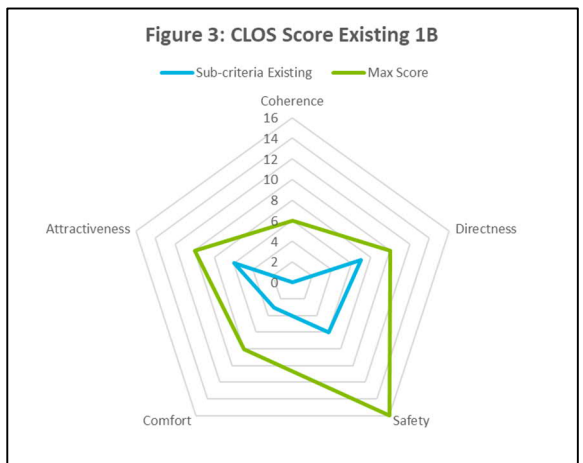
Section 1B has failed to meet the 70% threshold to pass the CLoS audit, scoring 44%. The section also features two critical fails. Critical fails are due to:

- An AADT of 14000 (above the critical fail threshold of 10000); and,
- Cyclists sharing the carriageway nearside lane, which is within critical range of between 3.2m and 3.9m wide (measured from aerial imagery, topographical survey required for confirmation).

Max possible score	50
Audit % score	44%
Pass/Fail (70% threshold)	Fail
Any Critical Fails? (Y/N)	Yes
Number of Critical Fails	2

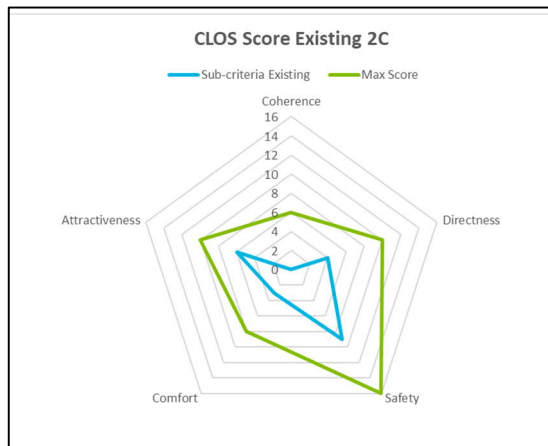
Section 2C has failed to meet the 70% threshold to pass the CLoS audit, scoring 44% with two critical fails. Critical fails are due to:

- An AADT of 21271 (above the critical fail threshold of 10000); and
- Cyclists sharing the carriageway nearside lane, which is within critical range of between 3.2m and 3.9m wide (measured from aerial imagery, topographical survey required for confirmation).

Max possible score	50
Audit % score	44%
Pass/Fail (70% threshold)	Fail
Any Critical Fails? (Y/N)	Yes
Number of Critical Fails	2

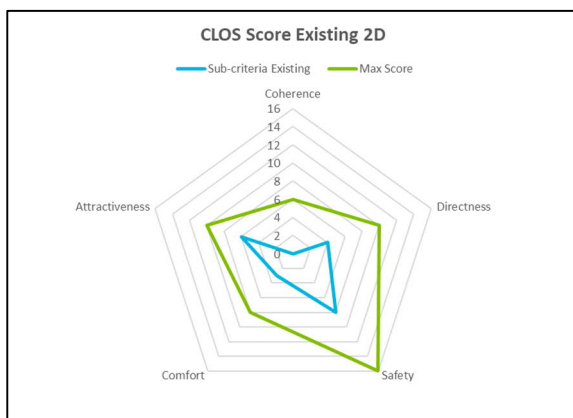
Section 2D has failed to meet the 70% threshold to pass the CLoS audit, scoring 44% and two critical fails. Critical fails are due to:

- An AADT of 14258 (above the critical fail threshold of 10000); and
- Cyclists sharing the carriageway nearside lane, which is within critical range of between 3.2m and 3.9m wide (measured from aerial imagery, topographical survey required for confirmation).

Max possible score	50
Audit % score	42%
Pass/Fail (70% threshold)	Fail
Any Critical Fails? (Y/N)	Yes
Number of Critical Fails	2

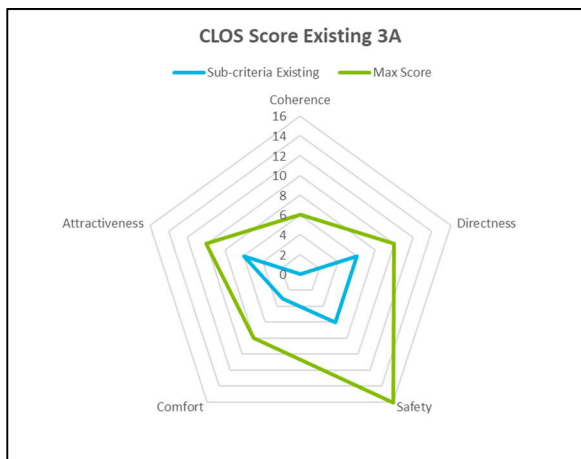
Section 3A has failed to meet the 70% threshold to pass the CLoS audit, scoring 42% with two critical fails. The critical fails are due to:

- An AADT of 10752 (above the critical fail threshold of 10000); and
- Cyclists sharing the carriageway nearside lane, which is within critical range of between 3.2m and 3.9m wide (measured from aerial imagery, topographical survey required for confirmation).

Max possible score	50		
Audit % score	42%		
Pass/Fail (70% threshold)	Fail		
Any Critical Fails? (Y/N)	Yes		
Number of Critical Fails	2		
Criteria	Max Score	Sub-criteria Existing	% score Existing
Coherence	6	0	0%
Directness	10	6	60%
Safety	16	6	38%
Comfort	8	3	38%
Attractiveness	10	6	60%
	50

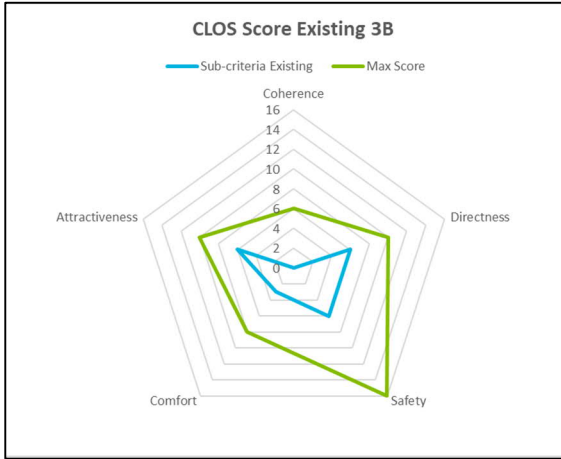
Section 3B has failed to meet the 70% threshold to pass the CLoS audit, scoring 42% with two critical fails. The critical fails are due to:

- An AADT of 22089 (above the critical fail threshold of 10000); and
- Cyclists sharing the carriageway nearside lane, which is within critical range of between 3.2m and 3.9m wide (measured from aerial imagery, topographical survey required for confirmation).

Max possible score	50
Audit % score	42%
Pass/Fail (70% threshold)	Fail
Any Critical Fails? (Y/N)	Yes
Number of Critical Fails	2

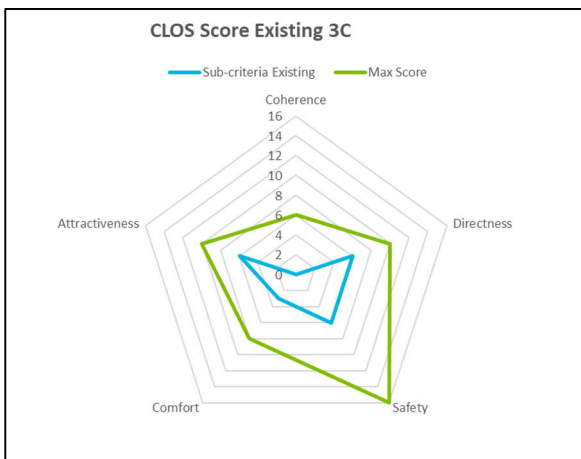
Section 3C has failed to meet the 70% threshold to pass the CLoS audit, scoring 42% with two critical fails. The critical fails are due to:

- An AADT of 20453 (above the critical fail threshold of 10000); and
- Cyclists sharing the carriageway nearside lane, which is within critical range of between 3.2m and 3.9m wide (measured from aerial imagery, topographical survey required for confirmation).

Max possible score	50
Audit % score	42%
Pass/Fail (70% threshold)	Fail
Any Critical Fails? (Y/N)	Yes
Number of Critical Fails	2

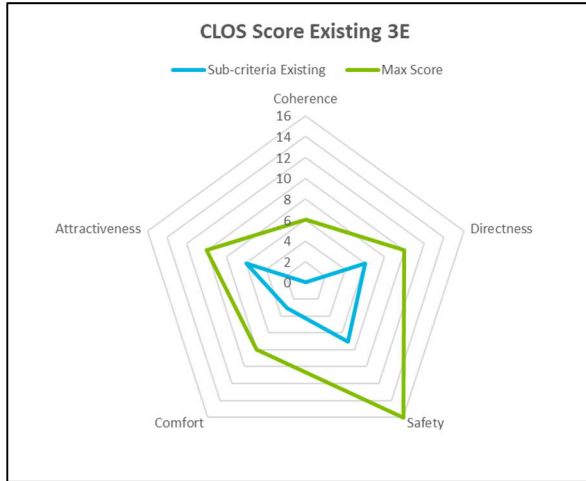
Section 3E has failed to meet the 70% threshold to pass the CLoS audit, scoring 44% with two critical fails. The critical fails are due to:

- An AADT of 23024 (above the critical fail threshold of 10000); and
- Cyclists sharing the carriageway nearside lane, which is within critical range of between 3.2m and 3.9m wide (measured from aerial imagery, topographical survey required for confirmation).

Max possible score	50		
Audit % score	44%		
Pass/Fail (70% threshold)	Fail		
Any Critical Fails? (Y/N)	Yes		
Number of Critical Fails	2		
Criteria	Max Score	Sub-criteria Existing	% score Proposed
Coherence	6	0	0%
Directness	10	6	60%
Safety	16	7	44%
Comfort	8	3	38%
Attractiveness	10	6	60%
	50

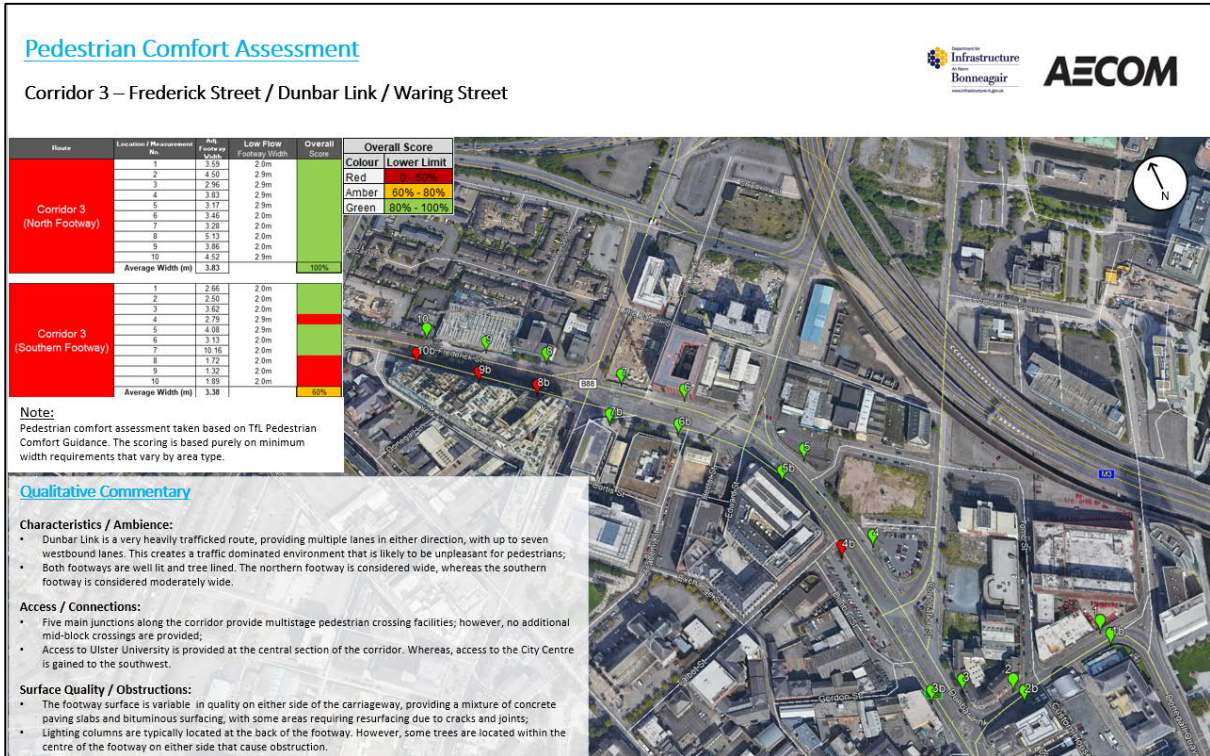
5.4 Pedestrian Comfort Levels baseline results

Results of the Pedestrian Comfort Level baseline assessment and qualitative commentary regarding the pedestrian environment for corridor three are shown in the figure below.

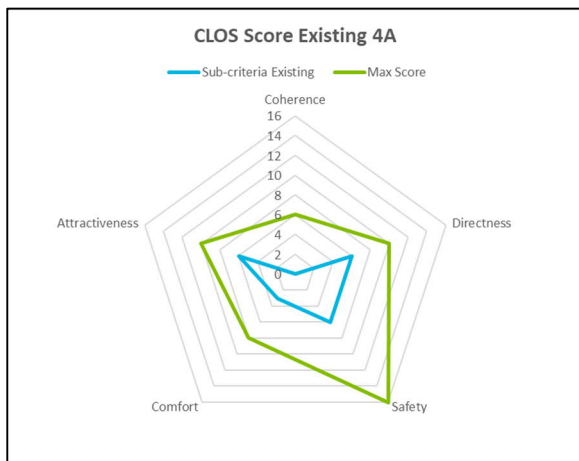
Section 4A has failed to meet the 70% threshold to pass the CLoS audit, scoring 42% with two critical fails. The critical fail is due to:

- An AADT of 13791 (above the critical fail threshold of 10000); and
- Cyclists sharing the carriageway nearside lane, which is within critical range of between 3.2m and 3.9m wide (measured from aerial imagery, topographical survey required for confirmation).

Max possible score	50		
Audit % score	42%		
Pass/Fail (70% threshold)	Fail		
Any Critical Fails? (Y/N)	Yes		
Number of Critical Fails	2		
Criteria	Max Score	Sub-criteria Existing	% score Existing
Coherence	6	0	0%
Directness	10	6	60%
Safety	16	6	38%
Comfort	8	3	38%
Attractiveness	10	6	60%
	50

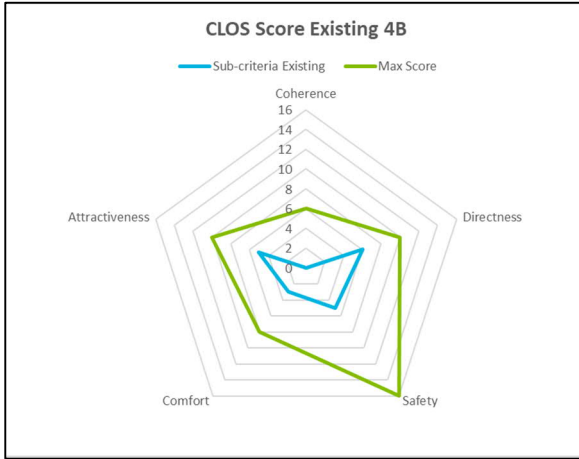
Section 4B has failed to meet the 70% threshold to pass the CLoS audit, scoring 42% with two critical fails. The critical fail is due to:

- An AADT of 13791 (above the critical fail threshold of 10000); and
- Cyclists sharing the carriageway nearside lane, which is within critical range of between 3.2m and 3.9m wide (measured from aerial imagery, topographical survey required for confirmation).

Max possible score	50
Audit % score	38%
Pass/Fail (70% threshold)	Fail
Any Critical Fails? (Y/N)	Yes
Number of Critical Fails	2

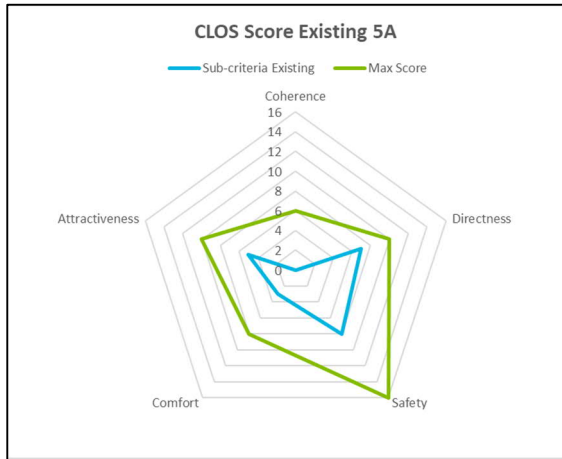
Section 5A has failed to meet the 70% threshold to pass the CLoS audit, scoring 46% and one critical fail. The critical fail is due to:

Max possible score	50
Audit % score	46%
Pass/Fail (70% threshold)	Fail
Any Critical Fails? (Y/N)	Yes
Number of Critical Fails	1

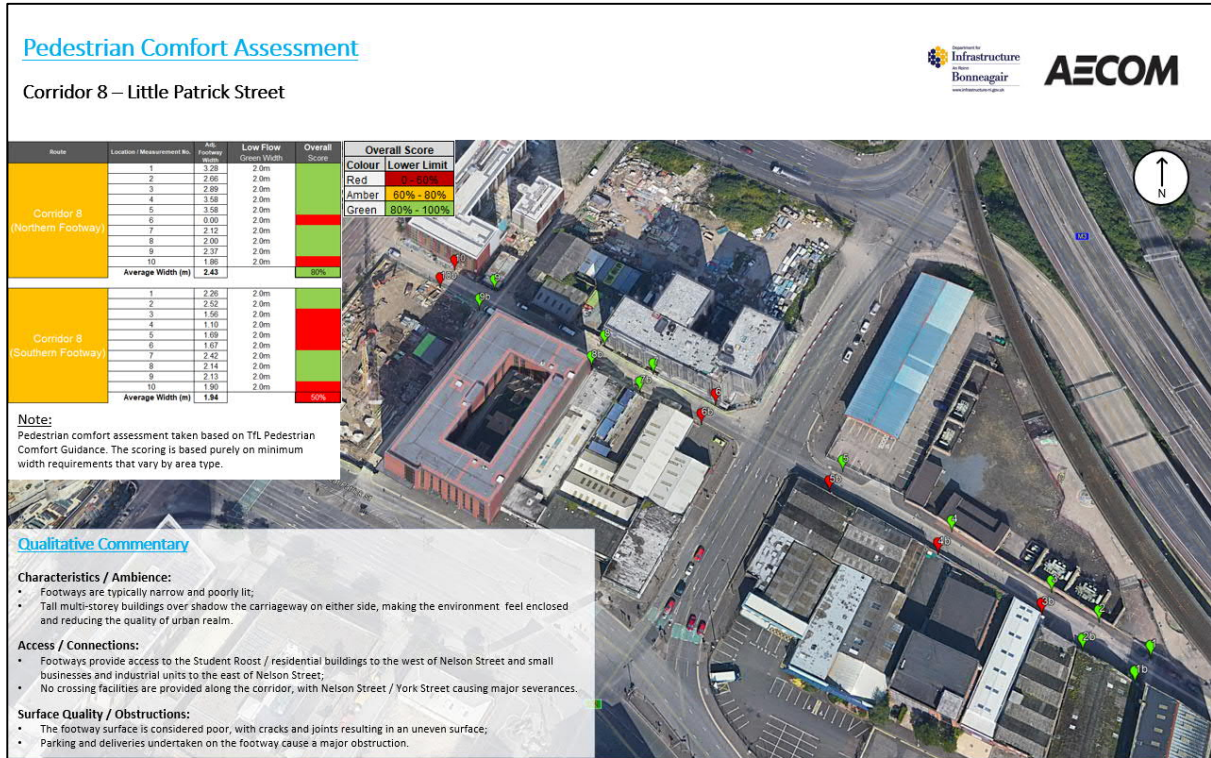
10.4 Pedestrian Comfort Levels baseline results

Results of the Pedestrian Comfort Level baseline assessment and qualitative commentary regarding the pedestrian environment for corridor eight are shown in the figure below.

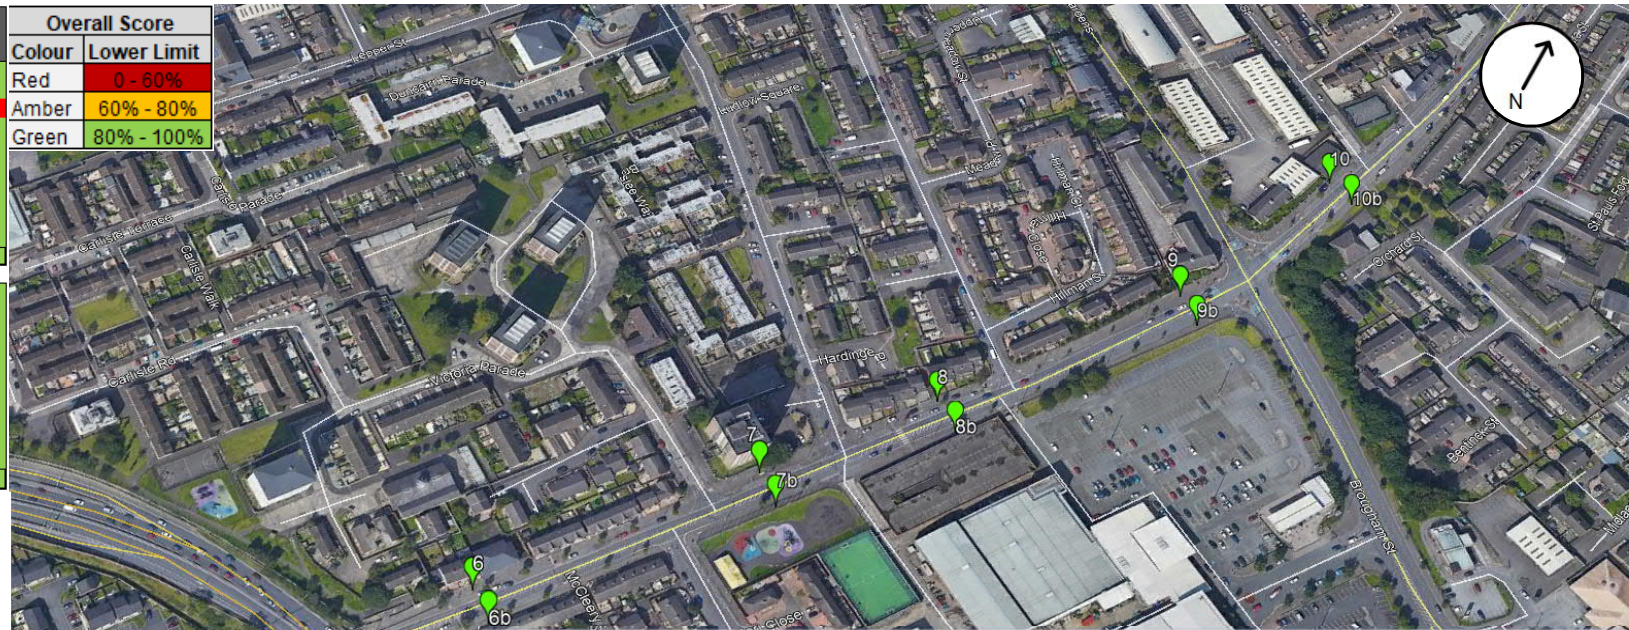
Corridor 1 - North Queen Street

Route	Location / Measurement No.	Adj. Footway Width	Low Flow Footway Width	Overall Score	Overall Score	
					Colour	Lower Limit
Corridor 1 (Western Footway)	1	4.00	2.9m	90%	Red	0 - 60%
	2	3.40	2.9m		Amber	60% - 80%
	3	2.79	2.9m		Green	80% - 100%
	4	2.87	2.0m			
	5	6.59	2.0m			
	6	4.68	2.0m			
	7	6.38	2.0m			
	8	4.98	2.0m			
	9	6.79	2.0m			
	10	3.60	2.0m			
Average Width (m)		4.61				
Corridor 1 (Eastern Footway)	1	3.64	2.9m	100%		
	2	7.75	2.9m			
	3	5.24	2.9m			
	4	2.68	2.0m			
	5	5.57	2.0m			
	6	2.68	2.0m			
	7	5.33	2.0m			
	8	5.11	2.0m			
	9	4.38	2.0m			
	10	3.84	2.0m			
Average Width (m)		4.62

Note:
Pedestrian comfort assessment taken based on TfL Pedestrian Comfort Guidance. The scoring is based purely on minimum width requirements that vary by area type.

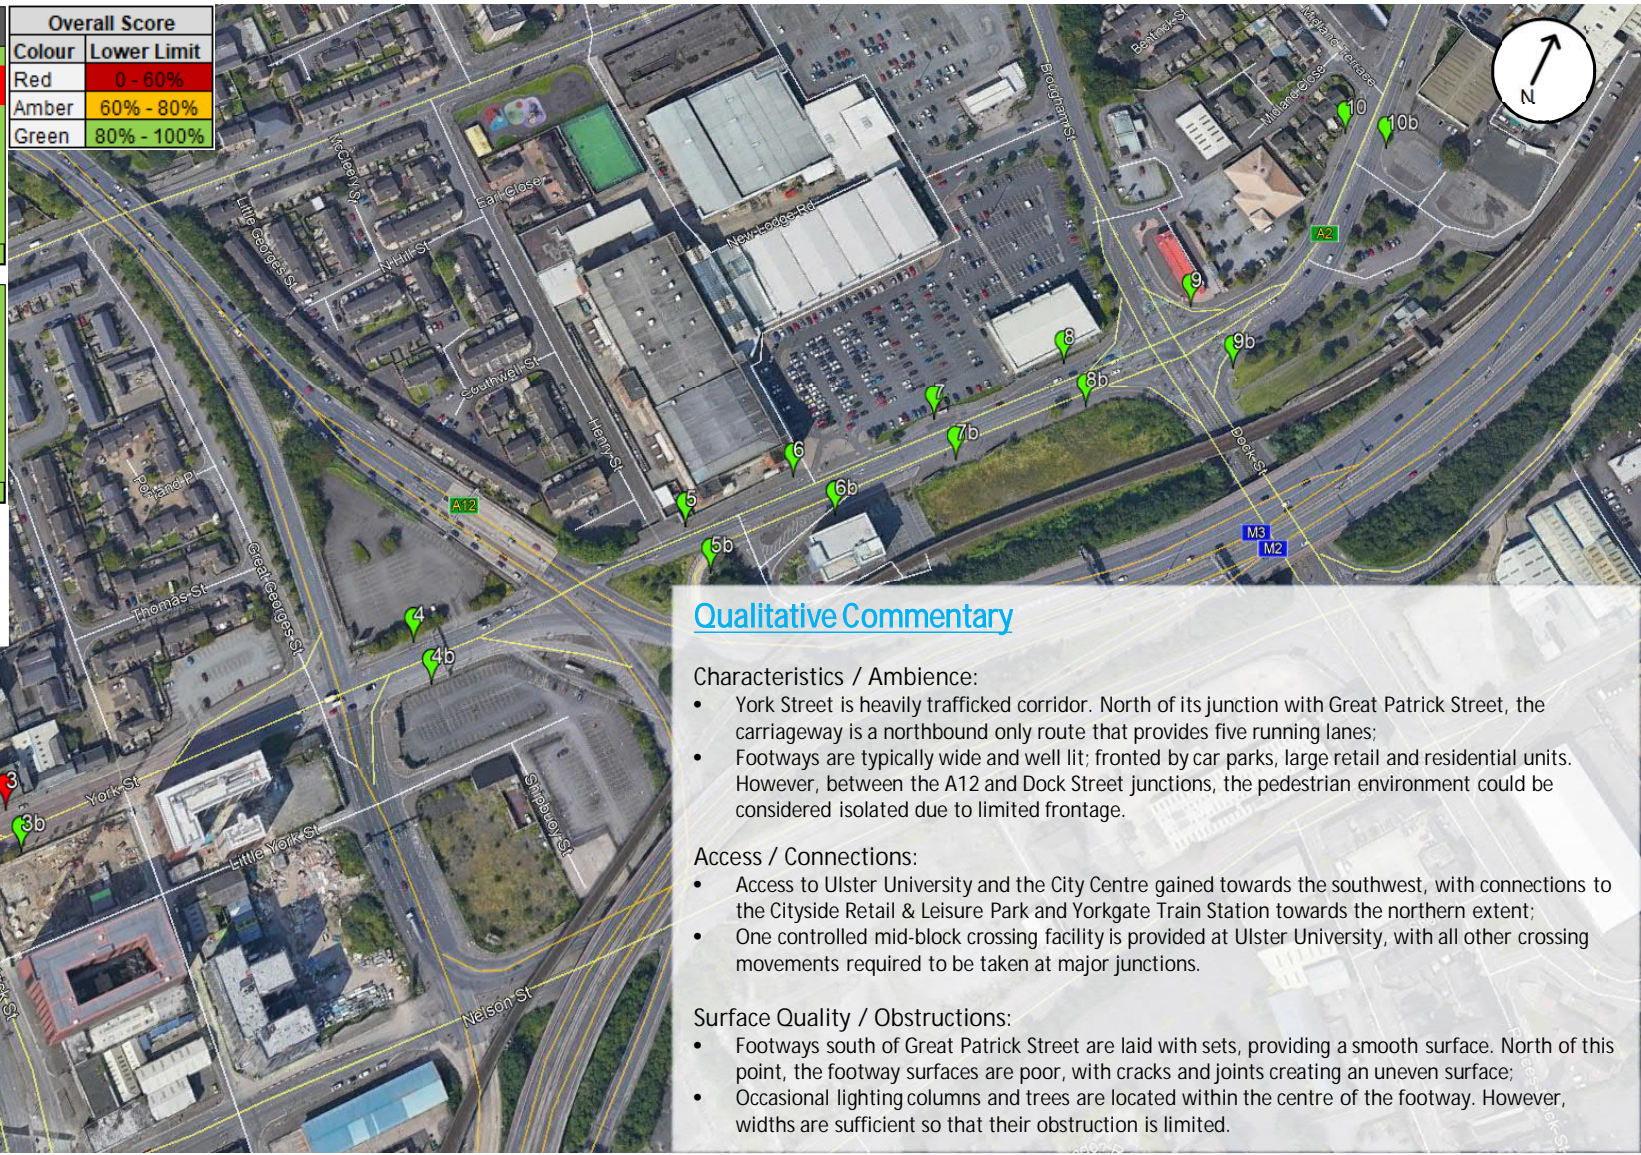
Route	Location / Measurement No.	Adj. Footway Width	Low Flow Footway Width	Overall Score
Corridor 2 (Western Footway)	1	4.30	2.9m	80%
	2	2.10	2.9m	
	3	2.36	2.9m	
	4	4.55	2.9m	
	5	4.84	2.0m	
	6	4.92	2.0m	
	7	3.12	2.9m	
	8	3.08	2.0m	
	9	4.57	2.0m	
	10	4.48	2.9m	
	Average Width (m)	4.00		
Corridor 2 (Eastern Footway)	1	3.48	2.9m	100%
	2	4.37	2.9m	
	3	4.49	2.9m	
	4	3.03	2.9m	
	5	3.28	2.0m	
	6	2.87	2.0m	
	7	6.63	2.0m	
	8	4.71	2.0m	
	9	3.53	2.9m	
	10	3.57	2.9m	
	Average Width (m)	4.00

Note:
Pedestrian comfort assessment taken based on TfL Pedestrian Comfort Guidance. The scoring is based purely on minimum width requirements that vary by area type.

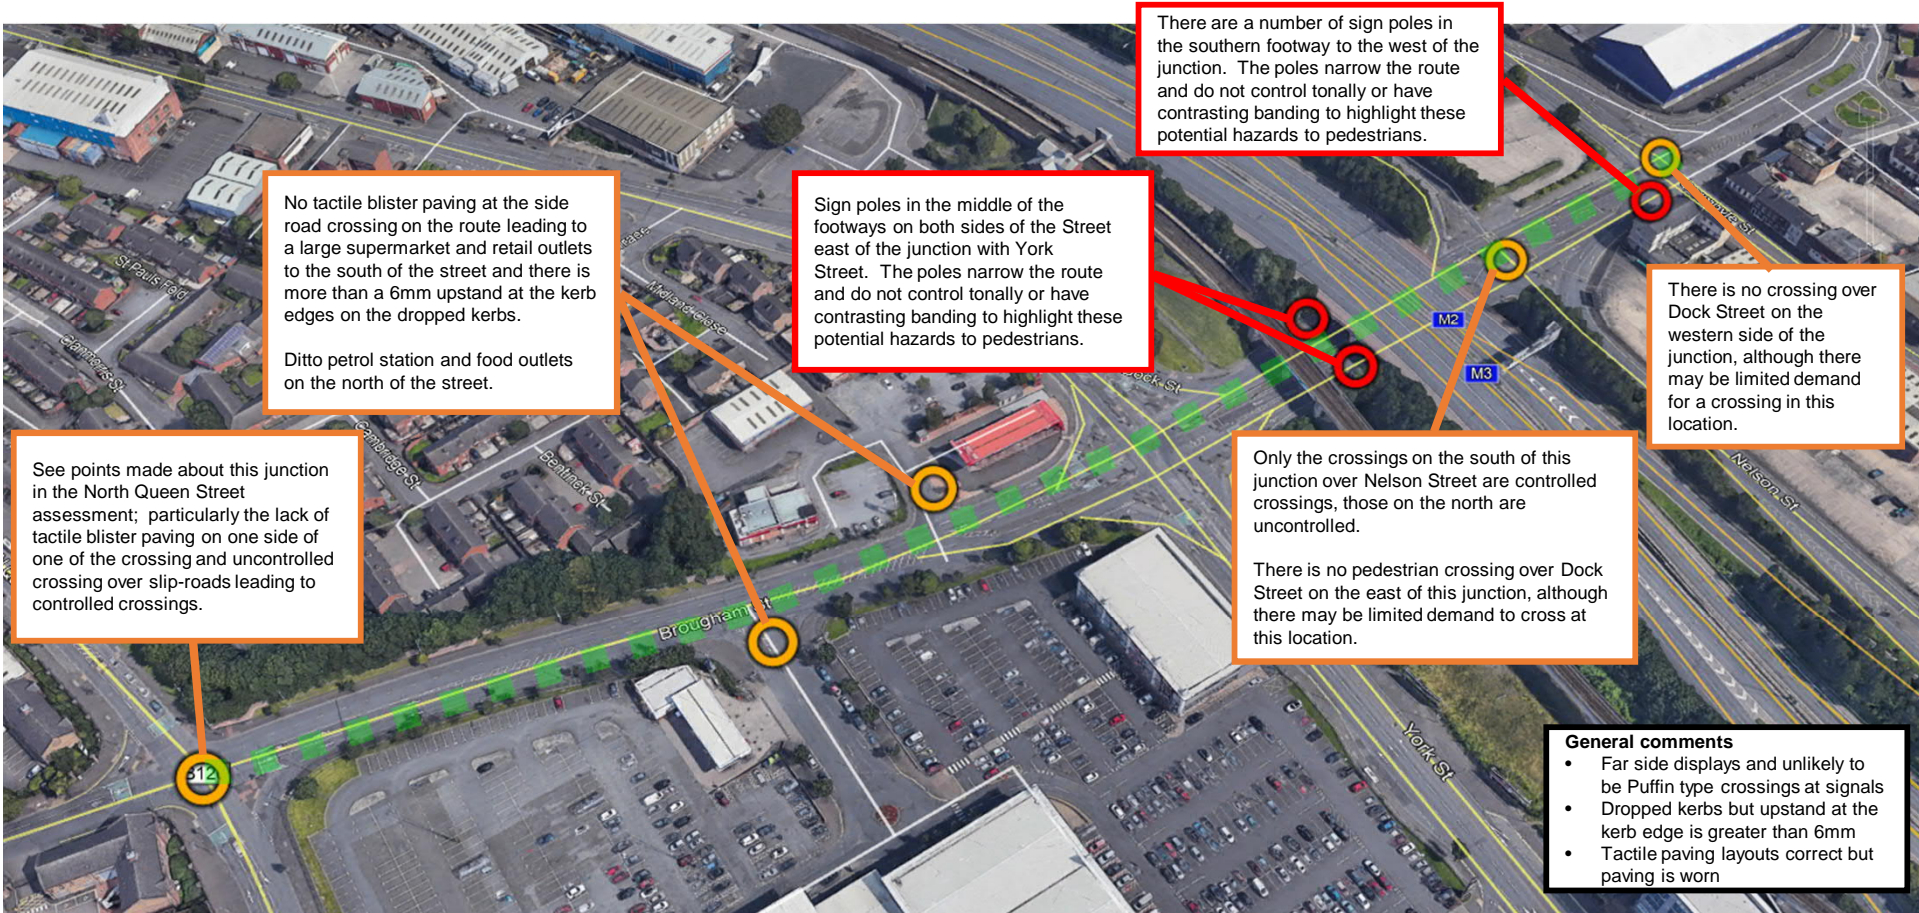
Mobility Impaired Assessment – Corridor 4 Brougham Street & Dock Street

No tactile blister paving at the side road crossing on the route leading to a large supermarket and retail outlets to the south of the street and there is more than a 6mm upstand at the kerb edges on the dropped kerbs.

Ditto petrol station and food outlets on the north of the street.

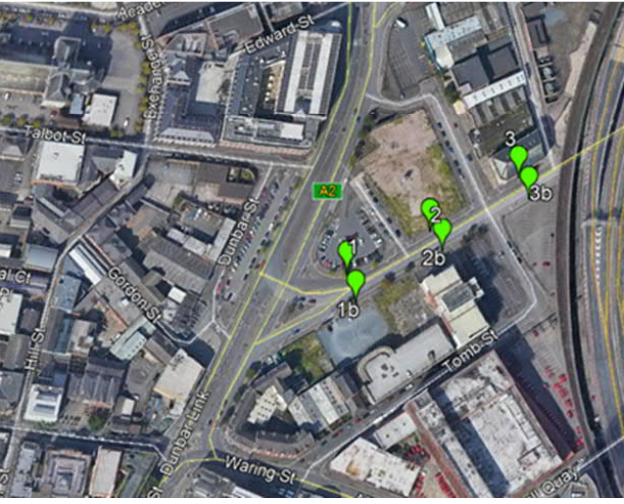
Note:
Pedestrian comfort assessment taken based on TfL Pedestrian Comfort Guidance. The scoring is based purely on minimum width requirements that vary by area type.

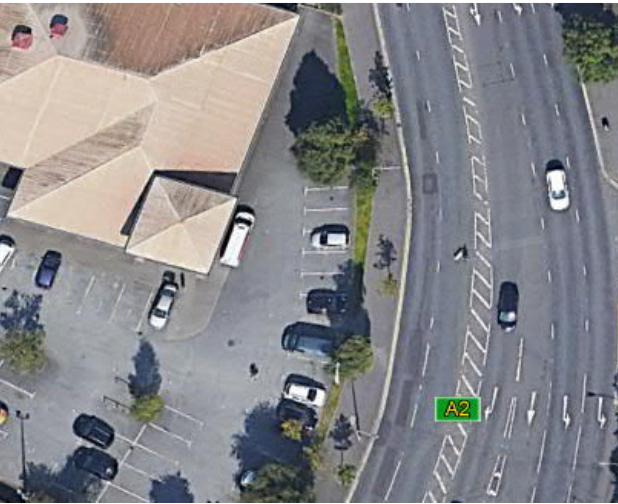
- The footway surface is considered poor, with cracked sets within the subway section;
- Joints and cracks also create an uneven surface to the east subway at the uncontrolled crossing of the one way link to Whitla Street east.

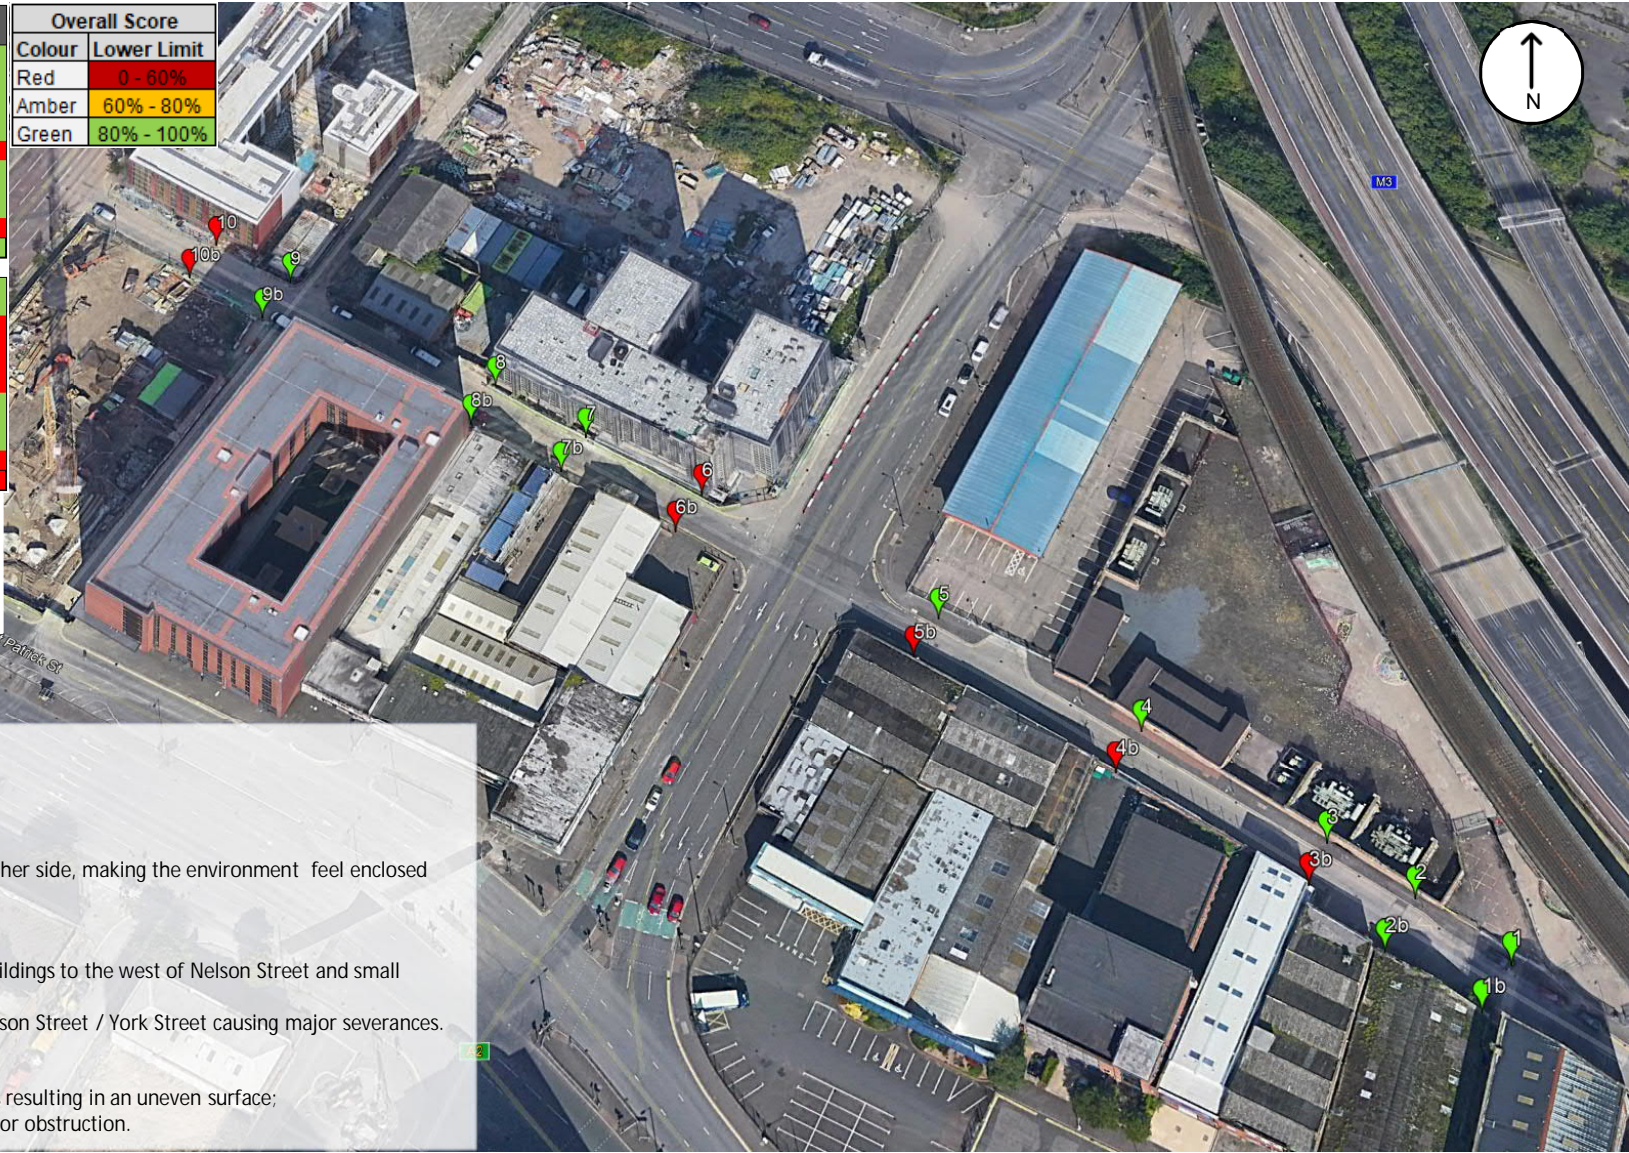
Route	Location / Measurement No.	Adj. Footway Width	Low Flow Green Width	Overall Score
Corridor 8 (Northern Footway)	1	3.28	2.0m	80%
	2	2.66	2.0m	
	3	2.89	2.0m	
	4	3.58	2.0m	
	5	3.58	2.0m	
	6	0.00	2.0m	
	7	2.12	2.0m	
	8	2.00	2.0m	
	9	2.37	2.0m	
	10	1.86	2.0m	
Average Width (m)		2.43		
Corridor 8 (Southern Footway)	1	2.26	2.0m	50%
	2	2.52	2.0m	
	3	1.56	2.0m	
	4	1.10	2.0m	
	5	1.69	2.0m	
	6	1.67	2.0m	
	7	2.42	2.0m	
	8	2.14	2.0m	
	9	2.13	2.0m	
	10	1.90	2.0m	
Average Width (m)		1.94

Note:
Pedestrian comfort assessment taken based on TfL Pedestrian Comfort Guidance. The scoring is based purely on minimum width requirements that vary by area type.
