# Bathing Water Profile

## Waterfoot

May 2022

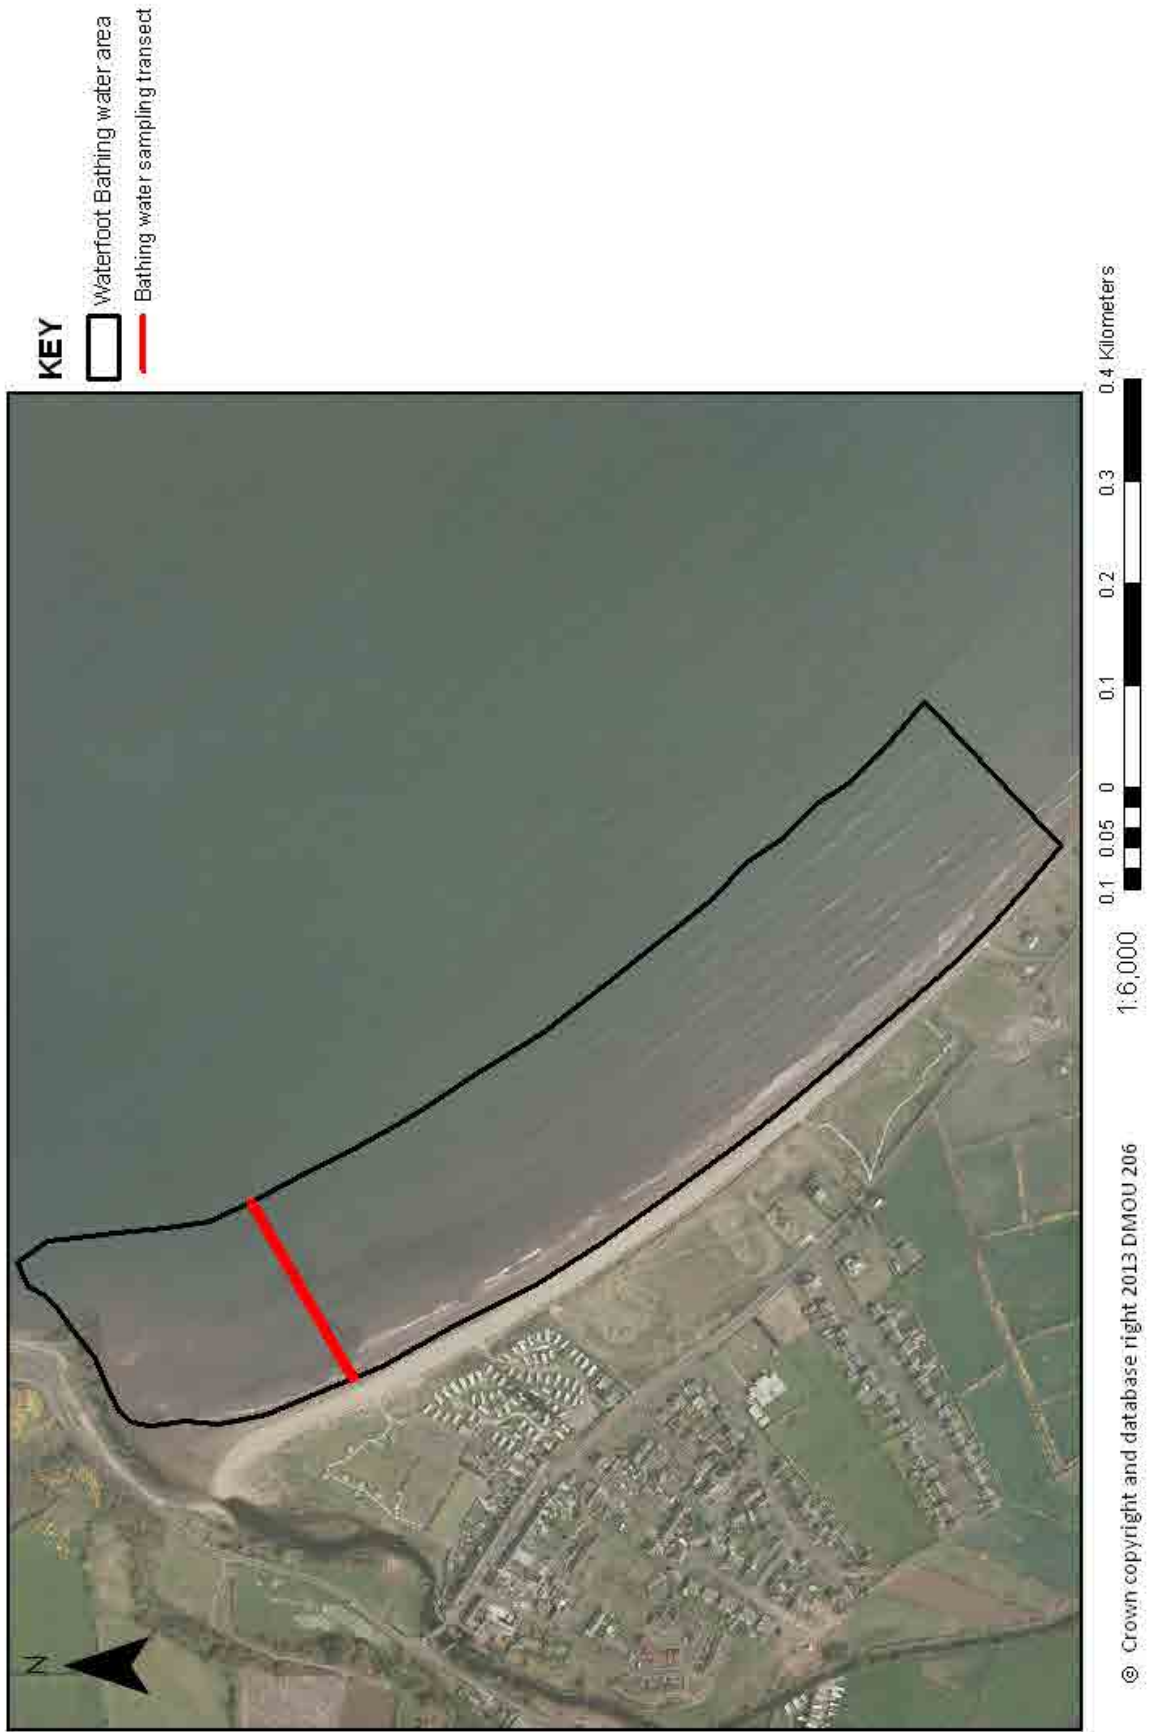
Map 2  
Waterfoot Bathing Water -  
EC Bathing Water Sample Location

<b>Bathing Water Name</b>	Waterfoot Bathing Water
<b>Location</b>	UK/Northern Ireland/County Antrim/Antrim Coast
<b>Year of identification</b>	2006
<b>Local council area</b>	Causeway Coast and Glens Borough Council
<b>Bathing Water Operator</b>	Causeway Coast and Glens Borough Council
<b>Description of bathing beach</b>	Sand, approximately 1.0 km in length, bounded by a river to the north
<b>Monitoring Point</b>	Northern end of bathing water, D 24192560 (Map 2)
