Historic
Environment
Division

Guidance for Historic Windows

March 2024

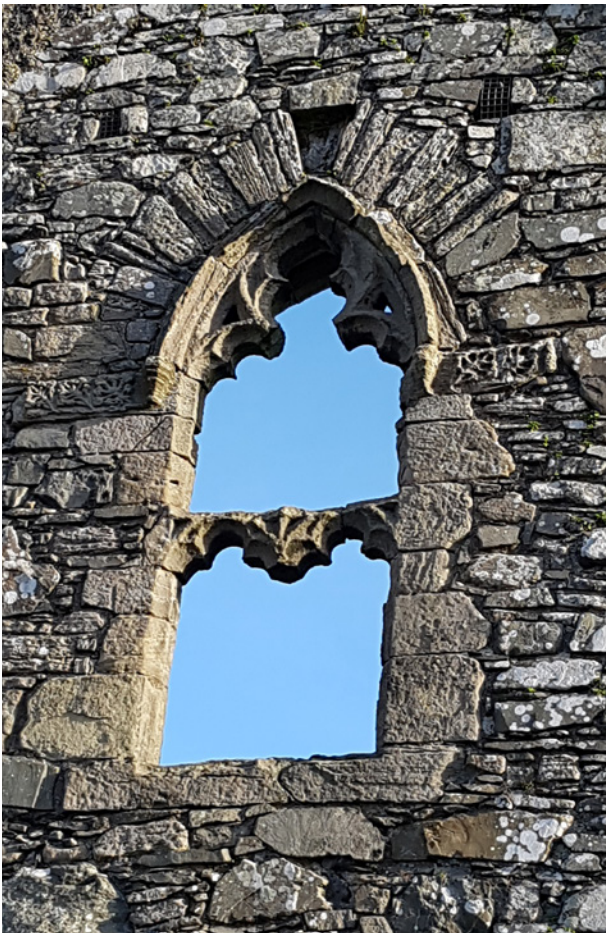
Medieval Window with high gothic tracery from Movilla Abbey

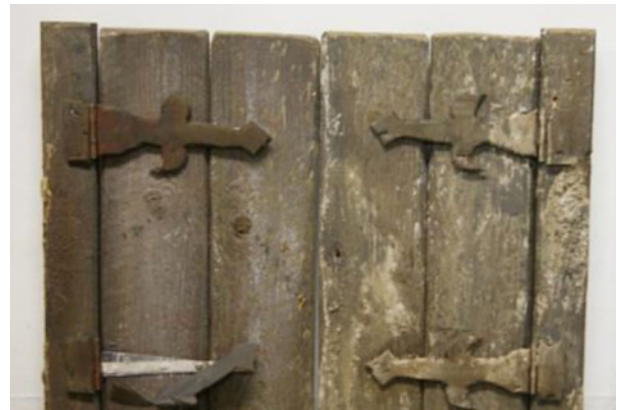
Most early buildings did not have any glazing. They had small windows open to the elements. Sometimes they had timber shutters that could close over at night or in extreme weather. These either hinged or were able to slide across.

English example of a medieval Shutter

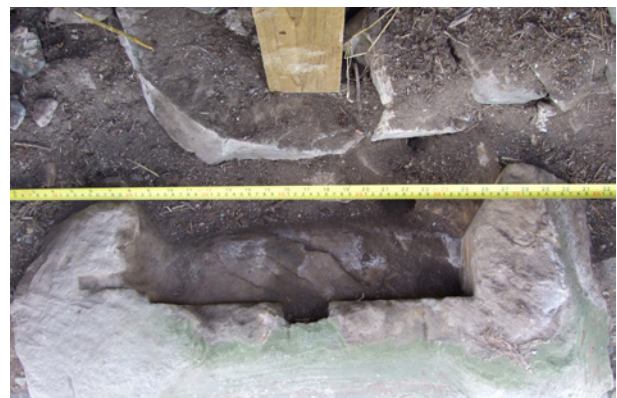
Medieval stone cill – the shutter pivoted in the hole on the left - Portaferry Abbacy

While no shutters remain from this time, we have archaeological evidence of their existence. Stone cills, such as that at the medieval Abbacy site near Portaferry – a medieval and early post medieval episcopal manor – show the hole for pivoting the shutter and other markings that indicate how the shutter would have fitted.

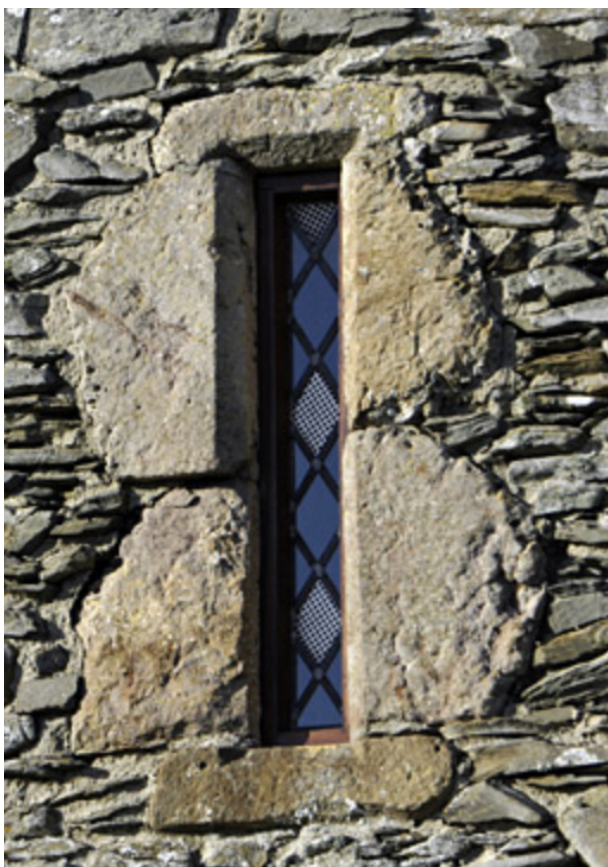
In some instances, large castles and houses had an adaptation of the church window called 'Quarry glazing' containing small diamond or square shaped panes set in lead 'comes'. These leaded windows were set directly within the frame or, more infrequently, in wrought iron casements.

Audleystown Castle – Recreated Tudor style window

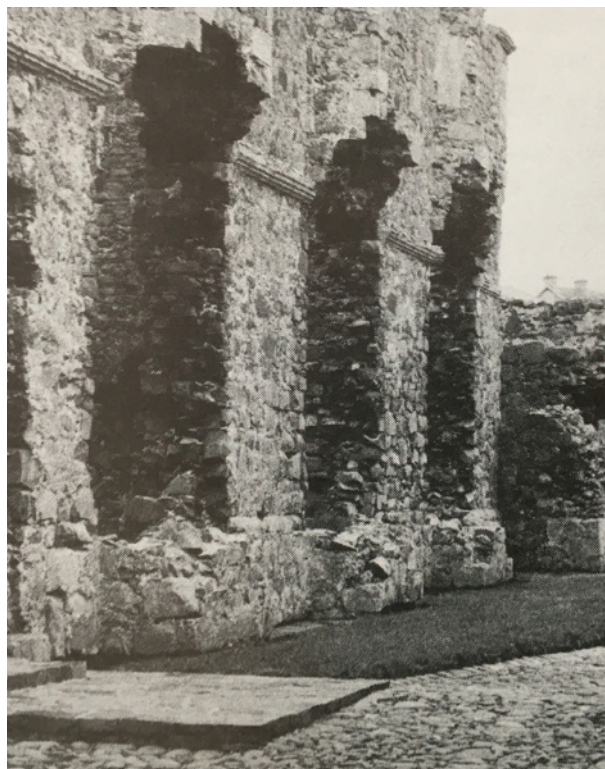
To span larger openings, rectangular leaded windows were grouped with stone mullions (vertical) and transoms (horizontal) in between. The windows may also have had a stone or timber drip mould over the top of the opening known as a hoodmould. This became a characteristic of late medieval and early renaissance architecture and is evident in 'Tudor, Elizabethan, and Jacobean styles.

Dunluce Castle-Tall Bay windows in the great Hall

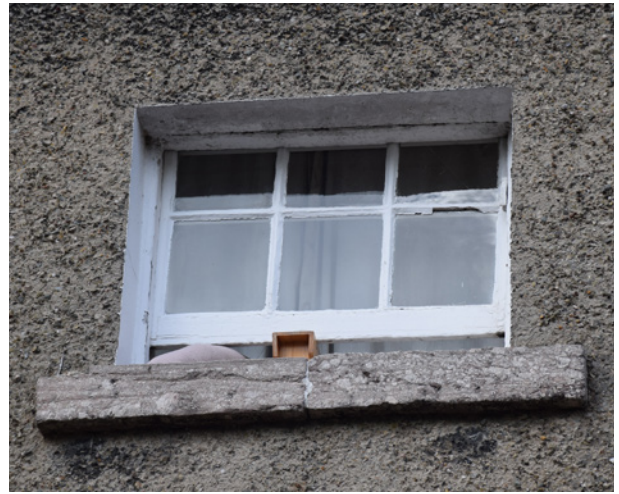
Early sash window, Armagh – sash moves vertically into a pocket.

Some of our earliest and most interesting sash windows facilitate sliding the sash vertically into a sash pocket. The houses at Vicars Hill in Armagh are an excellent surviving example.

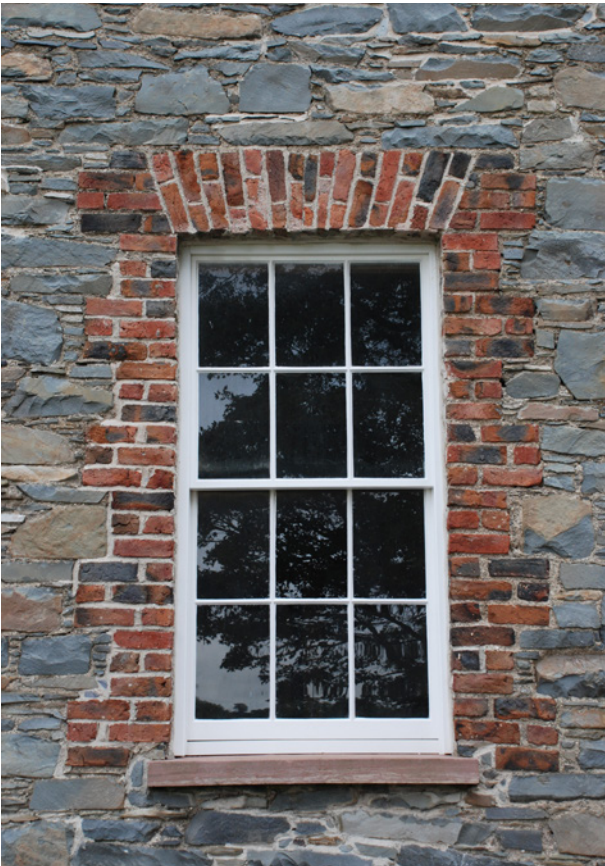
Typical Double Hung Sash Window

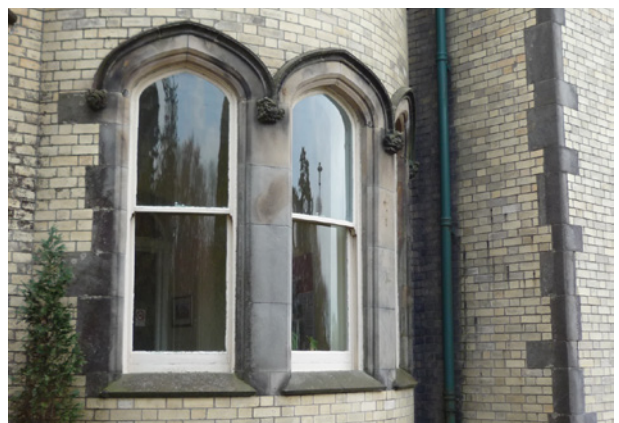
Curved sash windows with no glazing bars- note horns strengthening the mid rail.

Glass technology improved in the Victorian period, 1837-1901, to allow larger single sheets of glass, and as a result, glazing bars were reduced in number. From the 1870s, most sash windows were free of glazing bars and had a single pane of glass in each sash, but these larger expanses of glass distributed their weight differently than the smaller panes in the earlier windows. Where before the lattice of glazing bars dispersed a portion of the weight to the side rails, now the total weight of the glass was bearing on the bottom rails. This weight puts increased stress on the joints, particularly the joint where the mid-rail meets the side rail.

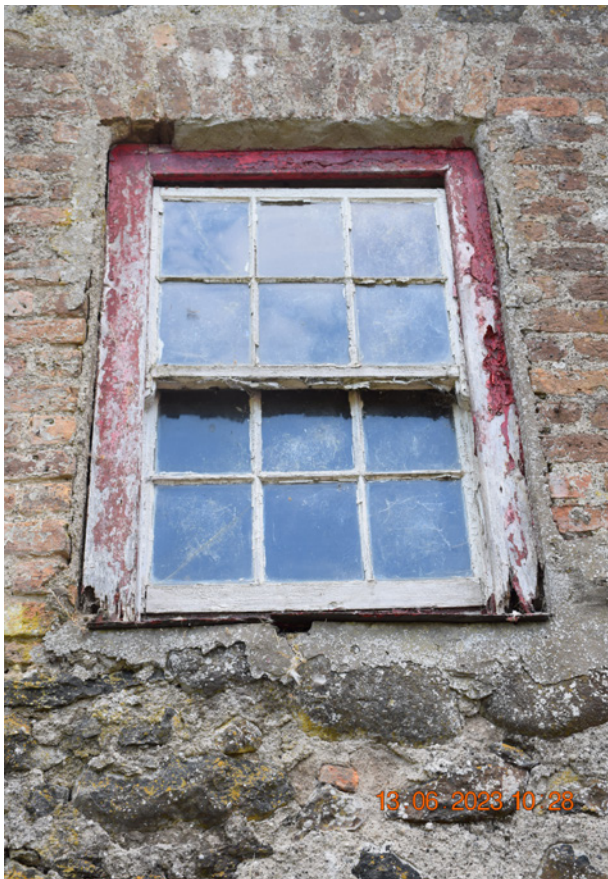
An exposed sash box can indicate an early sash; however, some caution should be exercised as there are many local examples where exposed boxed sash appears in buildings of later date. This ambiguity would suggest the persistence of the custom of using exposed box sash in some places rather than the presence of early windows. The adjacent illustration shows a house near Gracehill Ballymena, which was built as late as 1833 but had exposed box sashes.

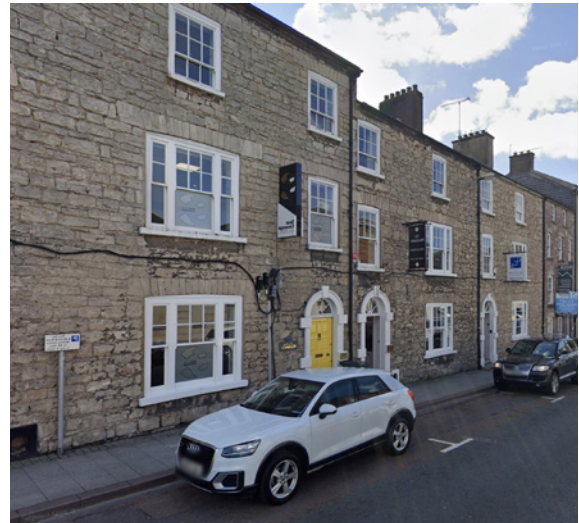
Buildings in College Street, Armagh dating from 1790- 1820 with flush mounted sash windows.

In Armagh, there is a prevalence of flush-mounted sash windows persisting well into the 19th century.

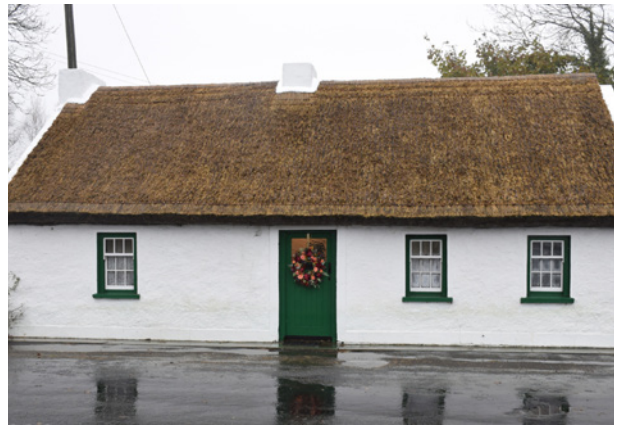
Windows in vernacular buildings closely followed developments in more formal architecture, though many did without sash cords and weights and instead employed external props or the friction of the box. The glazing bars also tended to be simpler and thicker. It is common to find sash boxes exposed. Many vernacular sash windows dispensed with weights altogether, reducing the need for a deep box.

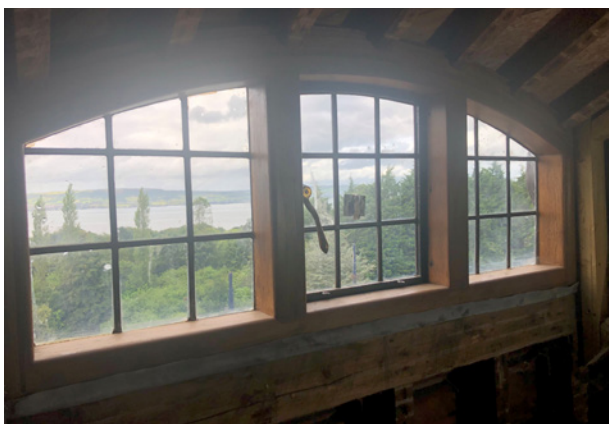
A casement-style window opens with hinges, usually at the side of the window frame. It can also be hinged at the top or, even more rarely, at the bottom.

The most common arrangement in a historic window is for the casement, or opening part, to be hinged to the side with a system of catches to lock and hold it in place, though top-hung casements were more common in some buildings such as schools. Most casement windows open outwards because it is easier to weatherproof. Those behind stone mullions, however, tend to open inwards.

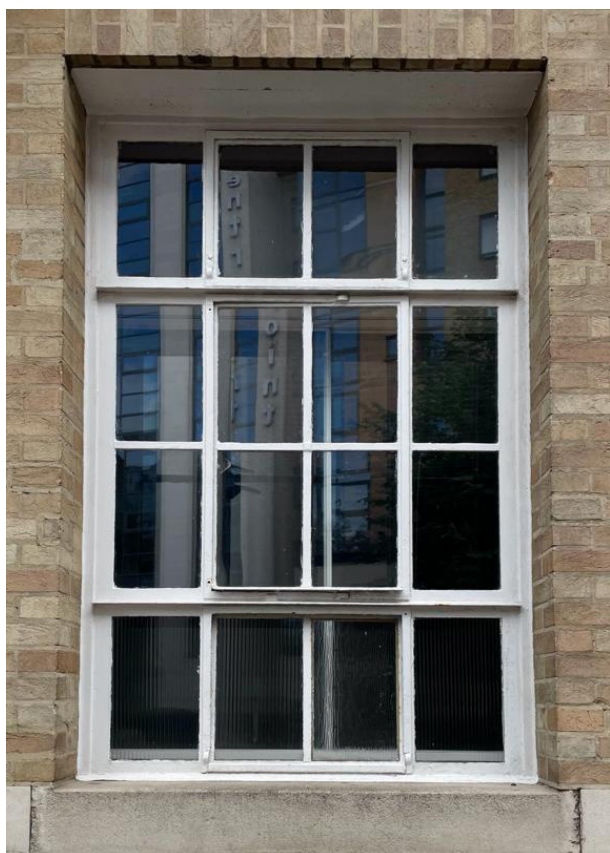
Crittall Window at BBC broadcasting House, Belfast

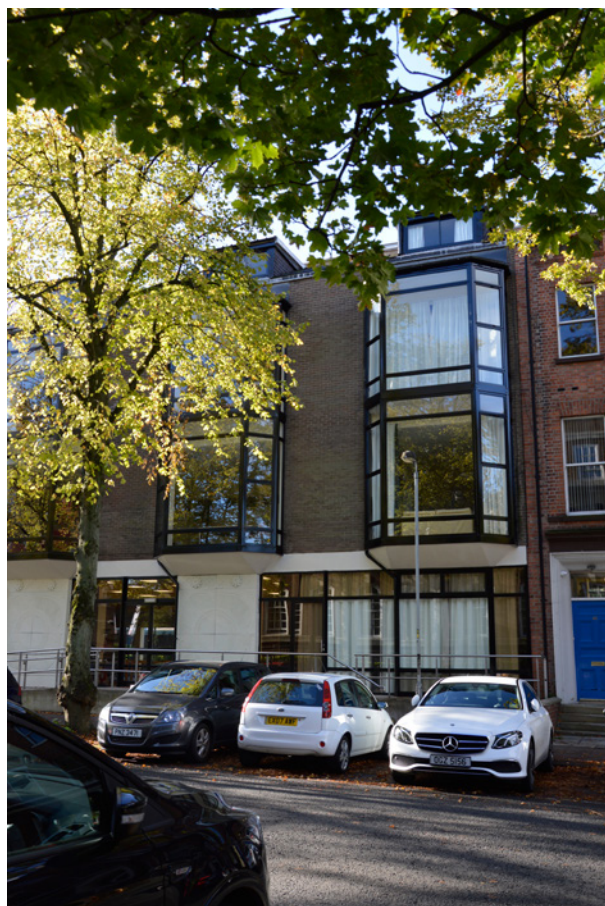
Curtain walling at Catholic Chaplaincy, QUB

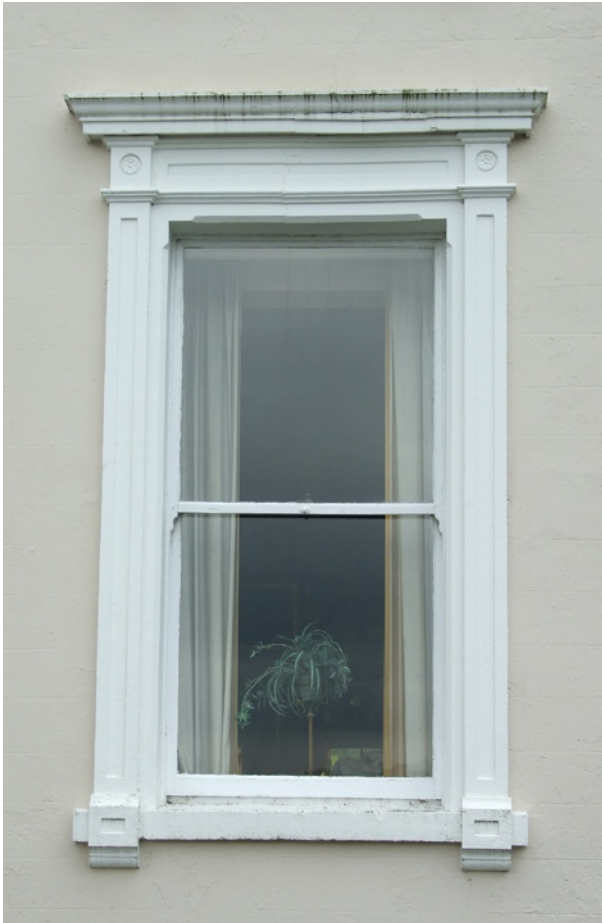
Except for some windows in ecclesiastical buildings, the sills in historic buildings are often of a remarkably consistent depth (around twice the typical modern depth). They are usually stone with a fine vertical tooling discernible along the front edge.

Window surround

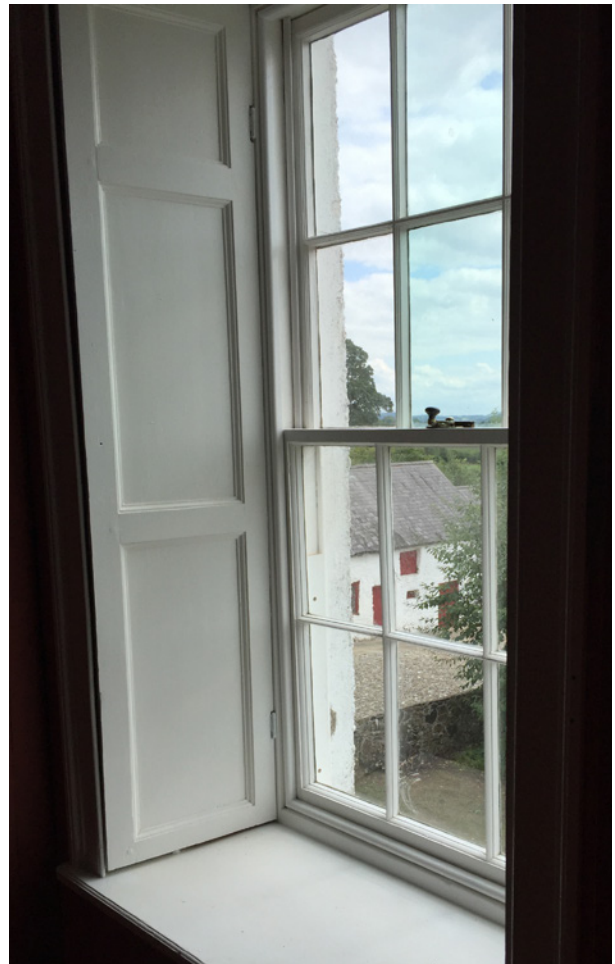
Formal houses often have internal shutters as an aid to insulation and security. Most fold back to the reveals on either side, but in some 19th-century houses, the shutters are below the window as an internal sash which slides up behind the window. Due to their complexity, owners have removed most of these windows, or they have become unworkable. Surviving examples are scarce and worthy of retention.

Internal fold back shutter

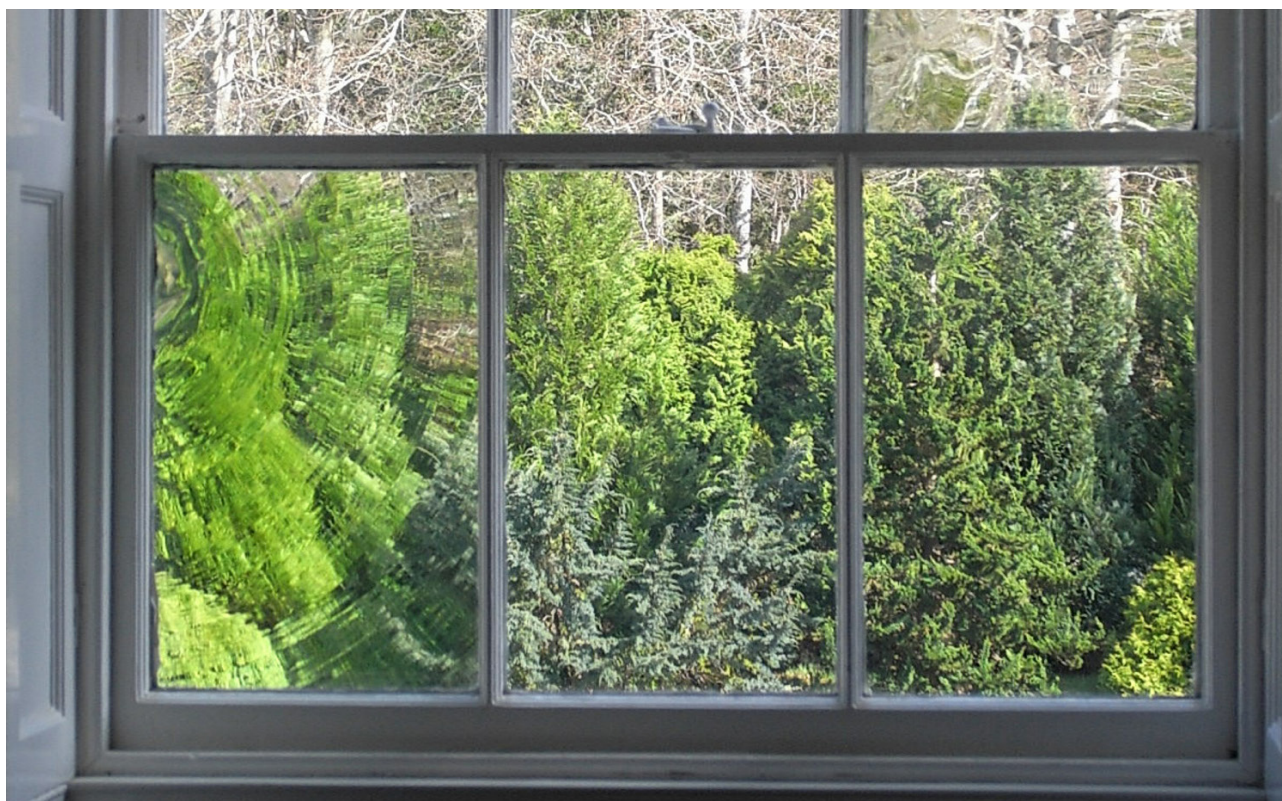
A rare example of Crown Glass

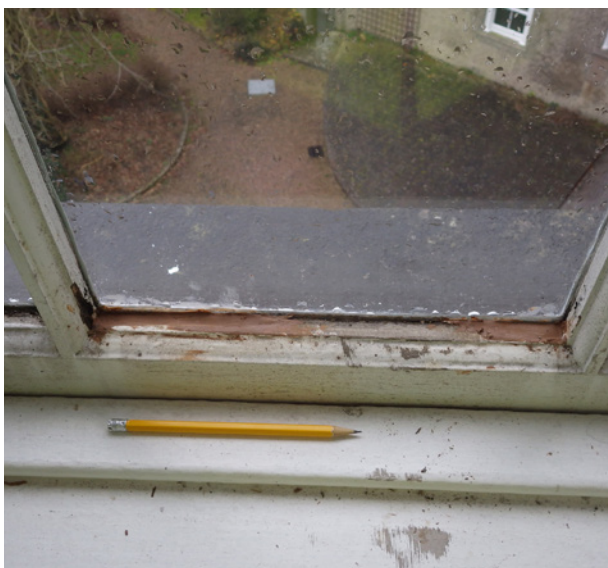
Examine a timber window for signs of water absorption as this could indicate rot. Signs include cracks in paintwork, pitting and swelling on the surface and decay of putty.

Horizontal areas are often most vulnerable.

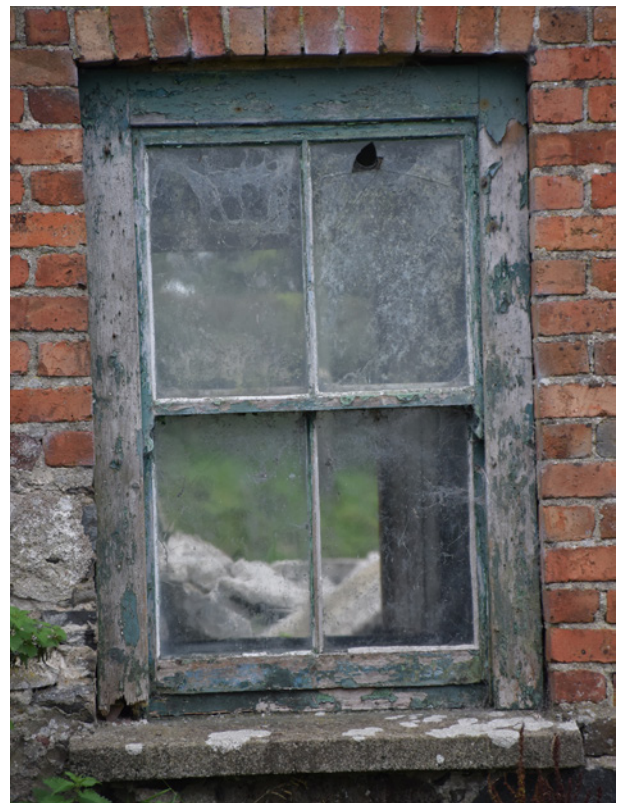
Window not properly maintained and beginning to rot.

Applying epoxy resin wood filler and preservative may be sufficient for small areas of decay. Try to understand how the rot has occurred. In most cases, this will be due to cracked paint allowing water to enter. If the rot is minor and the rest of the wood sound, scrape out the worst of the damp wood and allow the surrounding area to dry before treating it with a preservative. A wood filler can consolidate the adjacent weakened timber and build up the removed area and sand to a smooth finish for priming and painting. Monitor resin repairs over time in case differential movement between the resin and timber has allowed cracking to occur.

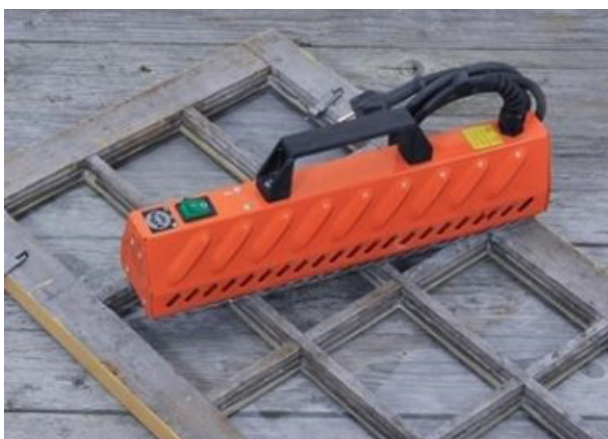
It is important to inspect window putty for signs of cracking. Brittle putty can crack and allow moisture through to the timber behind. Over-painting is sometimes sufficient to prevent further decay if cracks are recent, but if much moisture has penetrated the putty and is trapped, this will hasten decay and need to be replaced. Great care must be taken in removing putty to ensure that historic glass is not damaged. There are appliances on the market to help soften putty before removal to reduce this danger. Putty lamps use infrared heat to soften old paint and putty whilst being gentle on the wood and not causing the glass to crack.

HED recommends using linseed oil putty, the traditional material with preservative qualities that modern counterparts do not possess. New putty must be allowed to dry, and the paint should be taken slightly onto the glass to ensure a good seal.

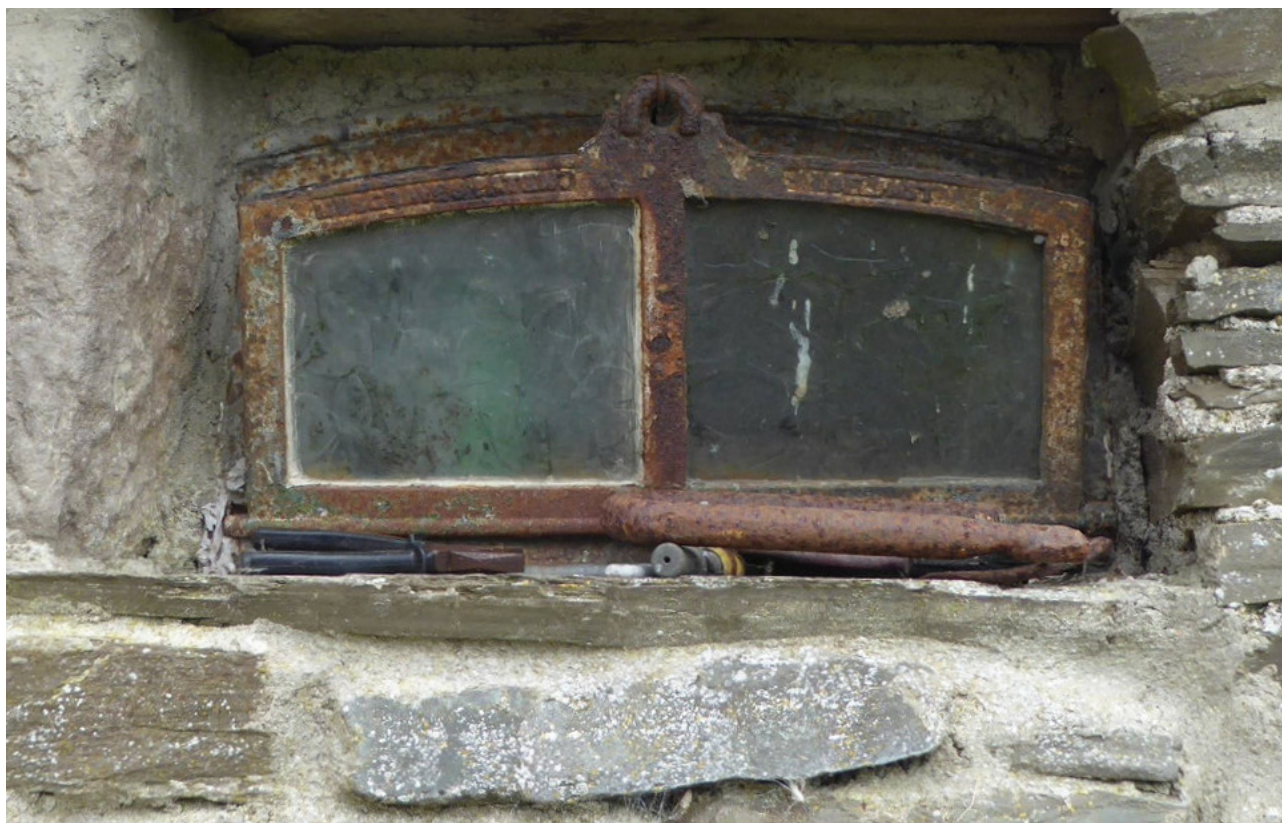
Cast iron with surface rust can usually be relatively easily restored.

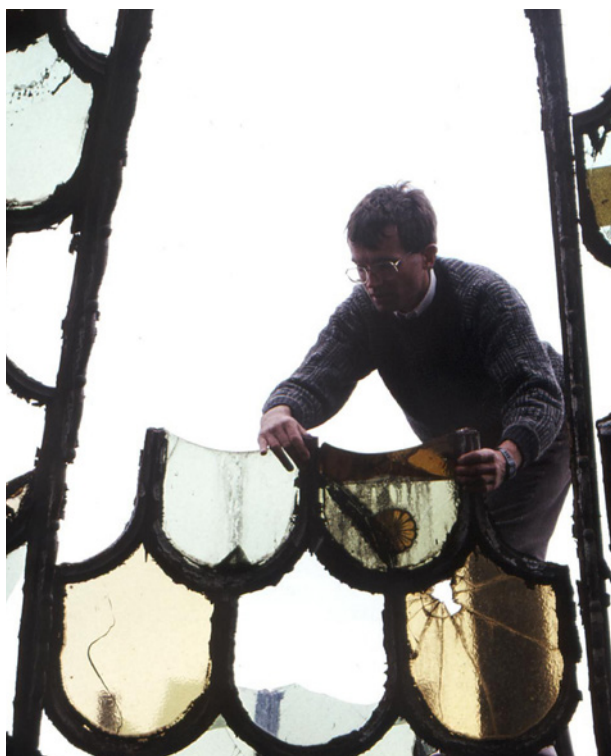
Lead in windows may have decayed or expanded due to being in strong sunlight or prevailing winds, and these will often need to be reset. This is a job for a specialist to repair or remove the window, remove the lead and replace it with the same pattern.

Repair to a stained glass window by skilled technician

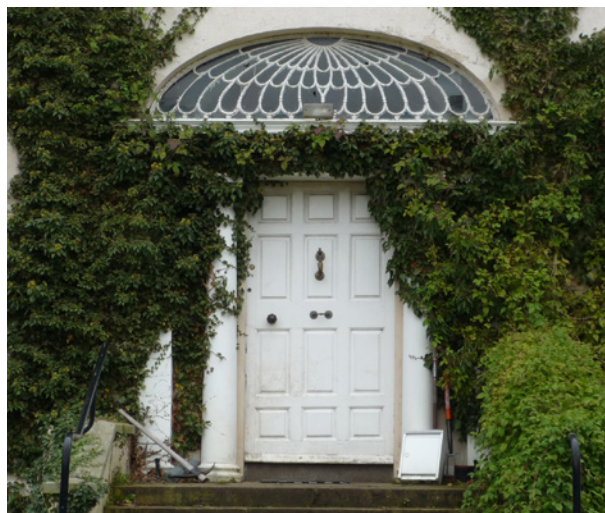
Fanlights often have a very detailed form of ironwork with surviving historic glass. It is recommended that a specialist be employed to care for these items.

Detailed Fanlights require a specialist to repair.

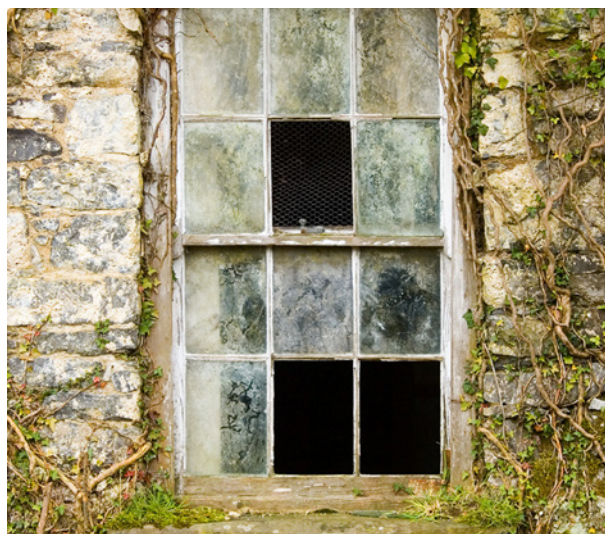
Significant repairs will require an assessment of the glass, especially if it is historic glass, to decide whether it can remain during the repair or need to be removed. It is worth highlighting to contractors the importance of retaining historic glass.

Glass repairs

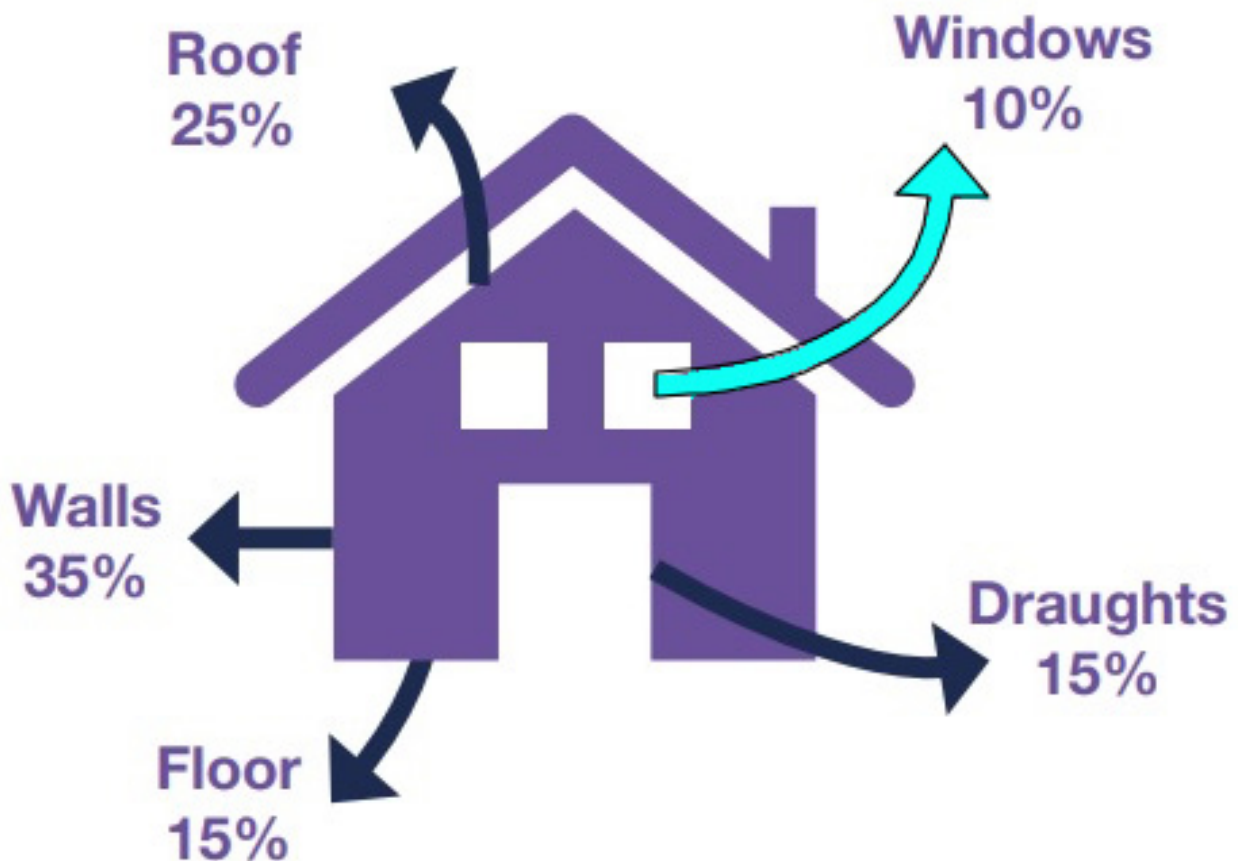
Typical heat loss through different elements of a dwelling

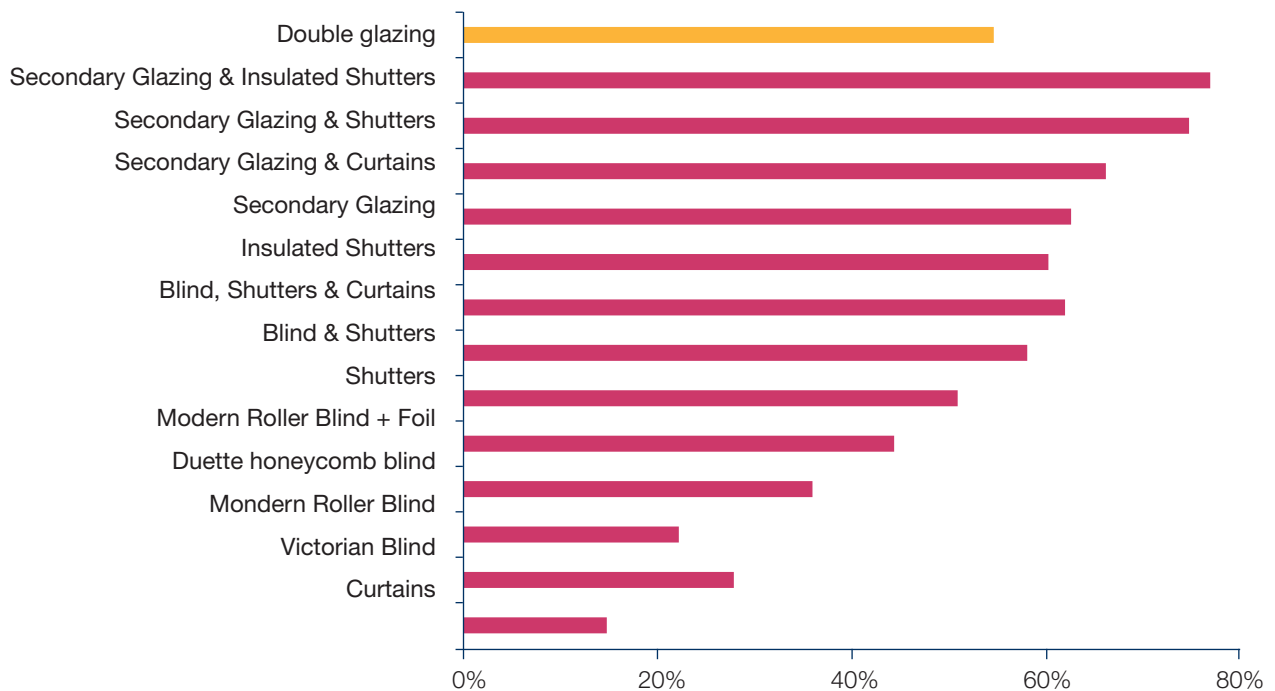
Reduction in heat loss through single glazing with option compared to single glazing only

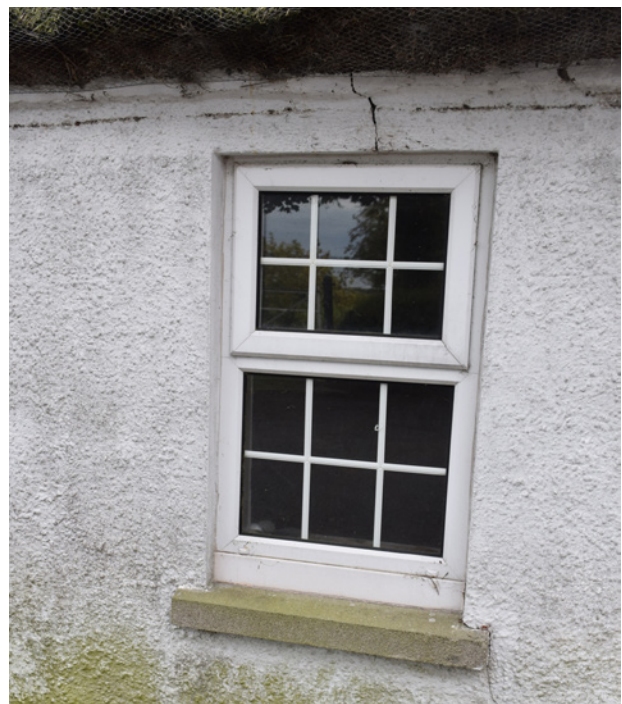
Inappropriate PVC-u replacement window detracting from the character of the building.

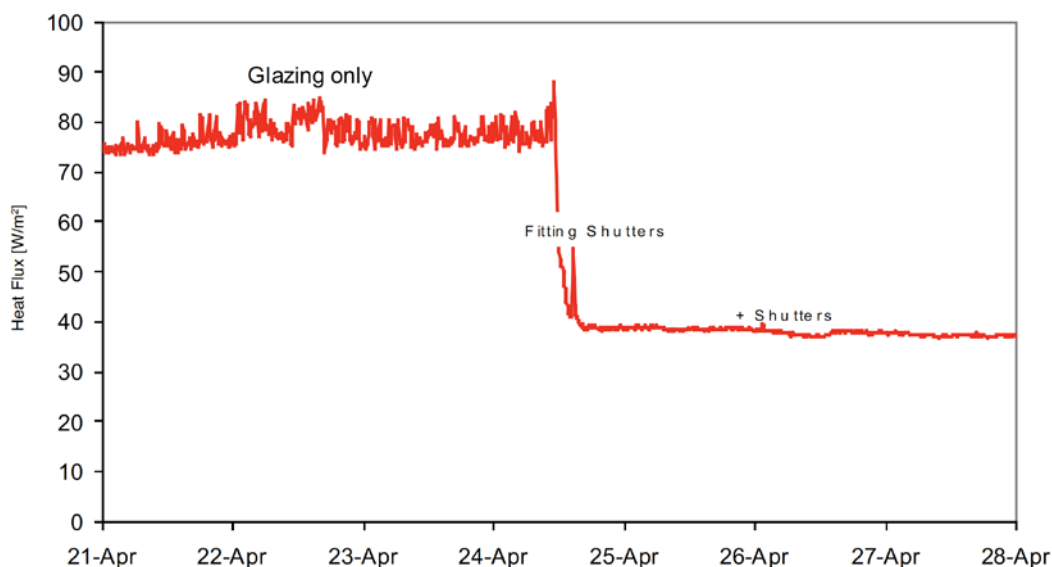
Effect of Closing Shutters

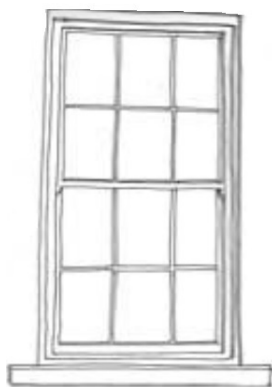
Six-over-six
Sash window

Sash windows with multiple panes are generally inappropriate for standard thickness double-glazed units, particularly 18th and mid-19th century multi-pane glazing with thin profile glazing bars and shallow reveals. The existing sash needs to be replaced to accommodate the thicker unit, and this is not acceptable in a listed building where it results in a loss of sound historic fabric and is detrimental to the overall character and appearance.

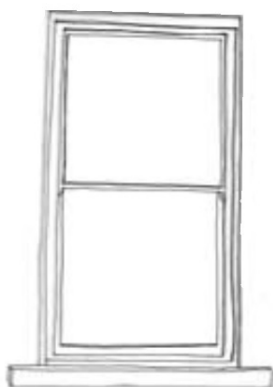
One-over-one
Sash window

Multi-pane sash windows are unlikely to be suitable for replacement with standard-width double-glazed units however it may be possible with a one-over-one sash. Where a building is listed, Replacement double glazing will require Listed Building Consent

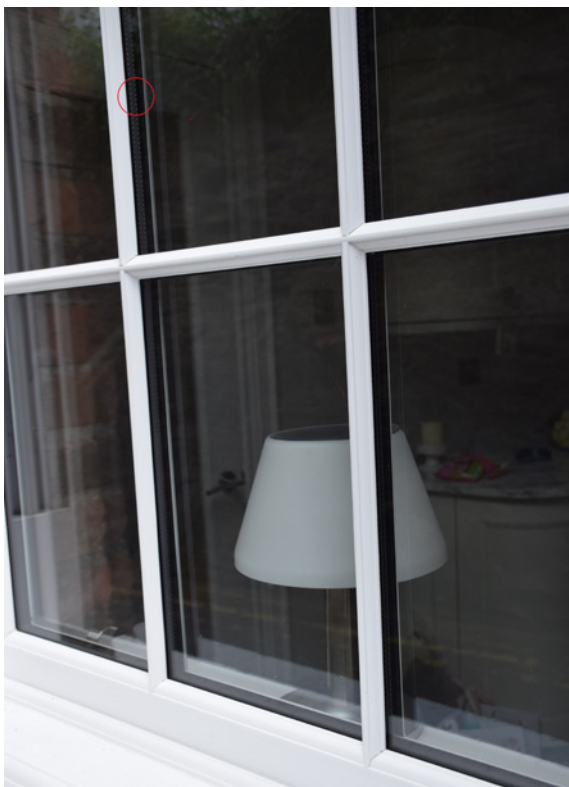
The wide edge seal is visible.

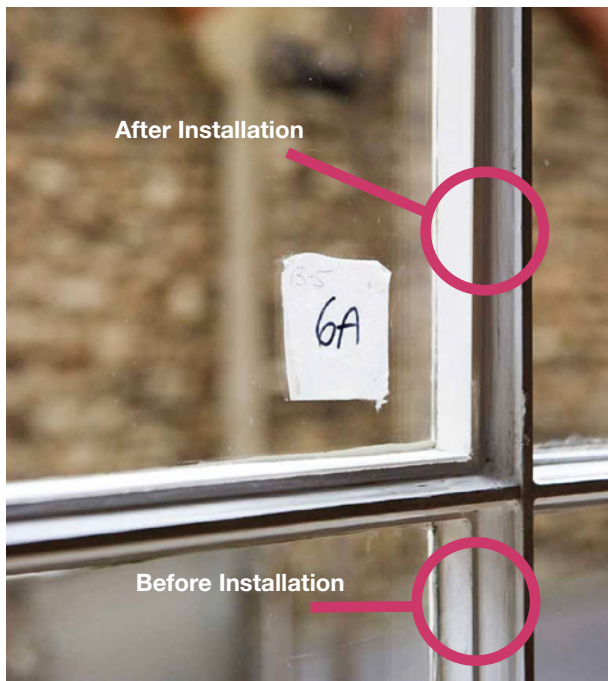
The windowpane labelled 6A has been altered while the lower windowpane has yet to be altered. This close-up view shows how less of the internal moulding profile of the glazing bar is visible after installation. Source: The Engine House Swindon. Thermal performance of energy efficiency improvements to timber windows (2017) Research Report Series no. 2/2017

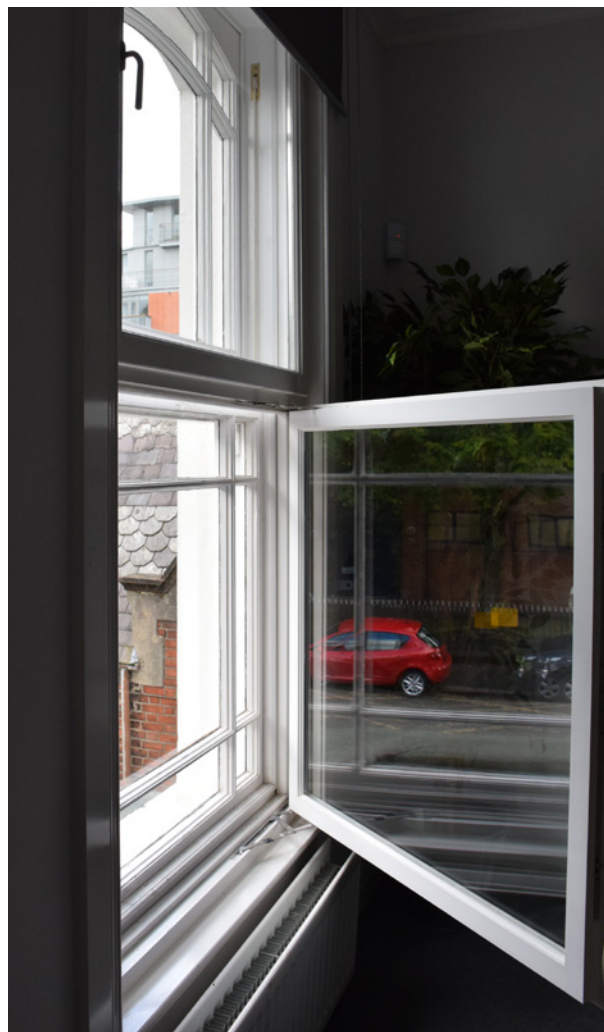
Secondary Glazing

SECONDARY GLAZING	Reduction in heat loss	U-Value (w/m ² k)
Single Glazed timber sash window	0	5.5
Secondary Glazing - single pane, timber frame	71%	1.5
Secondary Glazing -Double glazed, Aluminium frame.	85%	0.8
Secondary Glazing - Single sheet polycarbonate held with magnetic strips	56%	2.4

Glasgow Caledonian University conducted research for Historic Scotland using a 6 x 6 sash window in good condition. Their findings showed that when a timber frame double-glazed unit was added behind an existing sash window in poor condition, the heat loss was reduced by 85% (an improvement in U-value from 5.5 to 0.8 Wm²K).²⁴

Even secondary glazing with a single pane of glass achieved a remarkable reduction of 71%.

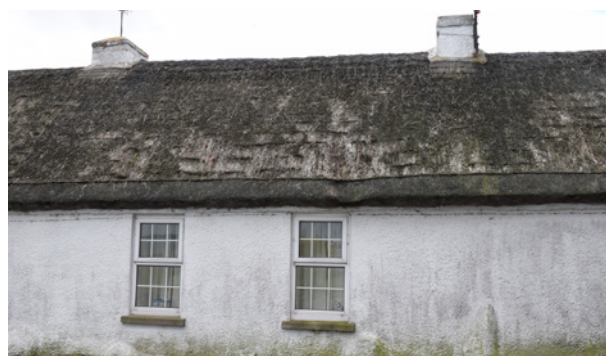
Unlike this example, it is preferable to replace a window that is unsympathetic and out of keeping with the age and character of the building with a window that replicates both the original style and material.

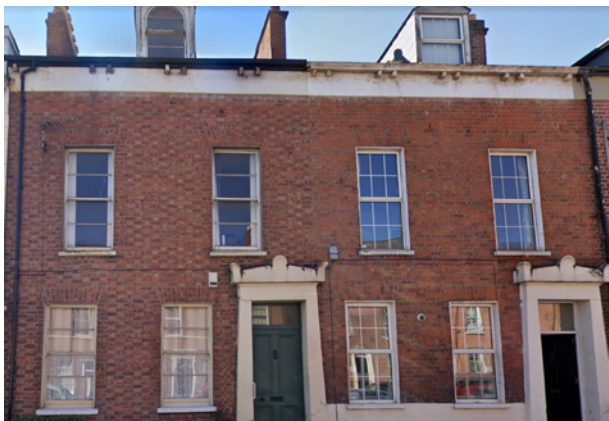
Replacement PVC-u windows (sash and dormer on the right) can alter the appearance of a terrace.

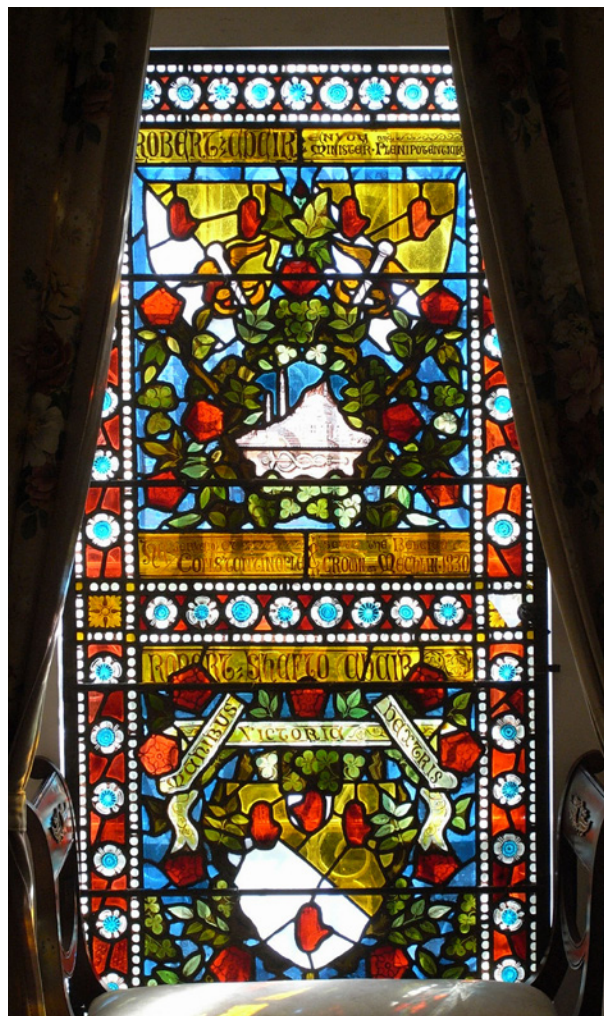
Types of environmental protective glazing

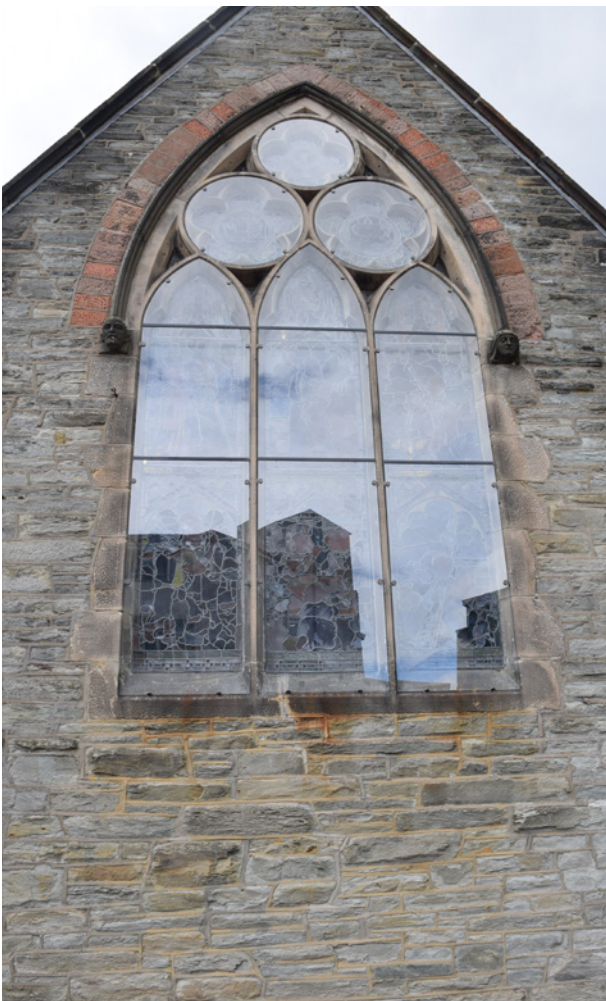
Another German approach has been to fit protective glazing panels that have rectilinear patterned leadwork, which subdivide the protective glazing. However, leadwork casts shadows on the original stained glass.

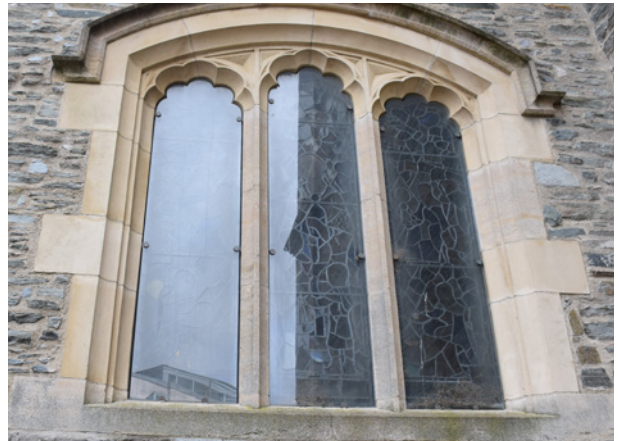
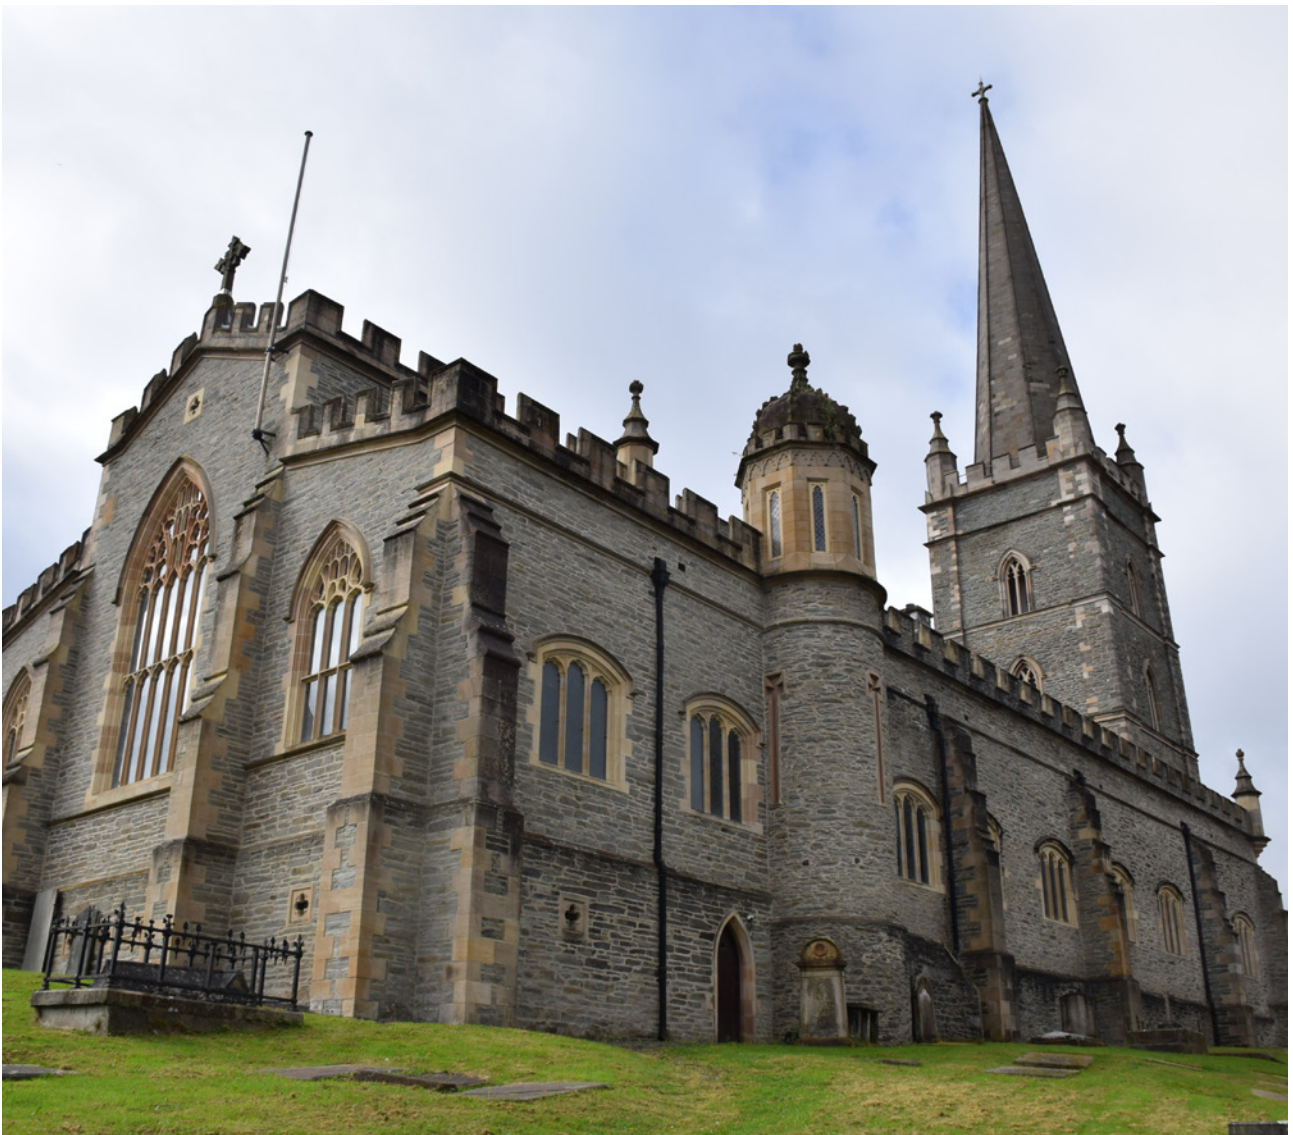
Deeply in set the protective Glazing –
St Columb's cathedral Derry/Londonderry

St Columb's cathedral Derry/Londonderry - The protective glazing is inset deeply;
this results in considerably less impact on the overall aesthetic of the building.
