Bathing Water Profile Murlough, County Down

May 2016

A Description of Murlough bathing water and the surrounding area

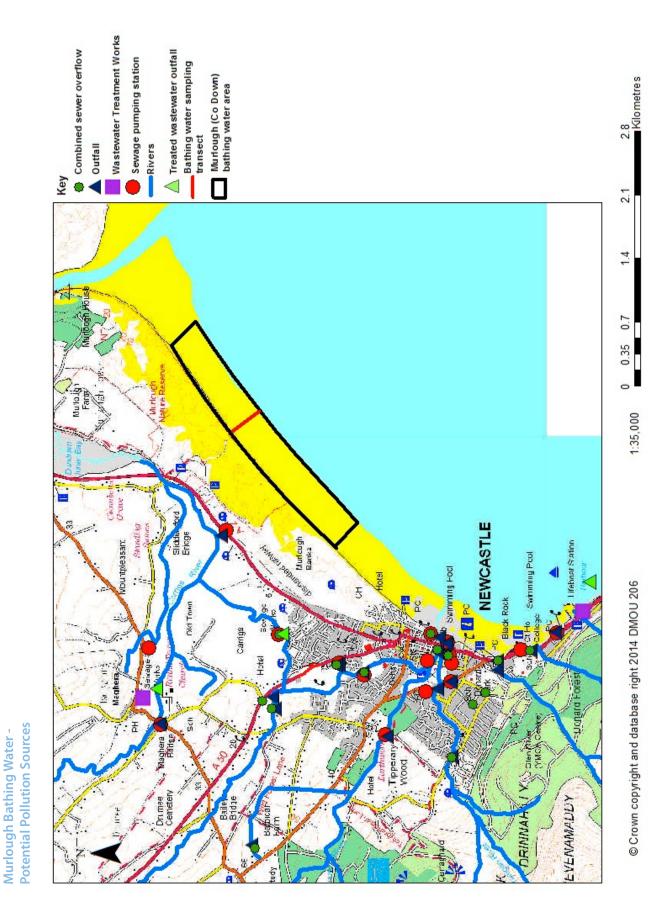
Map 1

The municipal collection and treatment of waste water has the potential to cause pollution because all collection systems must be designed to overflow in periods of extreme wet weather or following failure of the pumped system. If systems are not designed in that way, then sewers may overflow into residential areas. Within the wider Murlough area (including Newcastle and Dundrum) there are combined sewer overflows (CSO), emergency overflows and sewage pumping stations (SPS) with associated emergency overflows as shown on Map 1.

There are no discharges to the Murlough bathing water. The wider Newcastle area, including the Murlough area, is served by a combined sewerage system which delivers waste waters to a treatment facility adjacent to Newcastle harbour. Waste waters receive secondary treatment with bacterial reduction throughout the bathing season. The treated effluent is discharged some 300m from the shoreline, approximately 4 km south west of the Murlough bathing water (Map 1). There is also a small waste water treatment works serving the Dundrum area which discharges secondary treated effluent to inner Dundrum Bay some 2km from the Murlough bathing water.
