Bathing Water Profile

Ballyholme

May 2018

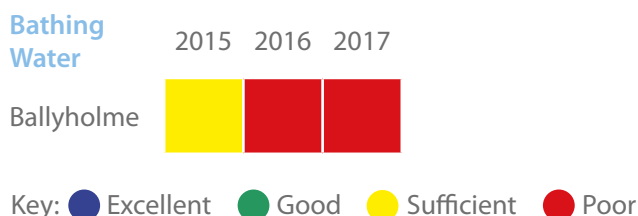
Ballyholme Bathing Water Quality 2015-2017

In 2015 the 1976 Bathing Water Directive was replaced by the European Bathing Water Directive 2006/7/EC. This revised directive introduced more stringent bathing water standards. Bathing Waters are classified as Excellent, Good, Sufficient or Poor (see above). This classification is based on a statistical assessment of results from the last four years.
