### Bathing Water Profile

# **Portrush (Curran Strand)**

May 2018

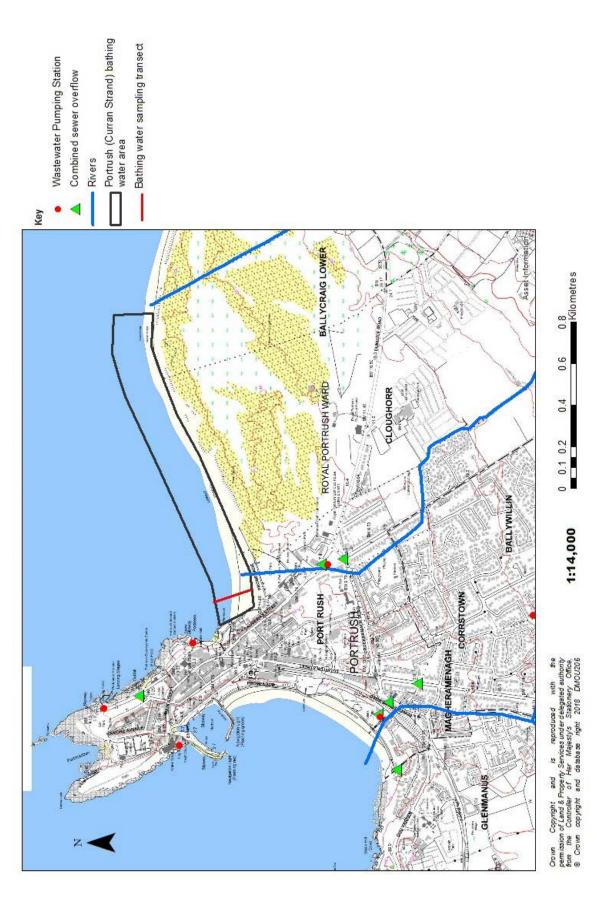
Map 1 Portrush (Curran Strand) Bathing Water -Potential Pollution Sources

The municipal collection and treatment of waste water has the potential to cause pollution because all collection systems must be designed to overflow in periods of extreme wet weather or following failure of the pump system. If systems are not designed in that way, then sewers may overflow into residential areas. Within the Portrush area there are combined sewer overflows (CSO), emergency overflows and wastewater pumping stations with associated emergency overflows as shown on Map 1.
