Brompton – Bathing Water Profile

Brompton Bay, Bangor, County Down, Northern Ireland

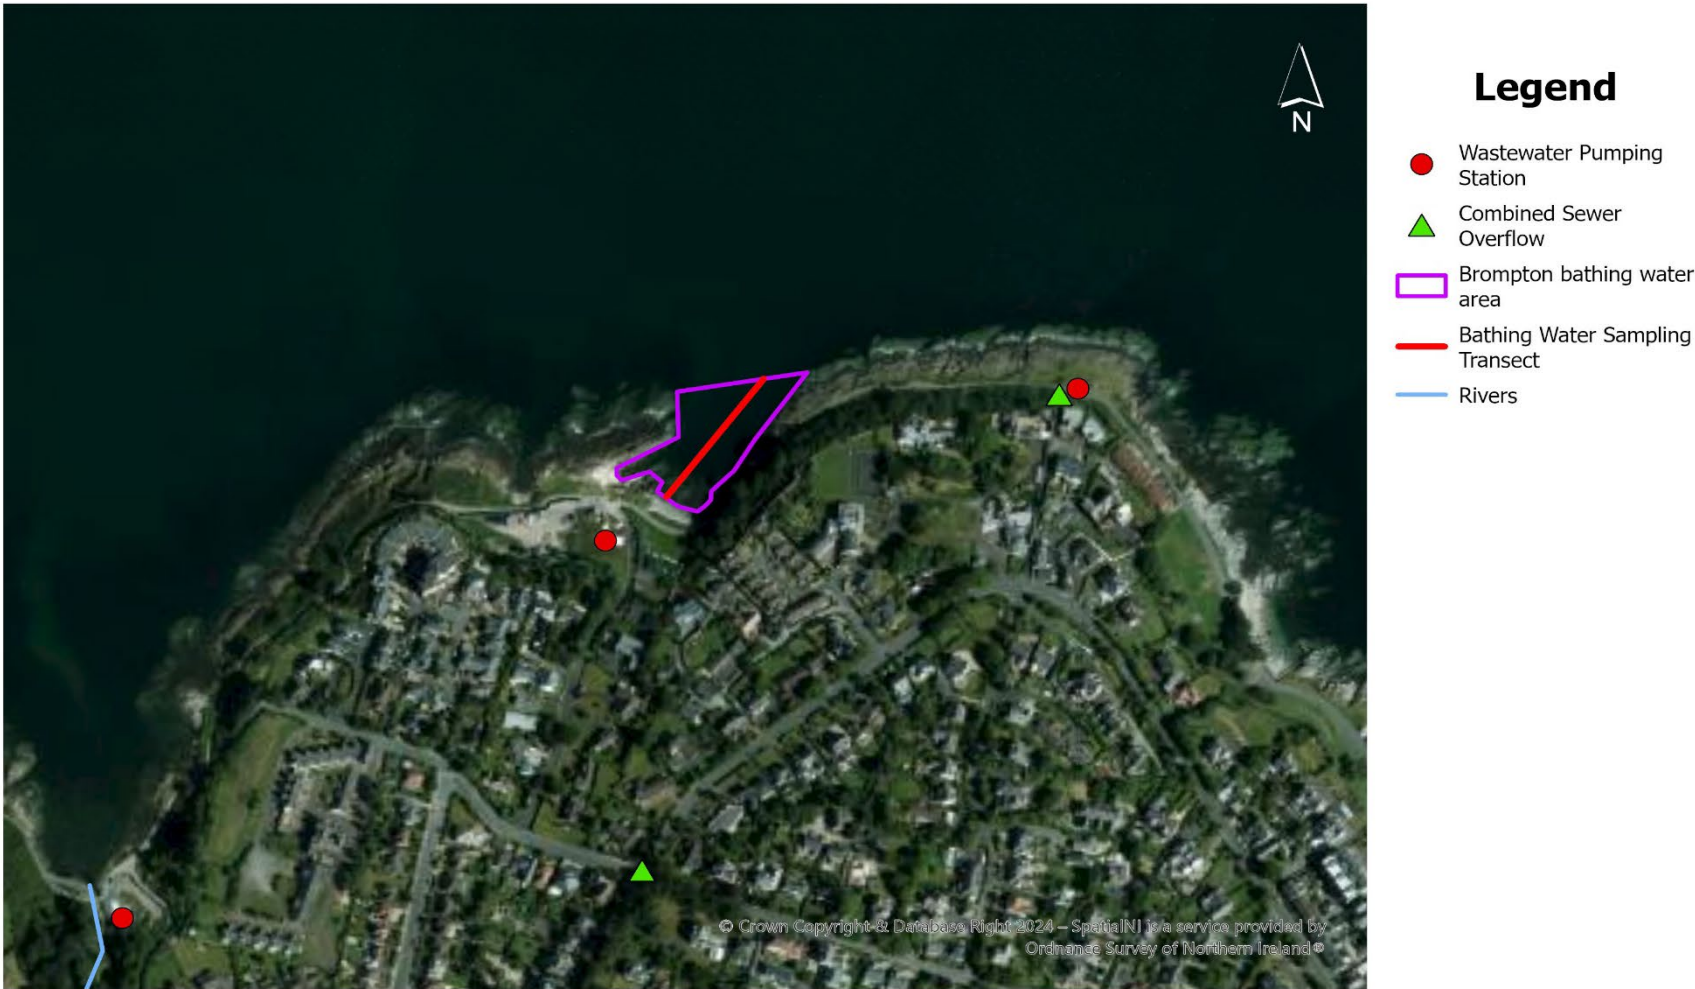
Map 1 Brompton Bathing Water

The collection and treatment of wastewater has the potential to cause pollution as sewage collection systems are often combined and designed to overflow in periods of extreme wet weather or there may be occasional failures in the treatment system. Near the Brompton area there are a number of combined sewer overflows (CSO) and wastewater pumping stations with associated emergency overflows, highlighted on Map 1.
