## Cranfield Bay – Bathing Water Profile

Cranfield beach, County Down, Northern Ireland

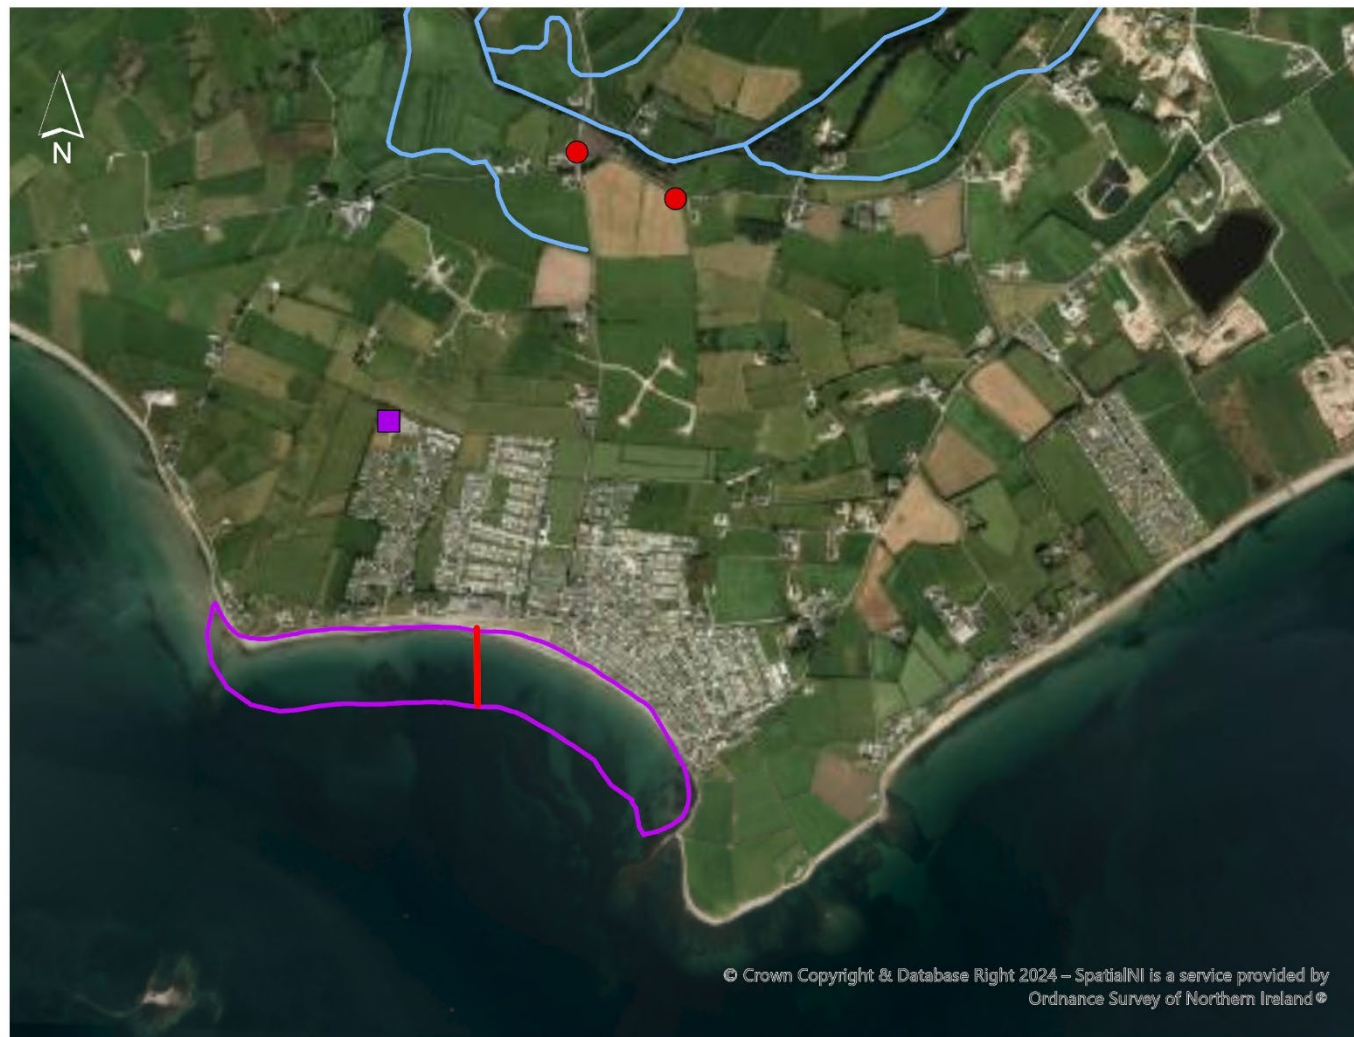
Map 1 Cranfield Bay Bathing Water

The collection and treatment of wastewater has the potential to cause pollution as all combined collection systems are designed to overflow in periods of extreme wet weather or following failure of the system. This prevents overflows into residential properties, Cranfield Bay area has a number of wastewater pumping stations and associated emergency overflows, highlighted on Map 1.

Inland from the caravan parks and amenity area is a small wastewater treatment works which serves the wider Cranfield area. Screened effluent is discharged at sea some 300m offshore, outside of the bathing water area.
