Cushendall – Bathing Water Profile

Cushendall, County Antrim, Northern Ireland, United Kingdom

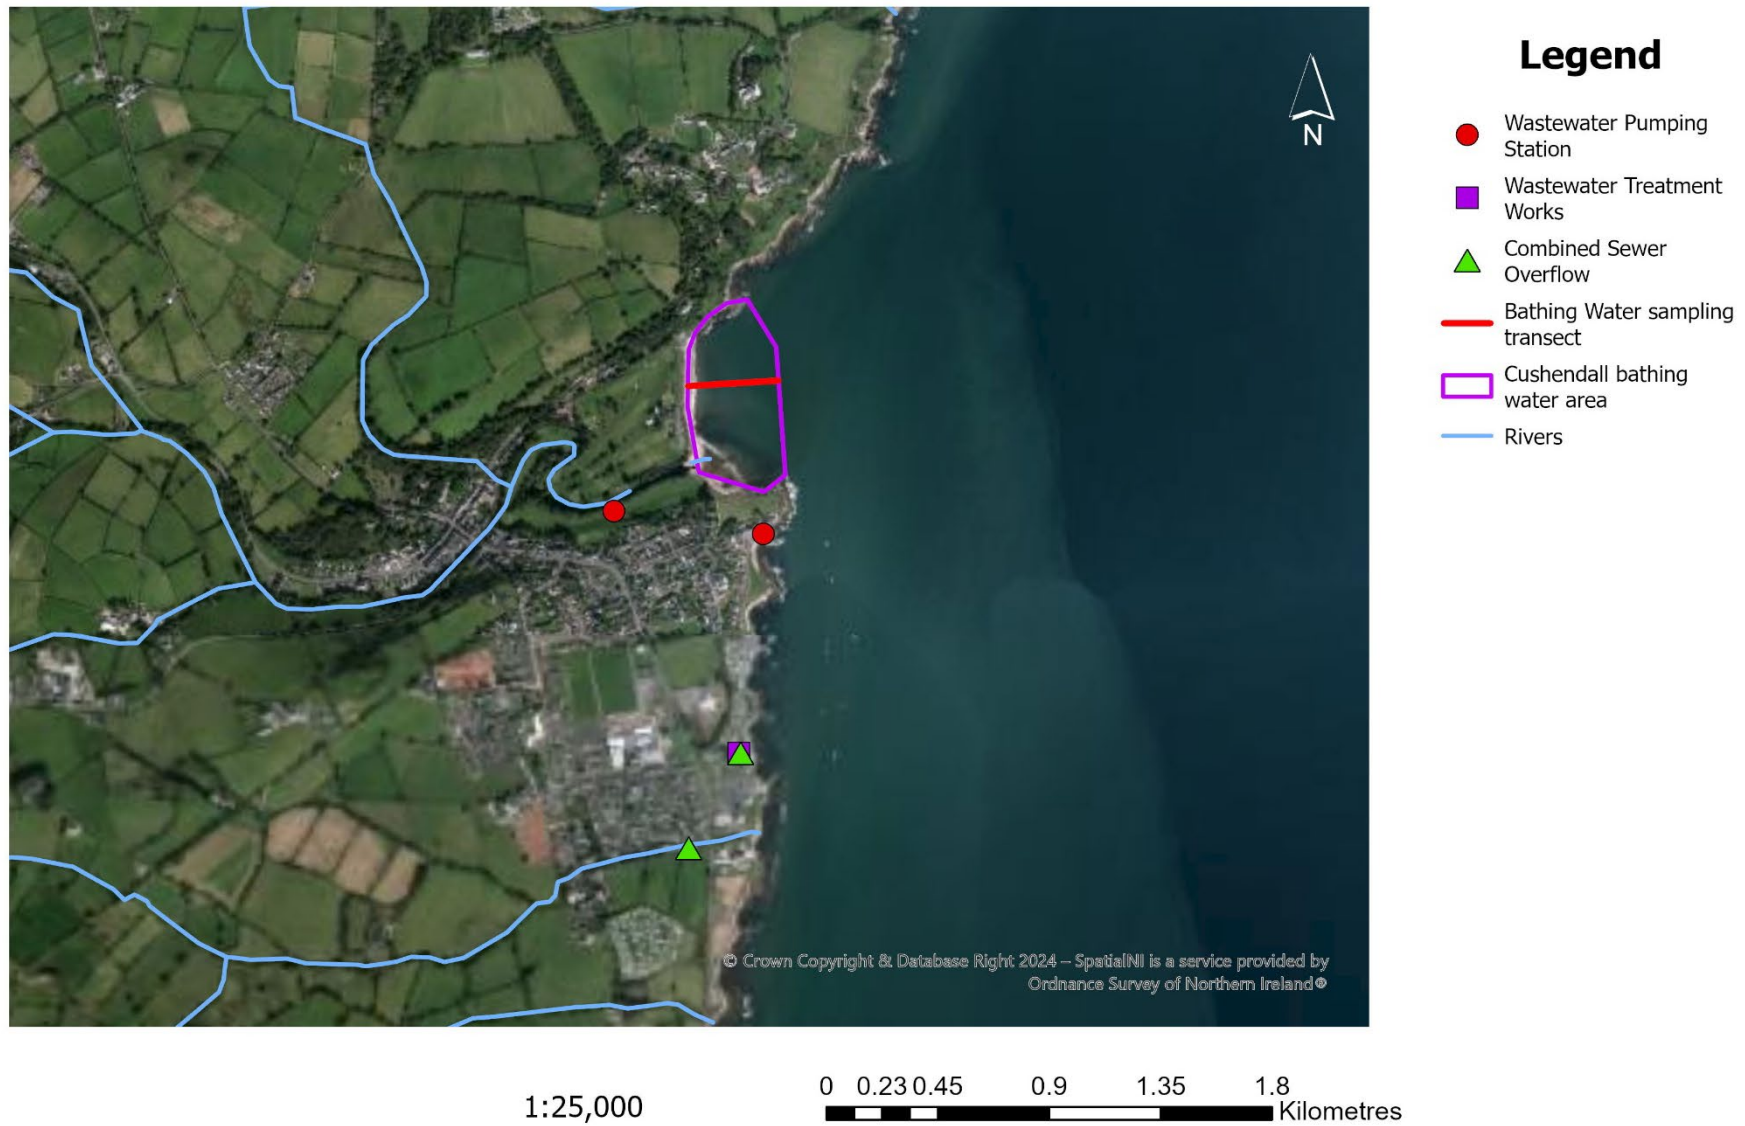
Map 1 Cushendall Bathing Water

The collection and treatment of wastewater has the potential to cause pollution as all combined collection systems are designed to overflow in periods of extreme wet weather or following failure of the system. This prevents overflows into residential properties. Within the Cushendall area there are combined sewer overflows (CSO) and wastewater pumping stations with associated emergency overflows, highlighted on Map 1.
