Rea's Wood – Bathing Water Profile

Rea's Wood, Antrim, County Antrim, Northern Ireland, United Kingdom

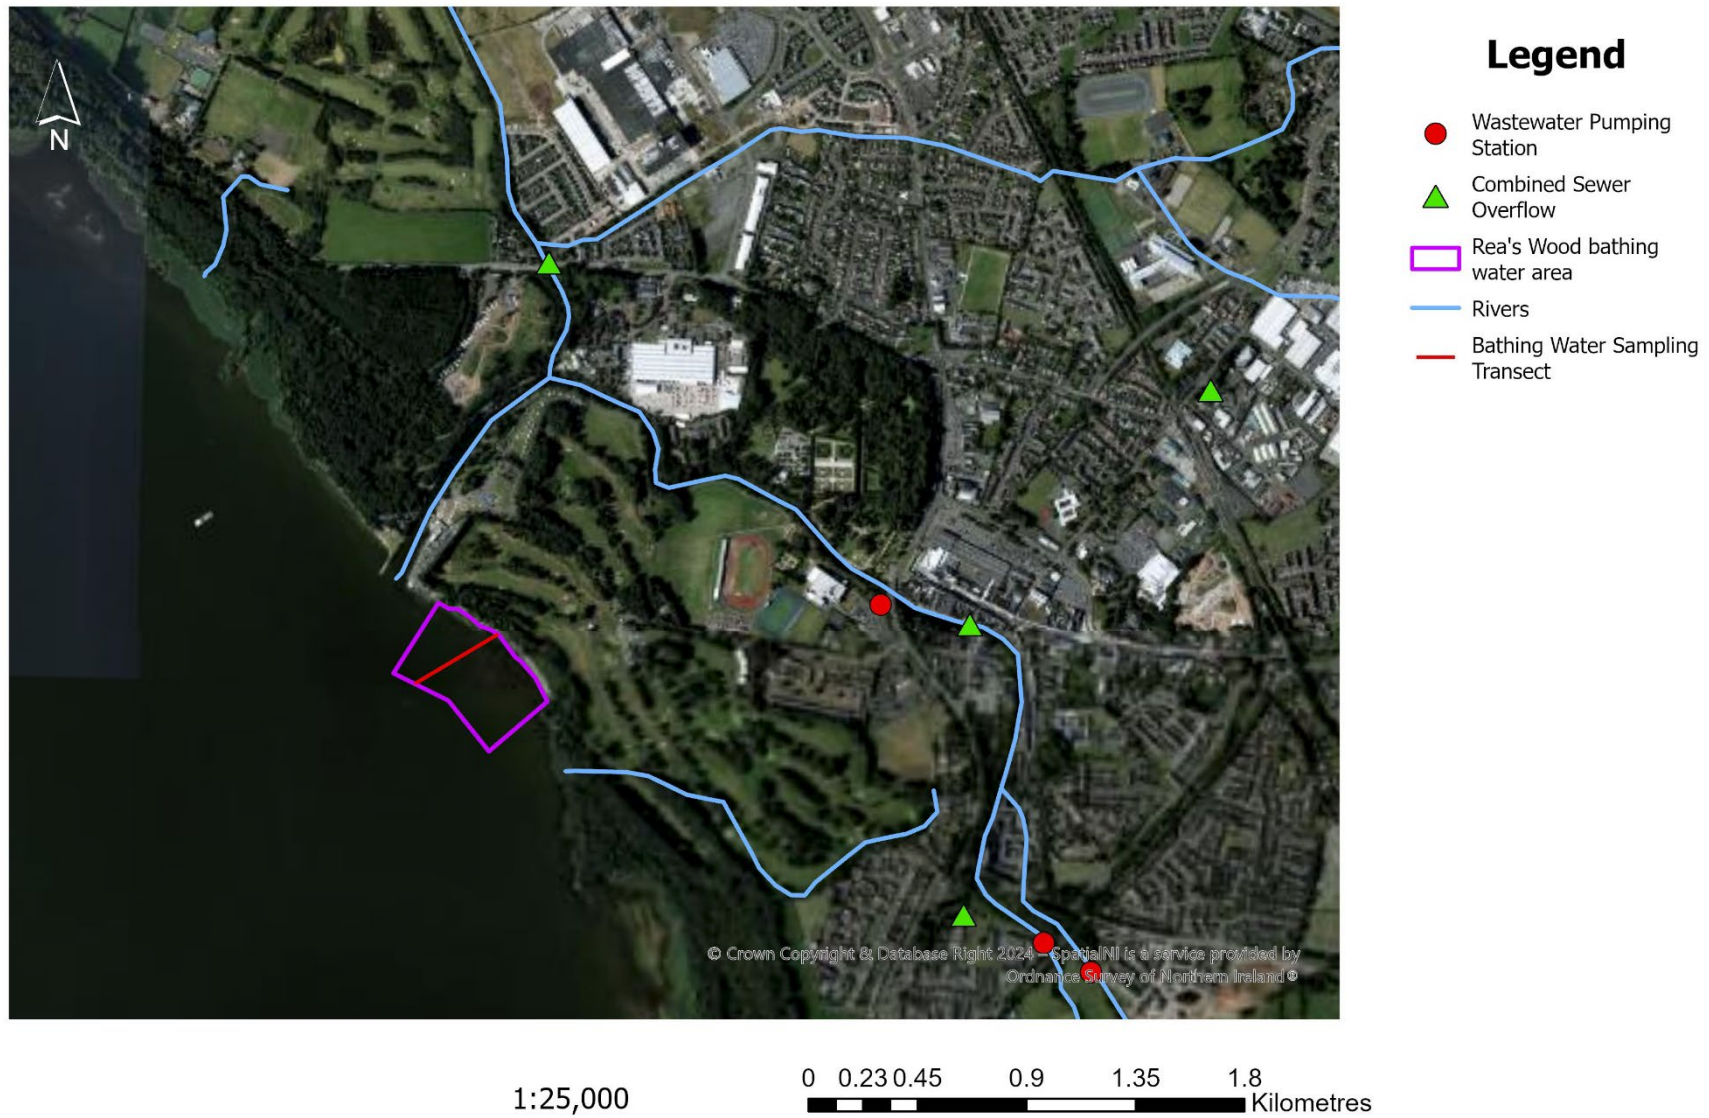
Map 1 Rea's Wood Bathing Water

The collection and treatment of wastewater has the potential to cause pollution as all combined collection systems are designed to overflow in periods of extreme wet weather or following failure of the system. This prevents overflows into residential properties. Within the area of Rea's Wood bathing water there are combined sewer overflows (CSO), a number of wastewater pumping stations and associated emergency overflows, highlighted on Map 1.
