# Cavity Wall Insulation Research Project 2019

Research study prepared for the  
Northern Ireland Housing Executive

Research study prepared by Consultancy, Investigation and Training (CIT)  
for the Northern Ireland Housing Executive

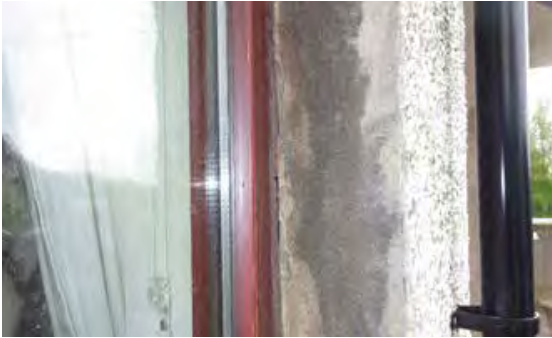
The perimeter seals on all ground floor windows on the front elevation and all ground floor windows and door on the rear elevation are defective and require remediation. The perimeter seals have either eroded or are missing and if left un-remediated will allow water to access into the cavity and potentially compromise both the CWI installation and inner wall area.

Figure 6.3 Compromised perimeter seal (window)

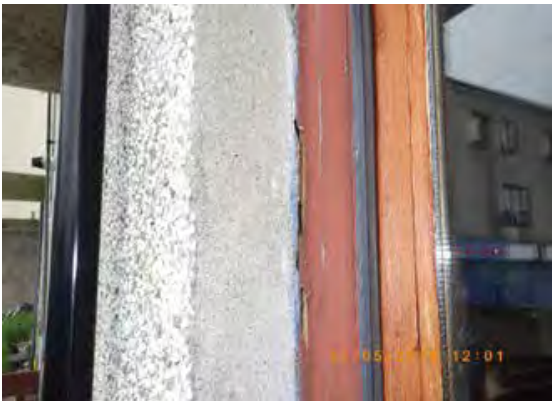
Figure 6.4 Compromised perimeter seal (door)

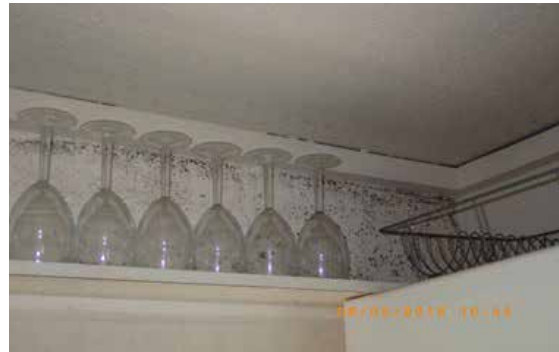
During the internal inspection, condensation was identified on all elevations. This normally indicates poor ventilation or possible presence of voids in the CWI in this area with cold bridging resulting that could promote condensation on the inner wall. The CWI should be removed and the cavity cleaned; then, following a period of time for the walls to dry, the property should be assessed for its suitability to have a CWI system installed.

Figure 6.6 Condensation in the kitchen

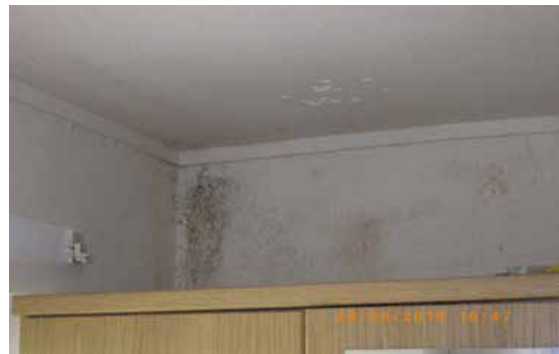
Figure 6.7 Condensation in the bedroom

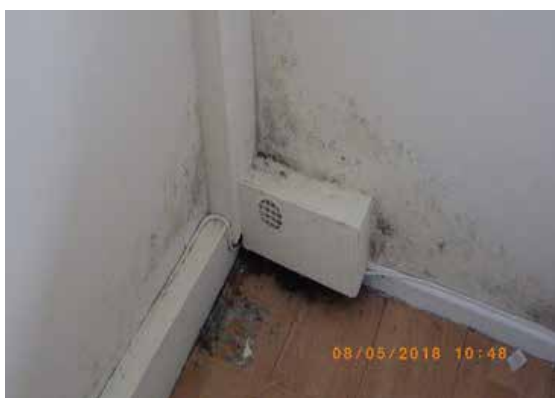
Damp was found on all internal elevations in correlation with the voids and debris identified in the cavity during the survey. The voids and debris will allow water to access into the cavity and potentially compromise both the CWI installation and inner walls area as has happened in this case. The CWI should be removed and the cavity cleaned; then, following a period of time for the walls to dry, the property should be assessed for its suitability to have a CWI system installed.

Figure 6.10 Damp on the internal wall

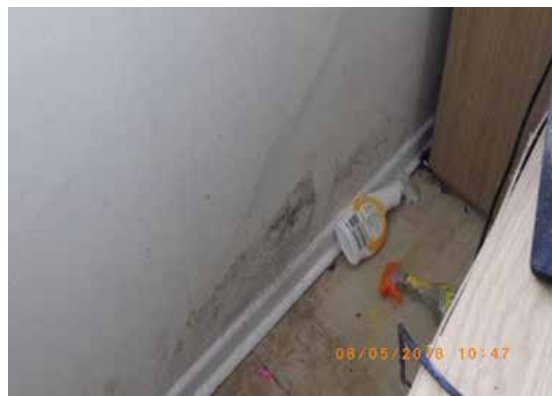
Figure 6.11 Damp on the bedroom wall

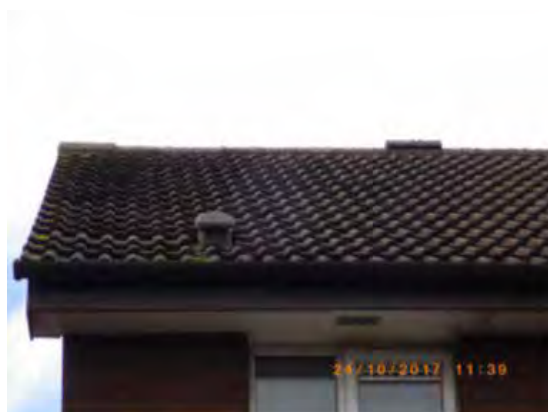
Figure 6.16 Vegetation growth in guttering (rear) elevation.

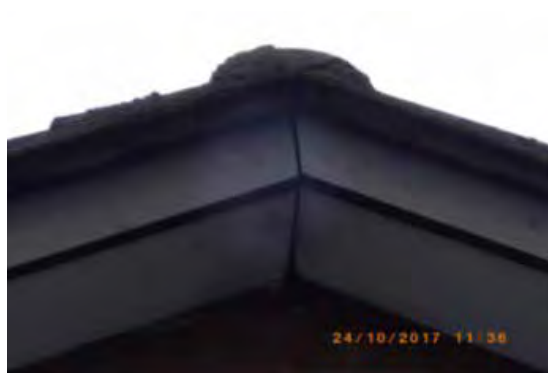
The soffit on the side elevation requires maintenance to a section that has split. If left un-remediated there is the potential for water to ingress into the cavity with the potential to compromise the inner walls.

Figure 6.17 Split soffit area

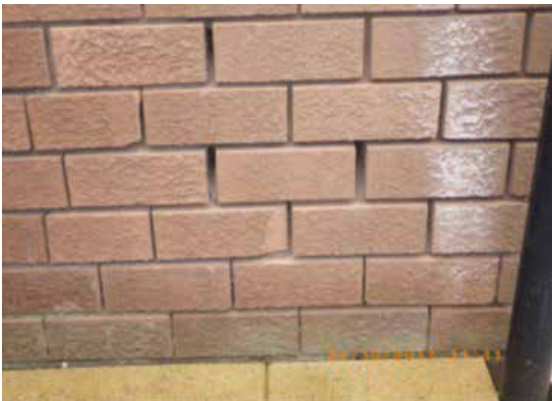
Figure 6.19 Mortar erosion (rear) elevation

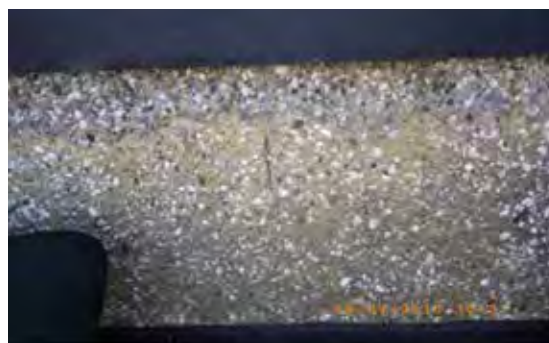
The render on the rear elevation requires remediation to a section that has split. If left un-remediated there is the potential for water to ingress behind the render, with a high risk of the render detaching from the wall and exposing the outer substrate to high volumes of water with the potential to compromise the inner walls.

Figure 6.30 Crack in the render

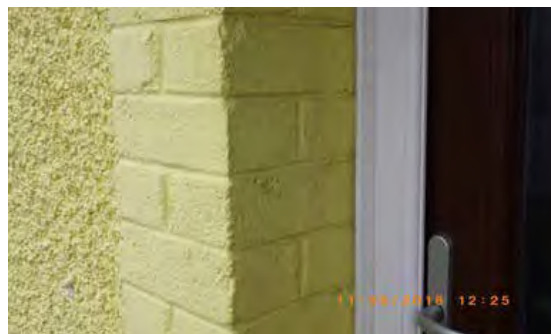
Figure 6.35 Door reveal juncture in good condition

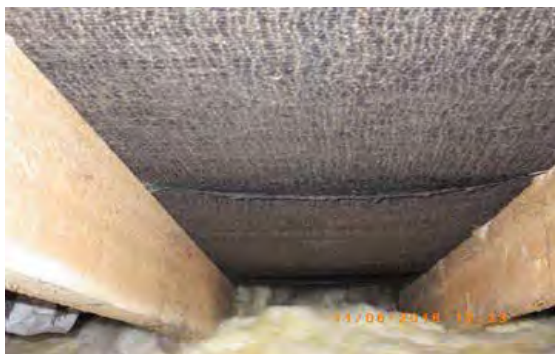
The internal walls showed no signs of damp or condensation. The occupant reported they had not witnessed any problems of this type. The loft space inspection found the internal gable wall to be in a good condition with the eaves clear of loft insulation, allowing for good crossflow ventilation.

Figure 6.46 Clear eaves area in loft space

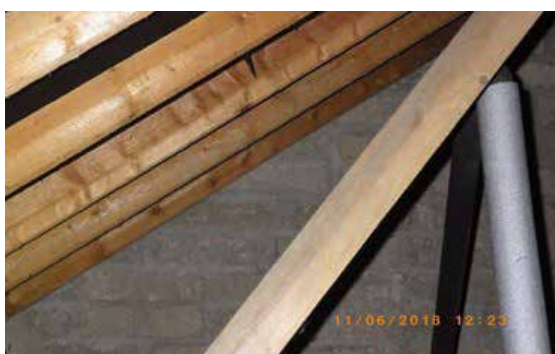
Figure 6.47 Gable wall in good condition

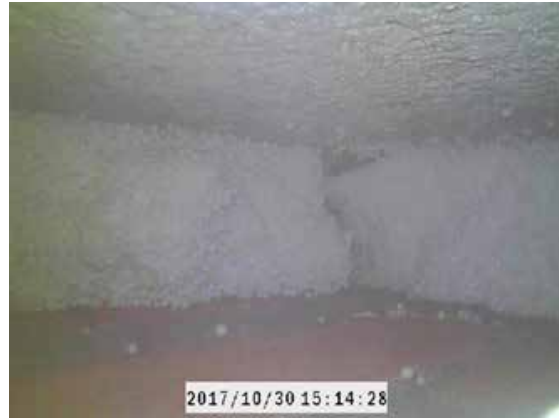
Voids in the CWI and/or debris in the cavity were identified in all properties surveyed (ref: figures 7.6, 7.7, 7.8 & 7.9). There was also evidence of a direct correlation between the void in the CWI fill and or debris bridging the cavity with the formation of damp or condensation on the internal wall.

Figure 7.9 Void in the CWI installation

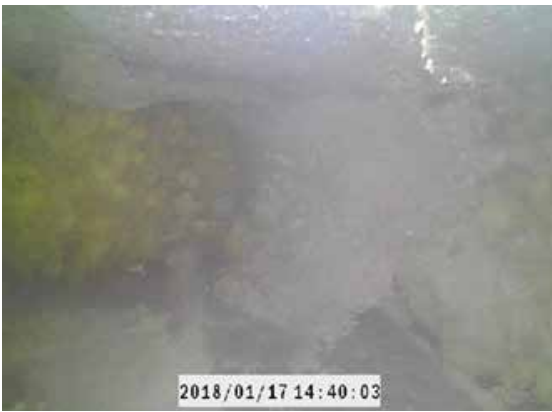
Figure 7.7 Void in the CWI installation and debris bridging the cavity

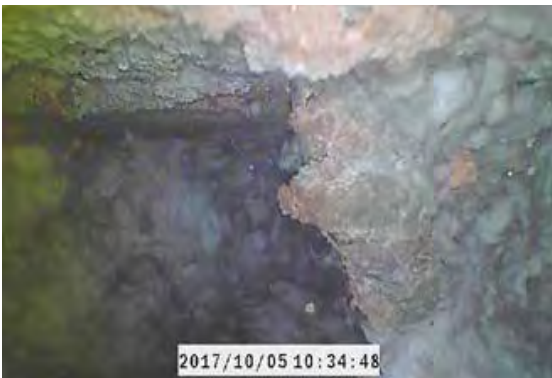
Figure 7.8 Void and debris bridging the cavity

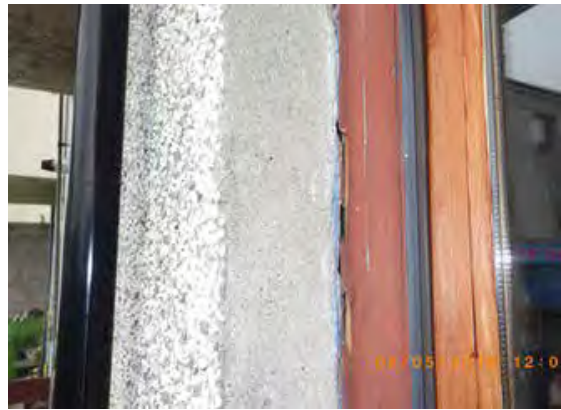
Defective perimeter seals to doors and windows (44%) (ref: figures 7.16 & 7.17). Defective perimeter seals on door and window frames increase the potential for wind-driven rain to breach the external façade and gain access to the cavity exposing it to a higher volume of water, with the risk of generating damp and compromising the internal walls.

Figure 7.16 Defective perimeter seal between door and wall

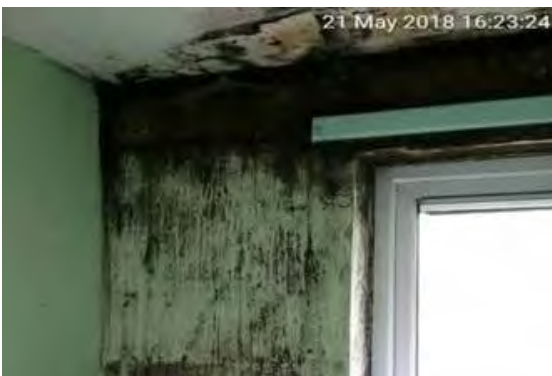
Damp (89%) (ref: figures 7.10 - 7.15). Evidence gathered shows voids and or debris in the CWI installation corresponding with the damp or damp and condensation on the inner walls of the properties.

Figure 7.14 Damp and condensation

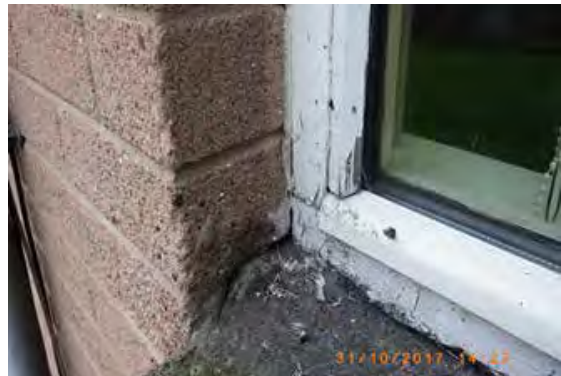
Figure 7.17 Defective perimeter seal between window and wall

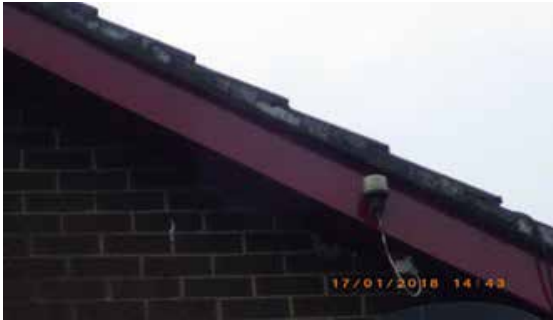
Damaged roof section (22%) (ref: figures 7.18 & 7.19). Damaged verge mortar can lead to rain water tracking across the top of the outer wall and gaining access to the cavity, with the potential to cause damp on the inner wall.

Figure 7.18 Damaged roof – Cracked verge mortar

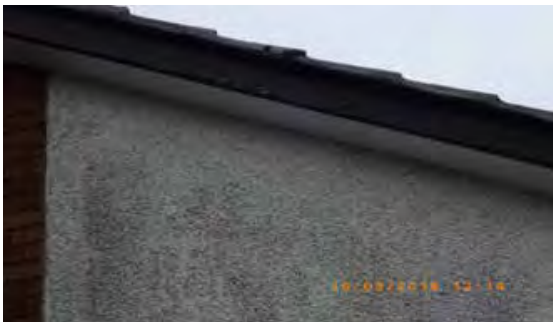
Figure 7.19 Damaged roof - Cracked verge mortar

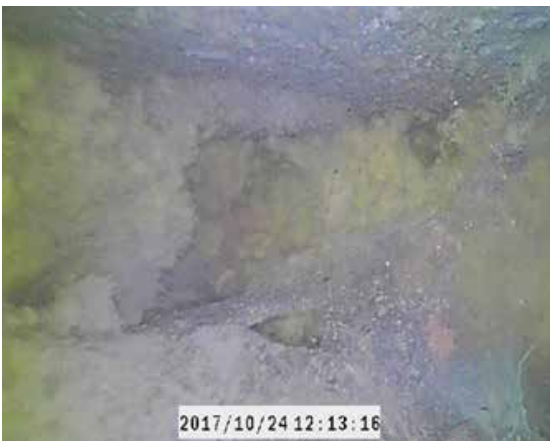
All Class 2 - Category A properties evidenced problems with voids in the CWI fill and debris in the cavity which require the CWI to be extracted from the cavity and for the cavity to be cleaned of all debris. Debris is required to be removed because it could be a conduit for moisture to travel across the cavity to the inner wall, representing a risk of compromising the inner wall and resulting in the formation of damp. Voids in the insulation could increase the risk of condensation on the inner wall due to the cold bridging effect (ref: figures 7.23 & 7.24).

Figure 7.24 Debris in cavity and void in CWI

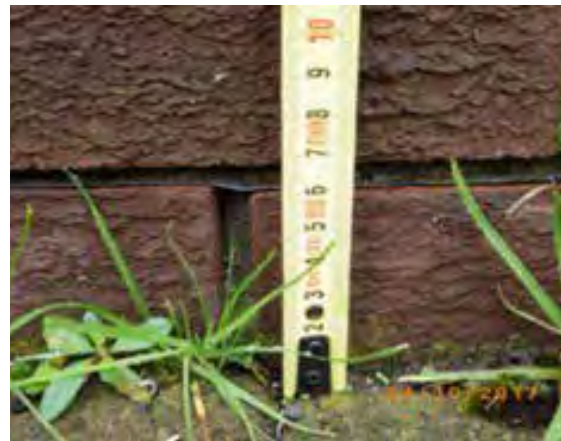
Other defects that could compromise the property external façade are mortar erosion (33%), (ref: figure 7.29), non-compliant DPC level, (27%) (ref: figures 7.27 & 7.28) and compromised verge boards, (20%) (ref: figure 7.30). Compromised mortar (e.g. recessed, missing, damaged or cracked) will weaken the external façade allowing excess water to penetrate the outer wall which may then cause the CWI to become saturated and or water to bridge across the cavity compromising the inner walls. DPC levels and the poor condition of verge boards also have the potential to compromise the external façade's weather resistance to protect the cavity from excess moisture ingress.

Figure 7.27 Non compliant DPC level (below 150mm)

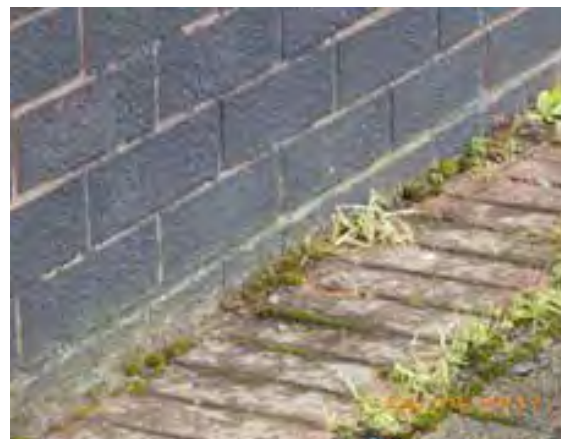
Figure 7.28 Non compliant DPC (below ground level)

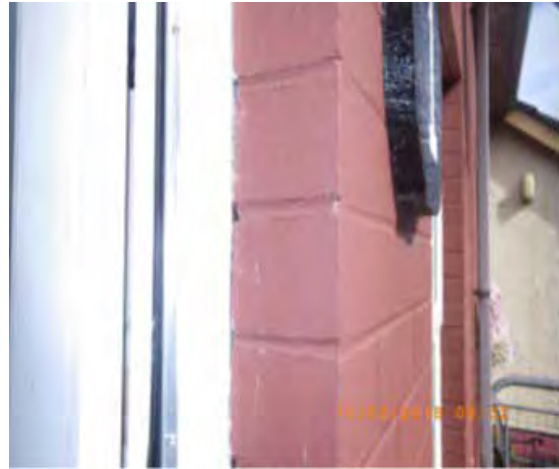
In terms of the external façade, defective perimeter seals on doors and windows was the main issue with almost two thirds of the properties surveyed requiring repair (64%) (ref: figures 7.31 & 7.32). If the juncture between the window/door frame is not sealed correctly, excess moisture may access into the cavity, with the potential risk to compromise the CWI and bridge the cavity, causing damp to form on the inner walls.

Figure 7.31 Defective perimeter seal (door)

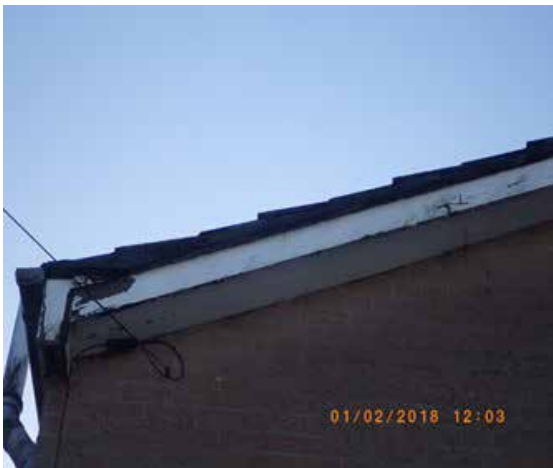
Figure 7.30 Compromised verge board

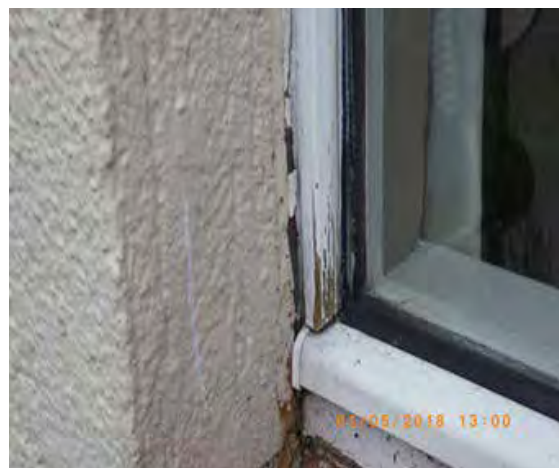
Figure 7.32 Defective perimeter seal (window)

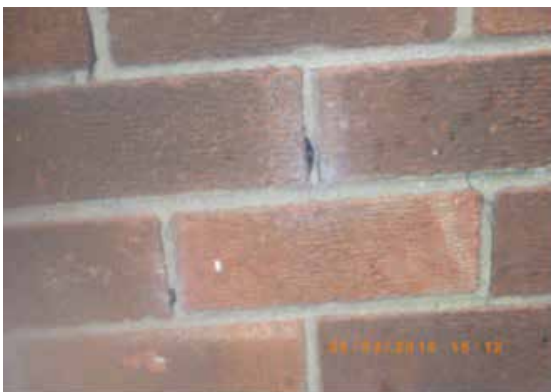
Mortar erosion (30%) (ref: figures 7.34 & 7.35). As can be seen from the photographic evidence poor making-good also factors within this area, where the exposure level to the cavity from wind-driven rain is higher due to poor maintenance of the external façade. Evidence gathered suggests that eventually the transmittance of moisture in a property installed with CWI will bridge the cavity with a high risk of affecting the inner wall and causing the formation of damp or condensation.

Figure 7.34 Compromised mortar joint

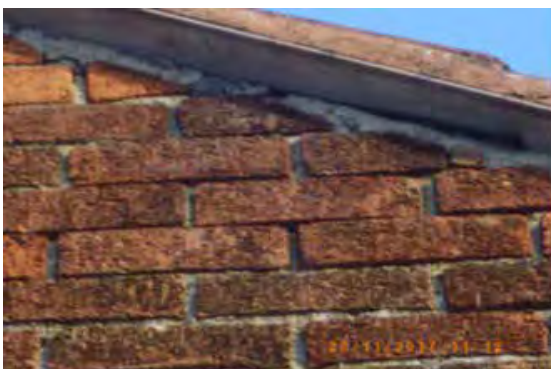
Figure 7.35 Compromised mortar joint

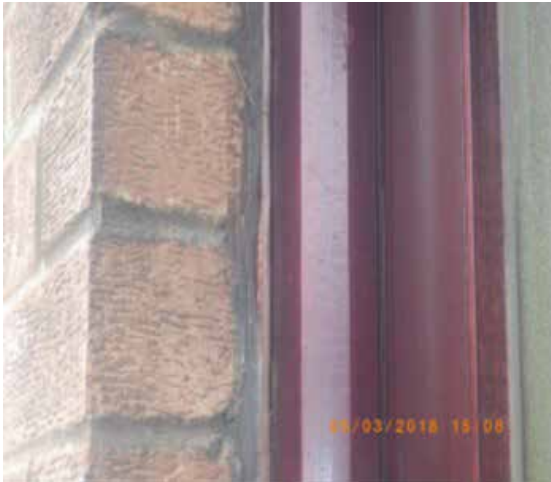
Defective perimeter seals on doors & windows (56%) (ref: figures 7.38 & 7.39). As can be seen in the photographic evidence, defective perimeter seal between doors and window frames can allow wind driven rain easier access

Figure 7.38 Defective perimeter seal (door)

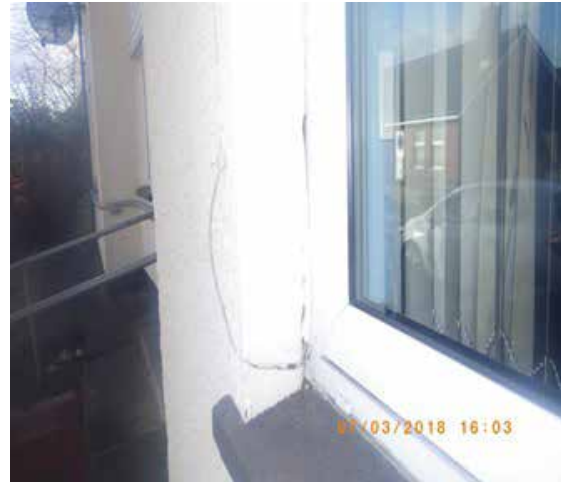
Figure 7.39 Defective perimeter seal (window)

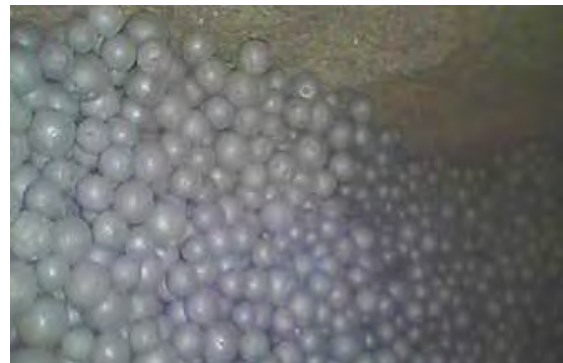
Voids in the CWI installation and or debris in the cavity (100%) (ref: figures 7.41- 7.46). All properties within this category exhibited voids in the CWI and/or debris in the cavity. Evidence also shows this to be identified for all types of CWI systems installed including foam, bead and fibre products. The consequence of voids/ debris will be a higher risk of moisture tracking across the cavity and compromising the inner walls.

Figure 7.44 Void in the CWI installation

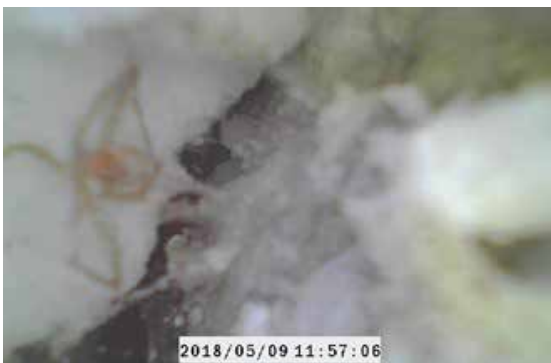
Figure 7.42 Void in the CWI installation

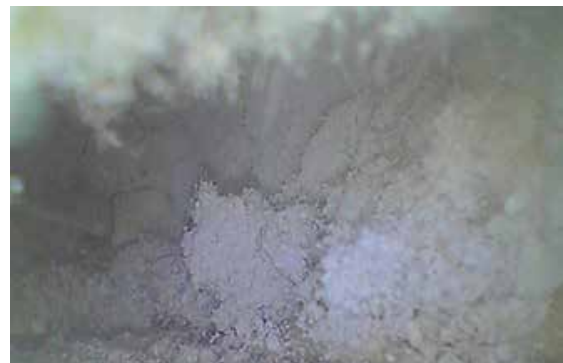
Figure 7.45 Void in the CWI installation

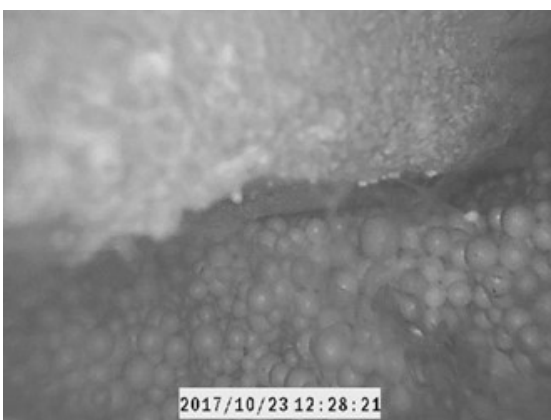
Figure 7.43 Void in the CWI installation

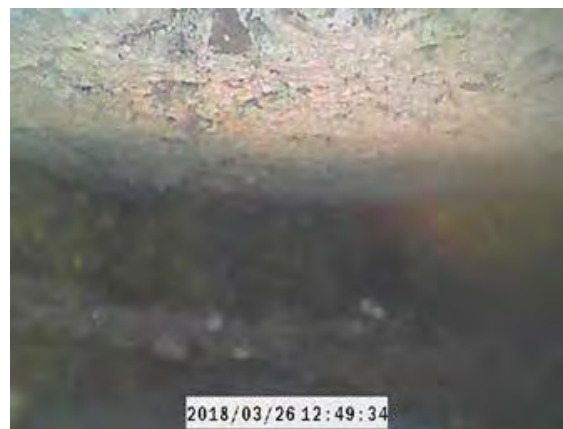
Figure 7.46 Void in the CWI installation

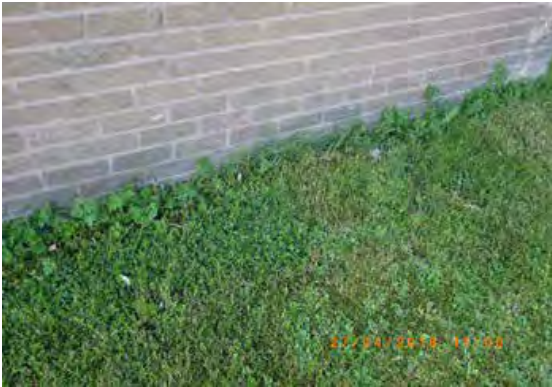
Non-compliant DPC Level (24%) (ref: figures 7.47 & 7.48). Where the floor level on the outside of the property is higher than the DPC level on the external wall there is the potential for a higher volume of moisture to track through to the cavity. The DPC should be at least 150mm above the ground for the property to be considered suitable to have CWI installed.

Figure 7.47 Non compliant DPC level (below 150mm)

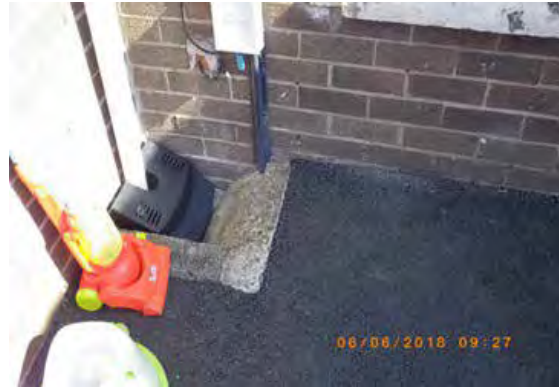
Figure 7.48 Non compliant DPC level (below the Tarmac)

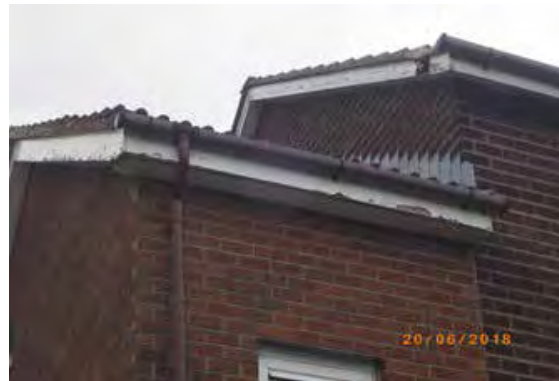
Damaged soffits and fascia (27%) (ref: figures 7.52 & 7.53). Poorly maintained soffits and fascia will, over time, reduce the weather tightness of the external façade increasing the risk of moisture access to the cavity.

Figure 7.53 Damaged soffit and fascia

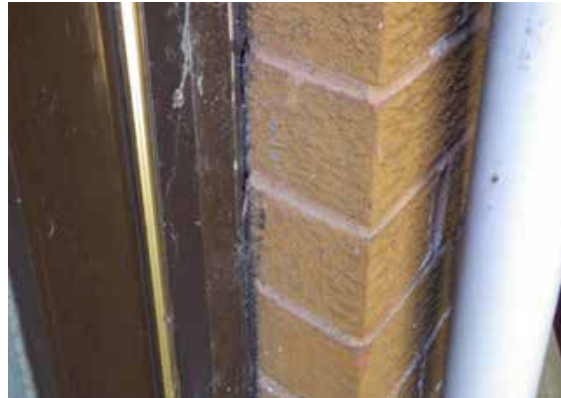
Defective perimeter seals to doors and windows (22%) (ref: figure 7.56 & 7.57). Gaps in the seals between the windows and doors will allow wind driven rain to gain access to the cavity increasing the risk of damp on the inner walls.

Figure 7.56 Defective perimeter seal (door)

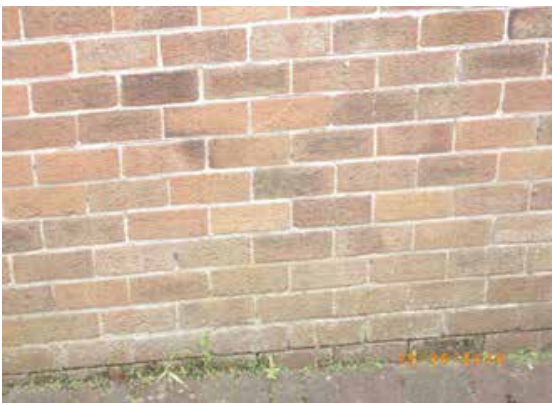
Non-compliant DPC level (23%) (ref: figures 7.54 & 7.55). If the DPC level on the external wall is below 150mm there is the potential for a higher volume of moisture to track through to the cavity, increasing the probability of damp on the inner wall. The DPC should be at least 150mm above the ground for the property to be considered suitable for CWI.

Figure 7.55 Non-compliant DPC level (below 150mm)

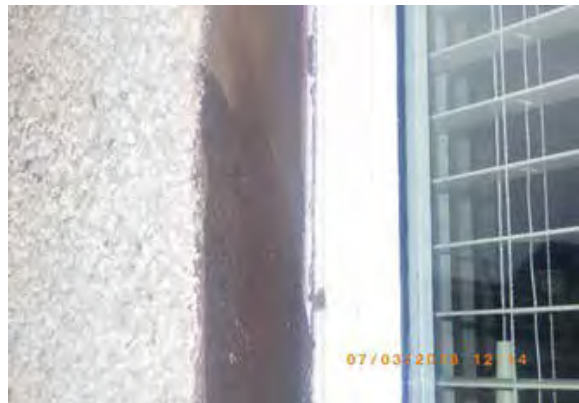
Figure 7.57 Defective perimeter seal (window)

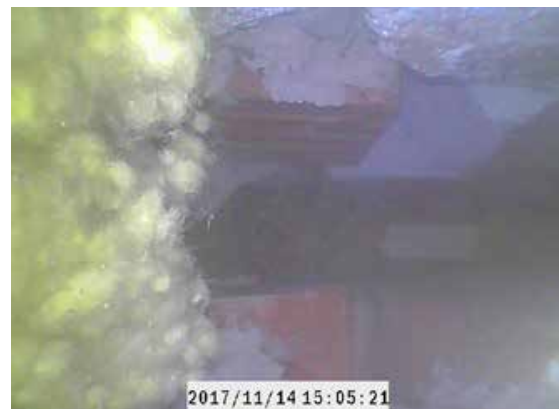
Voids in the CWI and or debris in the cavity (100%) in Class 1, Class 2 – Category A and Class 3 – Category A recommendations) (ref: figures 8.3 - 8.8). All properties within this category exhibited voids in the CWI and or debris in the cavity for all types of CWI systems installed (Foam, Bead and Fibre). The effects of the voids/ debris will be a higher probability of moisture tracking across the cavity compromising the inner walls.

Figure 8.4 Voids and debris in the fibre CWI

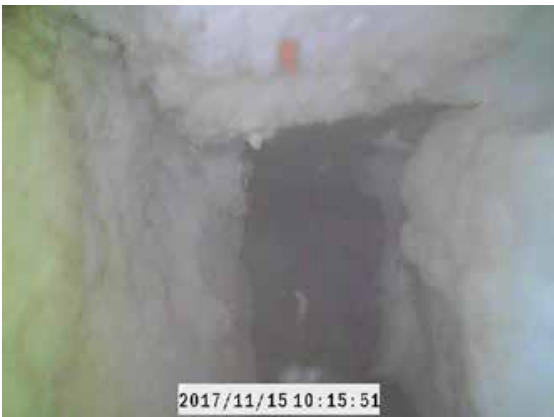
Figure 8.5 Voids in the foam CWI

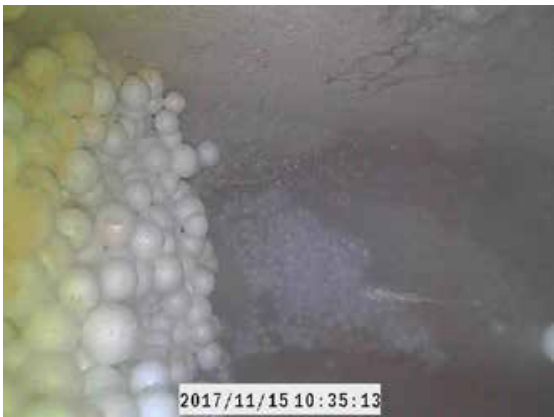
Figure 8.8 Voids and debris in the bead CWI

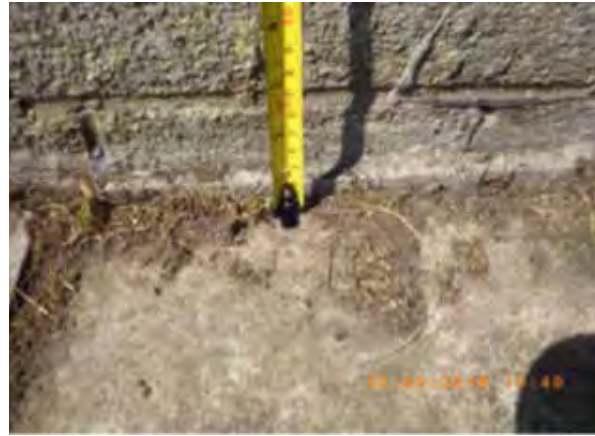
Non-compliant DPC level (25%) (ref: figures 8.13 & 8.14). As highlighted within the photographic evidence, the examples show the DPC level to be below the recommended 150mm for CWI to be installed. This non-conformity means the lower section of the walls is exposed to a higher volume of moisture.

Figure 8.14 Non-compliant DPC level (below 150mm)

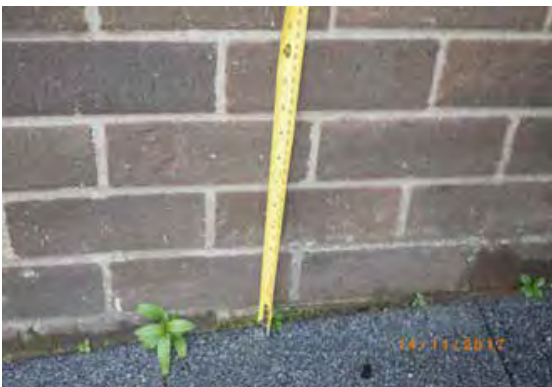
Figure 8.13 Non-compliant DPC level (below 150mm)

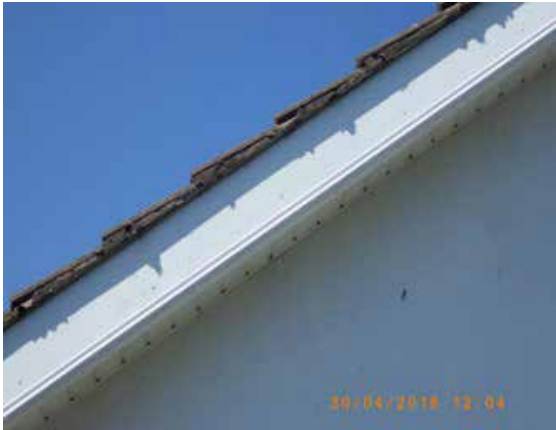
Damaged Verge boards (33%) (ref: figures 8.19 & 8.20). Poorly maintained verge boards and verge tiles have the potential to allow excess moisture to bridge across the brickwork into the cavity, possibly resulting in water compromising the inner walls.

Figure 8.20 Damaged verge board

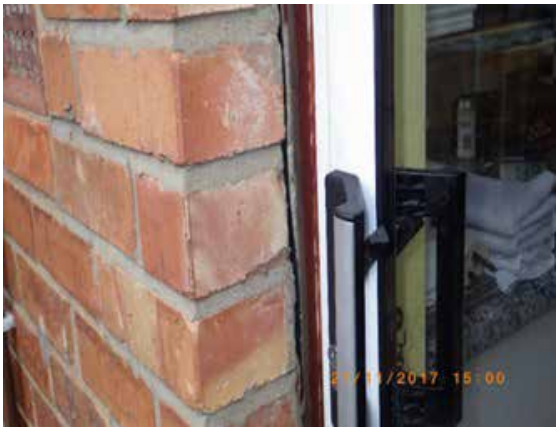
Defective perimeter seals on doors and windows (50%) (ref: figures 8.21 & 8.22). As can be seen from the photographic evidence, the poorly maintained or damaged perimeter seal between the window/door frames and the wall will allow wind driven rain easier access to the cavity, with a higher probability of water bridging the cavity and compromising the inner walls.

Figure 8.21 Defective perimeter seal (door)

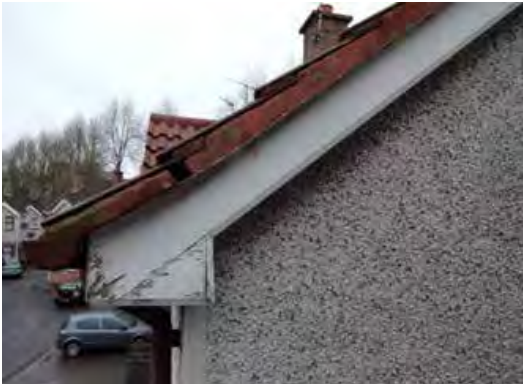
Figure 8.19 Damaged verge board

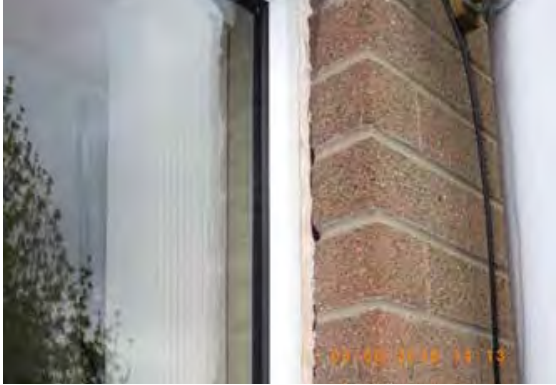
Figure 8.22 Defective perimeter seal (window)

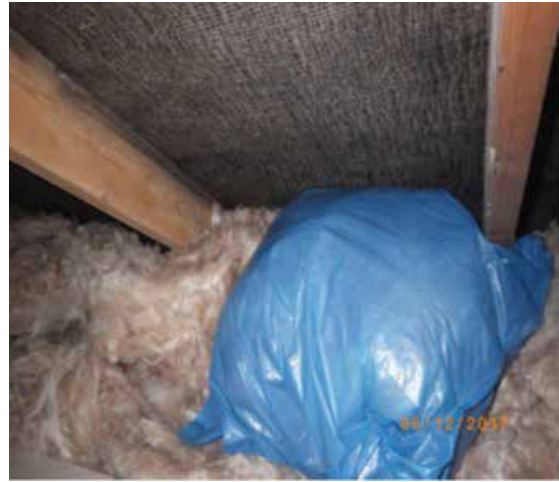
Eaves blocked with loft insulation (22%) (ref: figure 8.23 & 8.24). Where eaves are blocked with insulation (this can be either loft insulation or CWI) the insulation will reduce the air flow into the loft space which will increase the risk of condensation on underside of the roof. Over time this will allow water droplets to fall onto the ceiling below compromising the boards and loft insulation. The moisture forming on the underside of the roof may also affect the rafters, joists and the electrical wiring in the roof.

Figure 8.24 Eaves blocked with loft insulation
