# Bathing Water Profile

## Portrush (Mill Strand)

May 2022

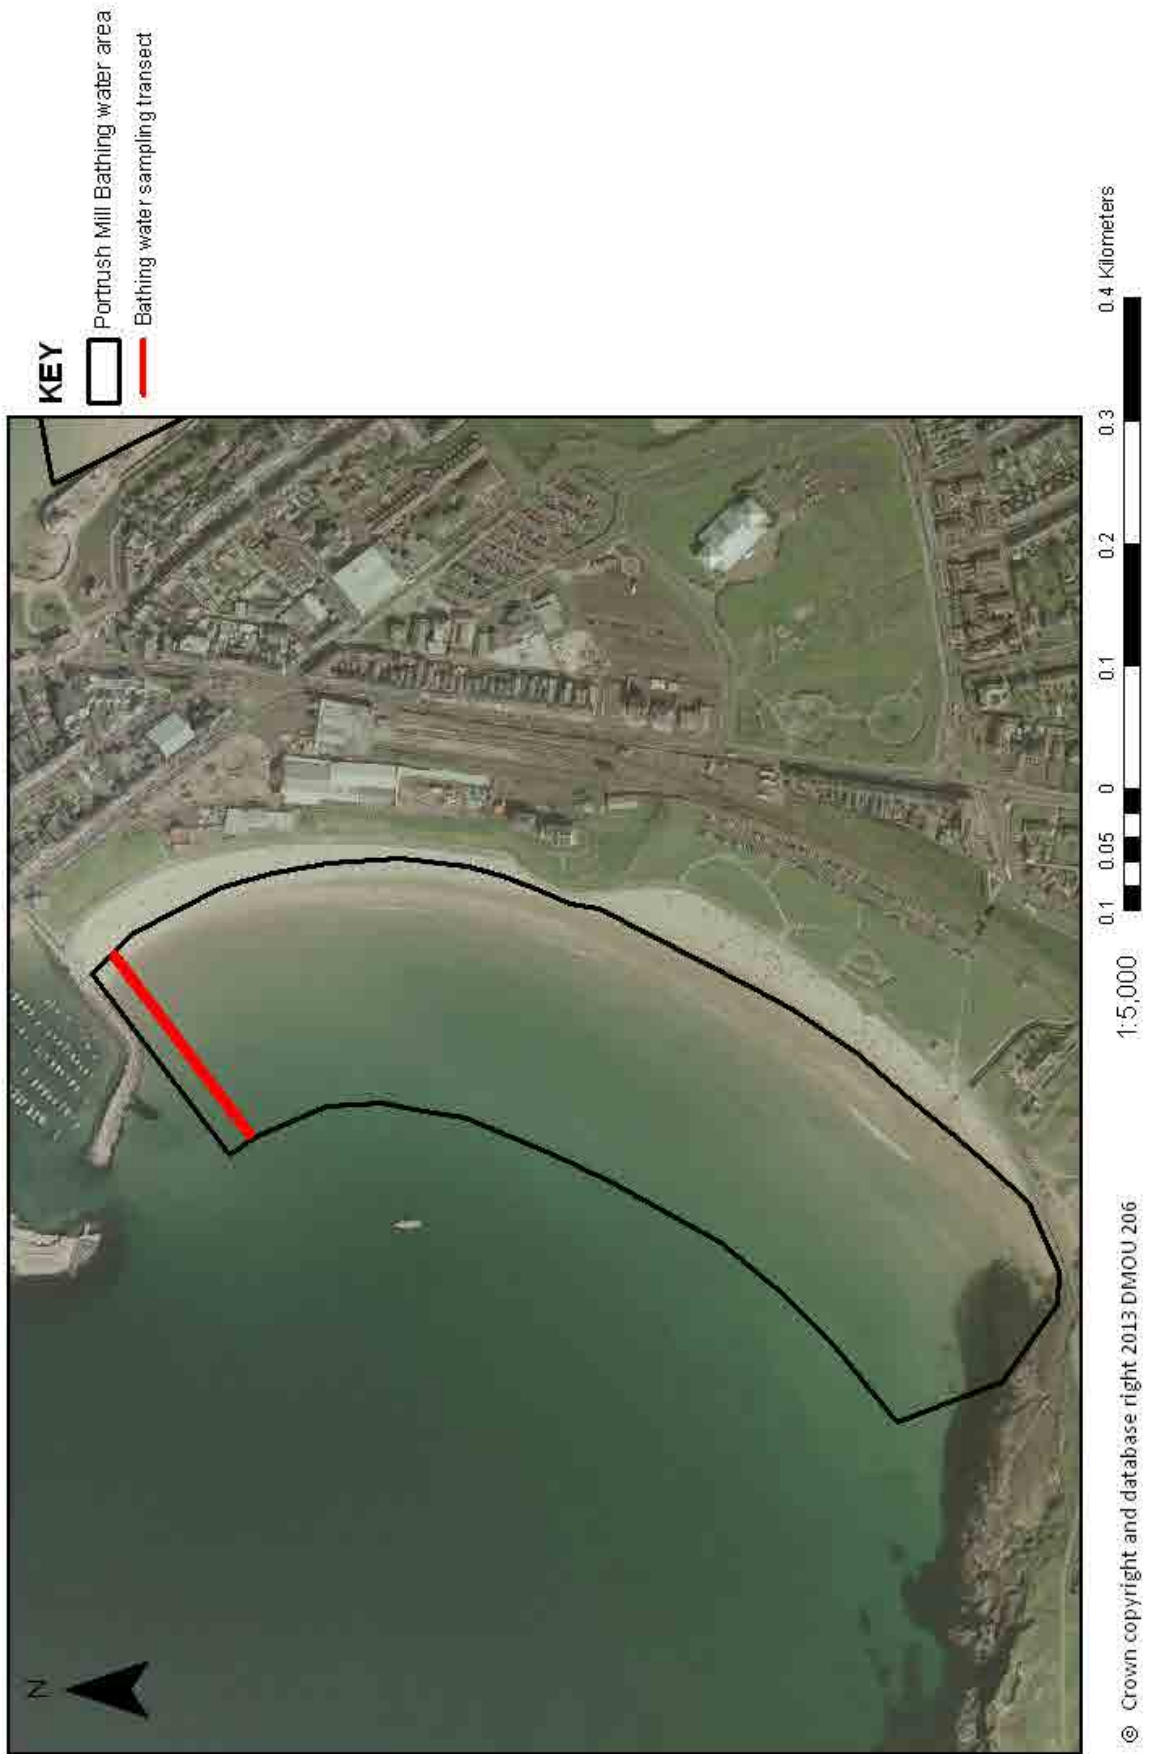
Map 2  
Portrush (Mill Strand) Bathing Water -  
EC Bathing Water Sample Location

<b>Bathing Water Name</b>	Portrush (Mill Strand) Bathing Water
<b>Location</b>	UK/Northern Ireland/County Antrim/North Coast
<b>Year of identification</b>	1988
<b>Local council area</b>	Causeway Coast and Glens Borough Council
<b>Bathing Water Operator</b>	Causeway Coast and Glens Borough Council
<b>Description of bathing beach</b>	Sand, approximately 0.9 kilometres in length
<b>Monitoring Point</b>	Northern end of bathing water, C85604063 (Map 2)
