Bathing Water Profile

Benone (Magilligan)

May 2016

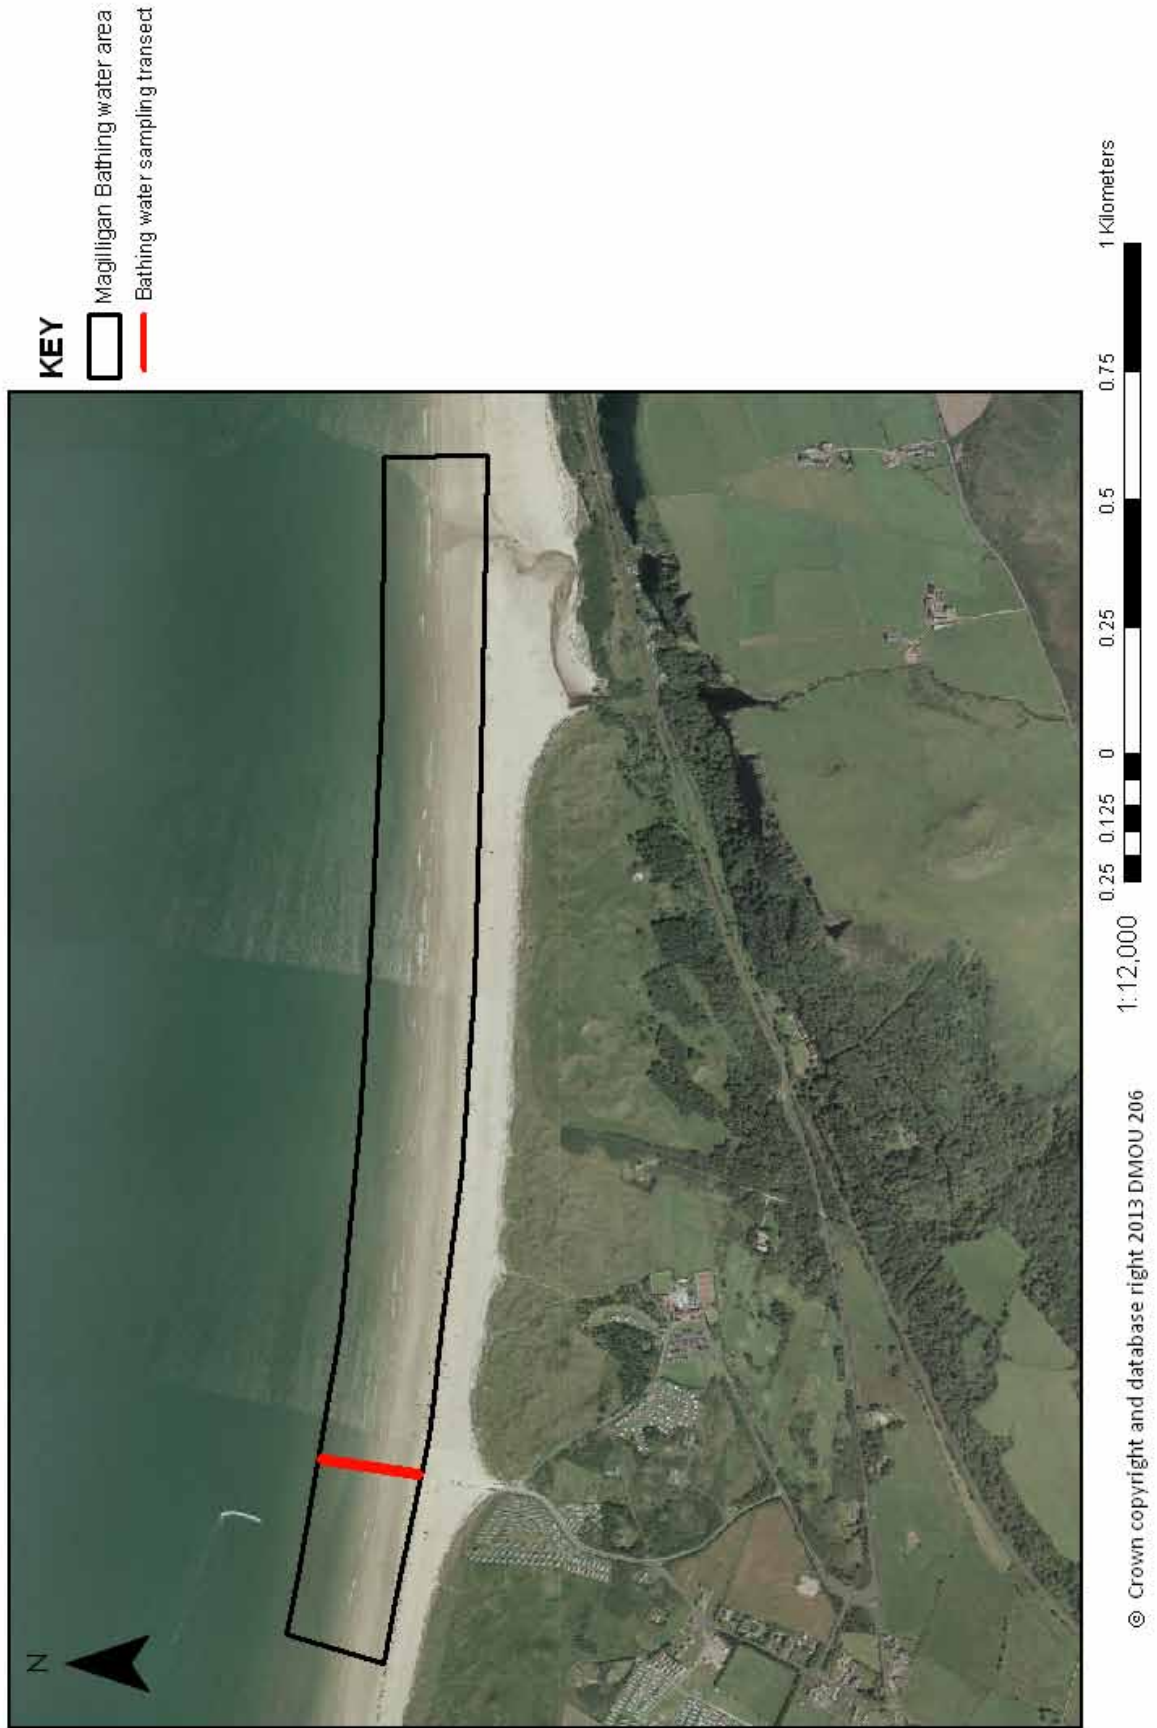
Map 2
Benone (Magilligan) Bathing Water -
EC Bathing Water Sample Location

Bathing Water Name	Benone (Magilligan) Bathing Water
EU bathing water ID number	UKNO4_46800
Location	UK/Northern Ireland/County Londonderry/North Coast
Year of identification	1993
Local council area	Causeway Coast and Glens Borough Council
Bathing Water Operator	Causeway Coast and Glens Borough Council
Description of bathing beach	Sand, 4 kilometres in length, contiguous with Downhill Bathing Water
Monitoring Point	End of access road onto beach, C7170 3625 (Map 2)
