# Bathing Water Profile Castlerock

May 2016

### **Background to Bathing Water Profiles**

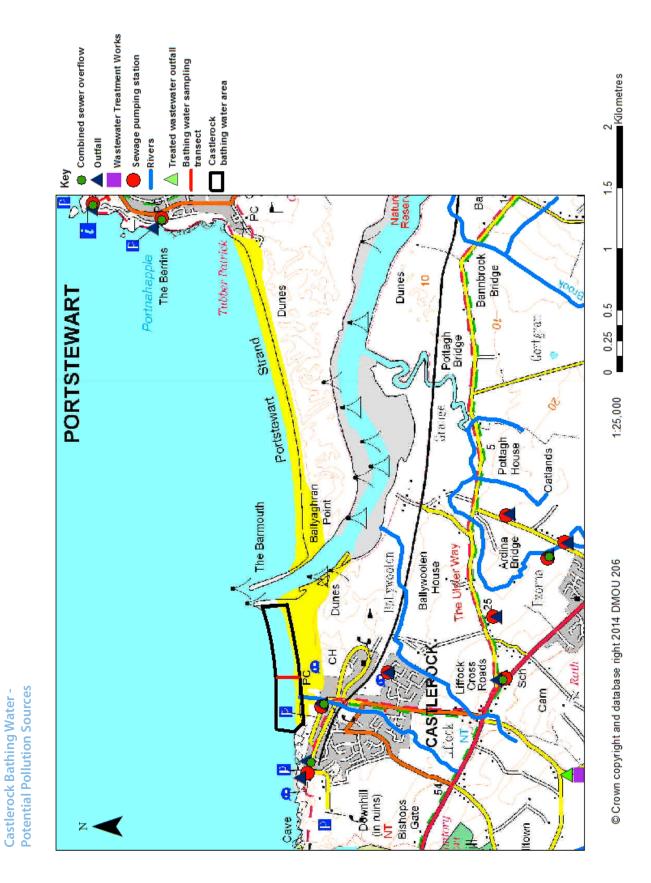
Map 1

The River Bann flows out to sea at the eastern end of the bathing area through the Barmouth (see Map 1). The River Bann flows primarily through rural areas with agriculture being the main land use, draining some 40% of Northern Ireland. However it also flows through several towns including Coleraine, Portglenone and Toome.

There is one minor waste water treatment works inland from Castlerock approximately 2.5 kilometres from the bathing area. (Map 1)

The municipal collection and treatment of waste water has the potential to cause pollution because all collection systems must be designed to overflow in periods of extreme wet weather or following failure of the system. If systems are not designed in that way, then sewers may overflow into residential areas. Within the Castlerock area there are sewage pumping stations (SPS) with associated emergency overflows as shown on Map 1. NIW has in the past made significant improvements to the sewer system in this area.
