Bathing Water Profile

Downhill

May 2016

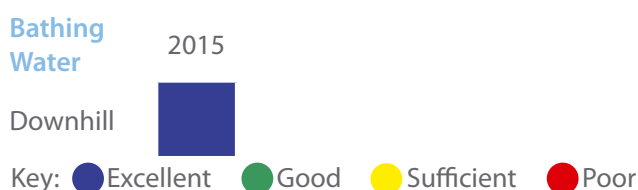
Downhill Bathing Water Quality 2015

In 2015 the 1976 Bathing Water Directive was replaced by the European Bathing Water Directive 2006/7/EC. This revised directive introduced more stringent bathing water standards. Bathing Waters are classified as Excellent, Good, Sufficient or Poor (see above). This classification is based on a statistical assessment of results from the last four years.
