Bathing Water Profile

Ballycastle

May 2018

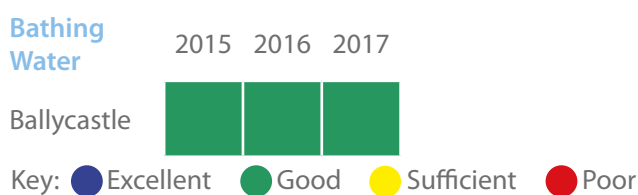
Ballycastle Bathing Water Quality 2015-2017

In 2015 the 1976 Bathing Water Directive was replaced by the European Bathing Water Directive 2006/7/EC. This revised directive introduced more stringent bathing water standards. Bathing Waters are classified as Excellent, Good, Sufficient or Poor (see above). This classification is based on a statistical assessment of results from the last four years.

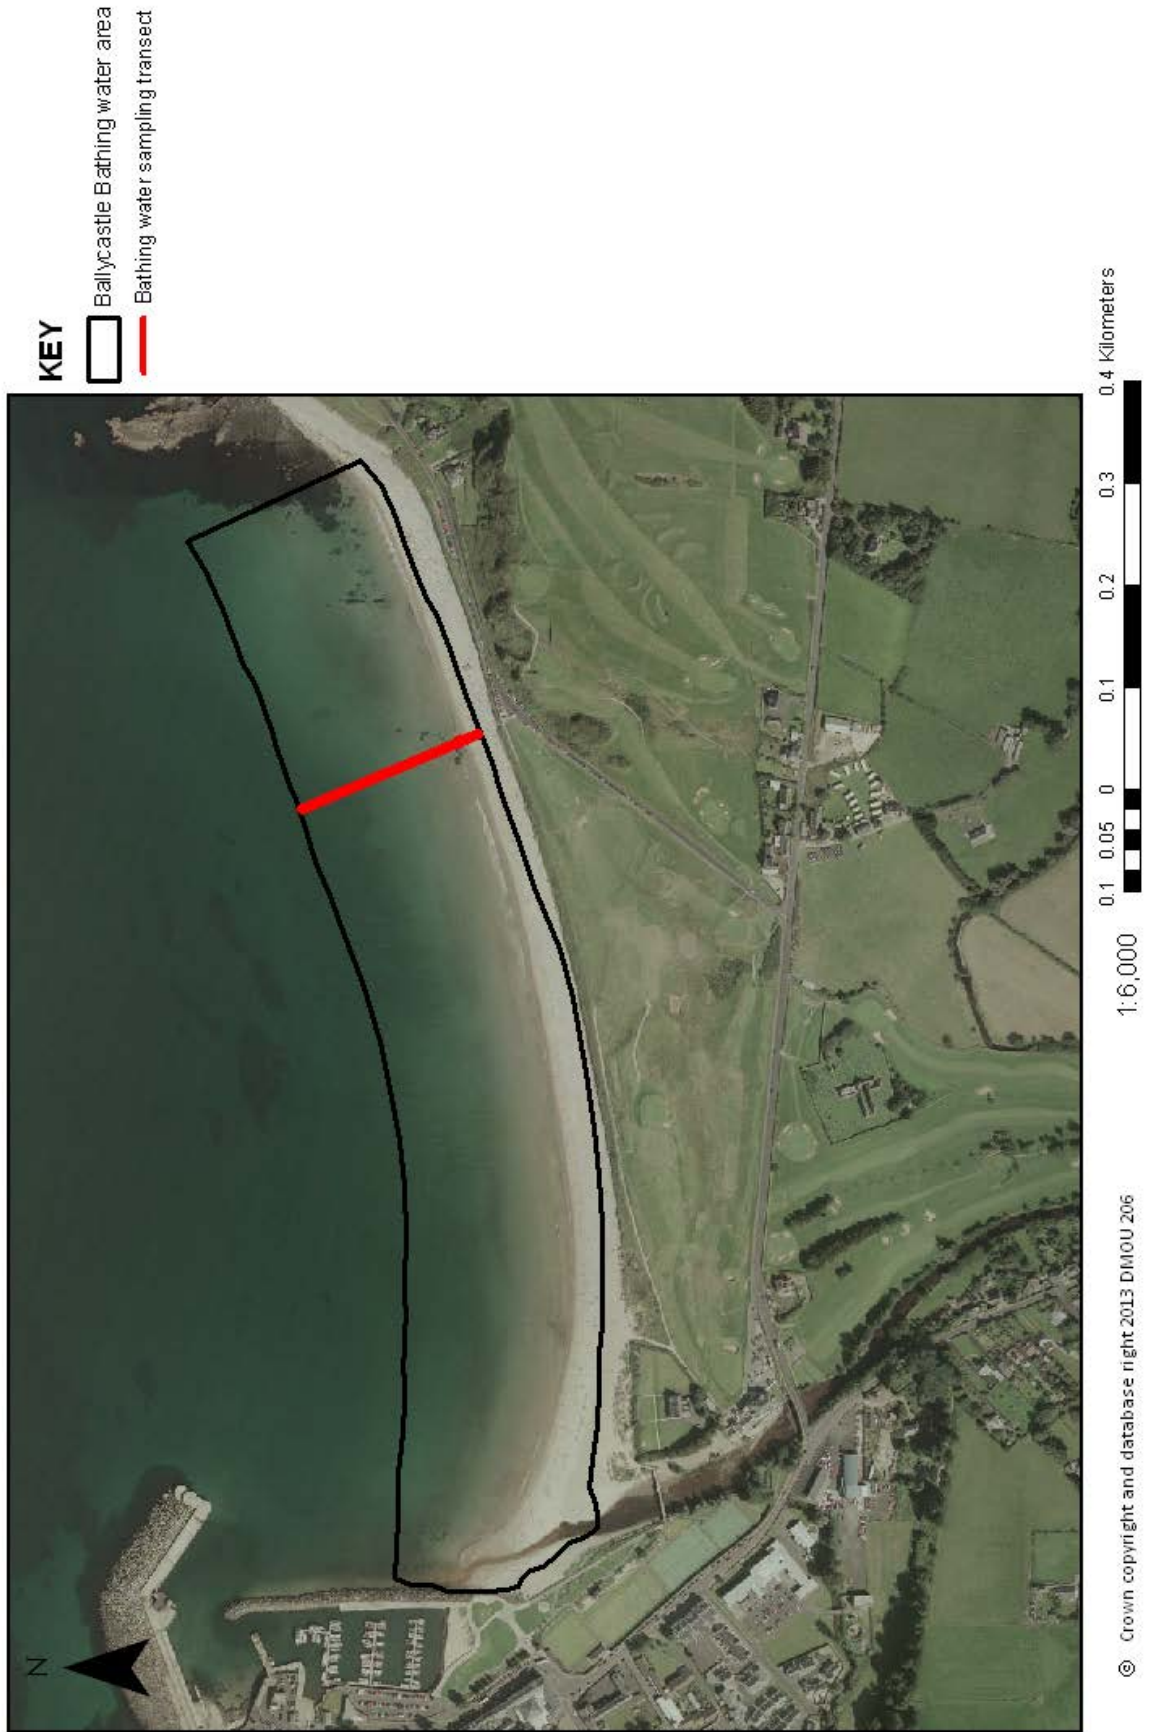
Map 2
Ballycastle Bathing Water -
EC Bathing Water Sample Location

Bathing Water Name	Ballycastle Bathing Water
EU bathing water ID number	UKNO4_50500
Location	UK/Northern Ireland/County Antrim/Antrim Coast
Year of identification	1988
Local council area	Causeway Coast and Glens Borough Council.
Bathing Water Operator	Causeway Coast and Glens Borough Council.
Description of bathing beach	Sand and shingle, approximately 1.2 kilometres in length
Monitoring Point	Eastern end of bathing water, D13034126 (Map 2)
