# Bathing Water Profile

## Castlerock

May 2018

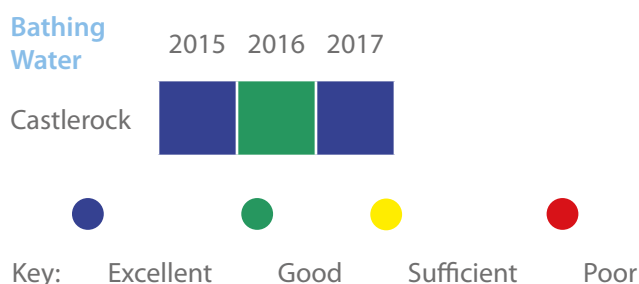
### Castlerock Bathing Water Quality 2015-2017

In 2015 the 1976 Bathing Water Directive was replaced by the European Bathing Water Directive 2006/7/EC. This revised directive introduced more stringent bathing water standards. Bathing Waters are classified as Excellent, Good, Sufficient or Poor (see above). This classification is based on a statistical assessment of results from the last four years.
