Ballyholme – Bathing Water Profile

Ballyholme beach, North Down, Northern Ireland

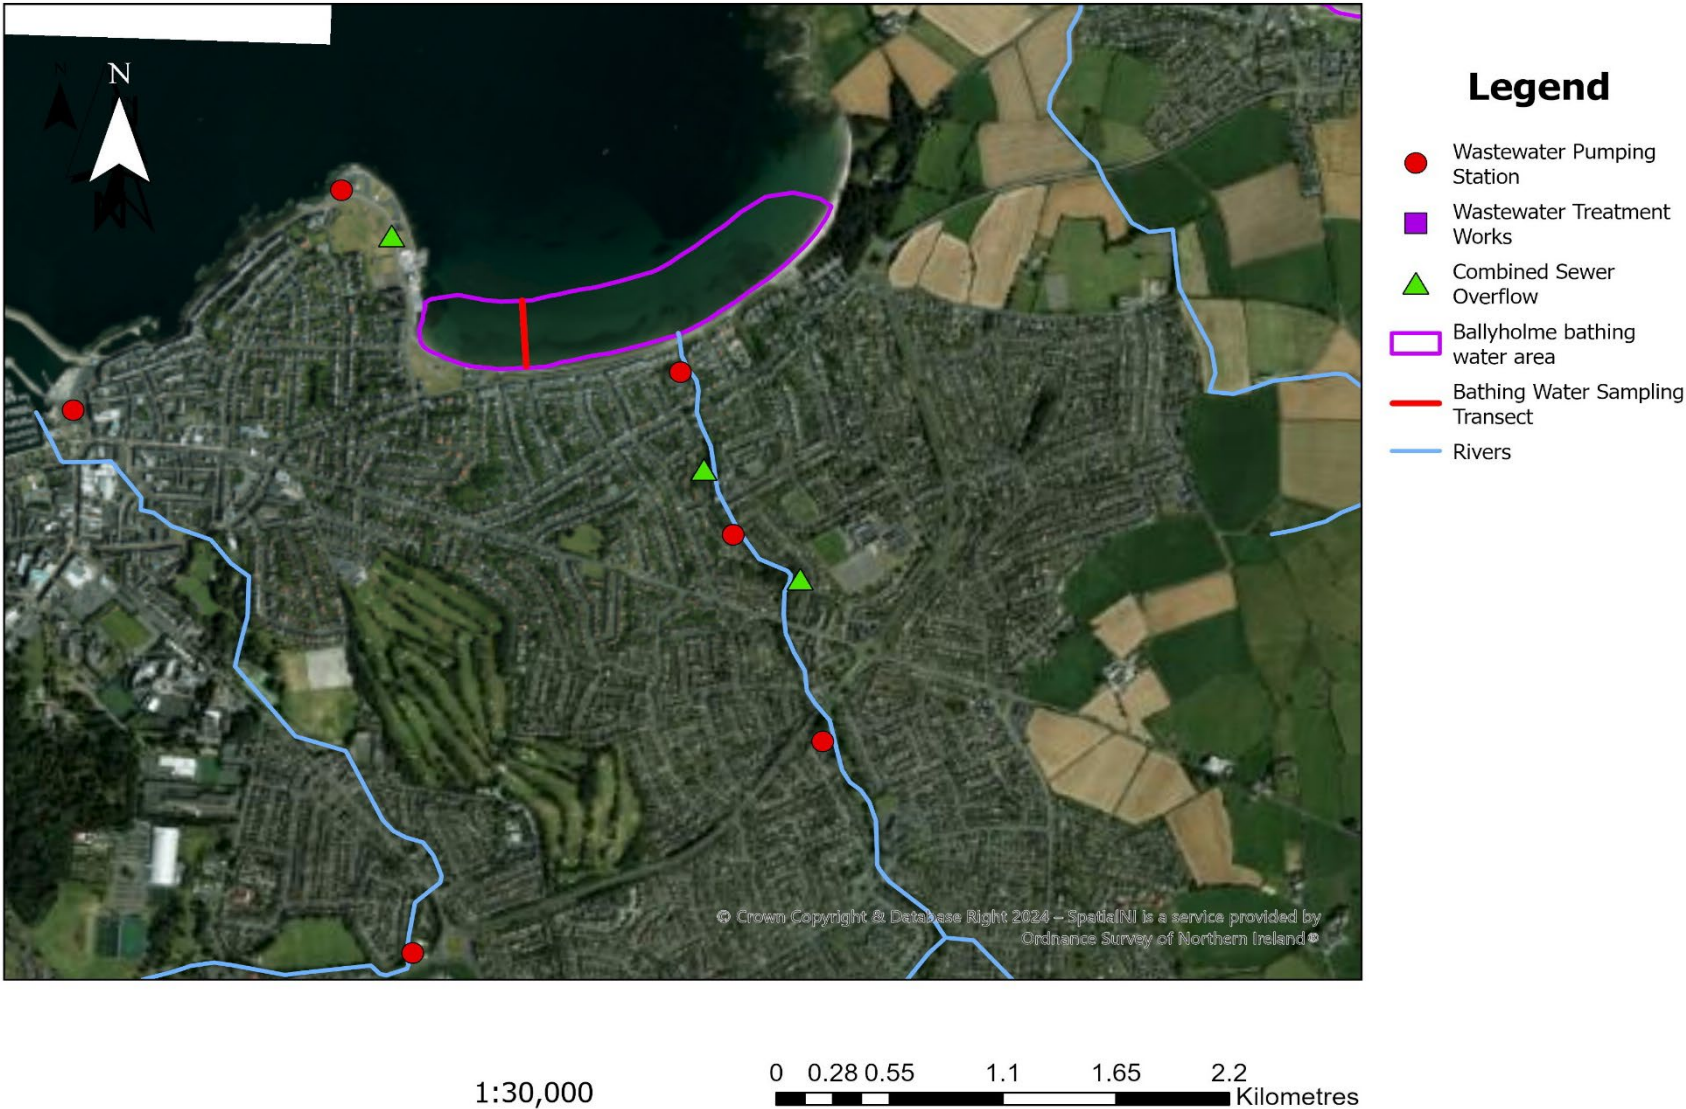
Map 1. Ballyholme Bathing Water

There are no treated wastewater outfalls and wastewater treatment works located in the immediate vicinity of Ballyholme bathing water (Map 1). Wastewater from the wider Bangor area is pumped to a major wastewater treatment facility between Bangor and Donaghadee. It provides secondary treatment with UV disinfection during the bathing season. The treated effluent is discharged some 600m offshore, to the northeast of Brigg's Rocks. This is approximately 4.5km northeast of Ballyholme bathing water.

The collection and treatment of wastewater has the potential to cause pollution as all combined collection systems are designed to overflow in periods of extreme wet weather or following failure of the system. This prevents overflows into residential properties. Within the Ballyholme area there are combined sewer overflows (CSO) emergency overflows and wastewater pumping stations with associated emergency overflows, highlighted on Map 1.
