Ballywalter – Bathing Water Profile

Ballywalter beach, County Down, Northern Ireland

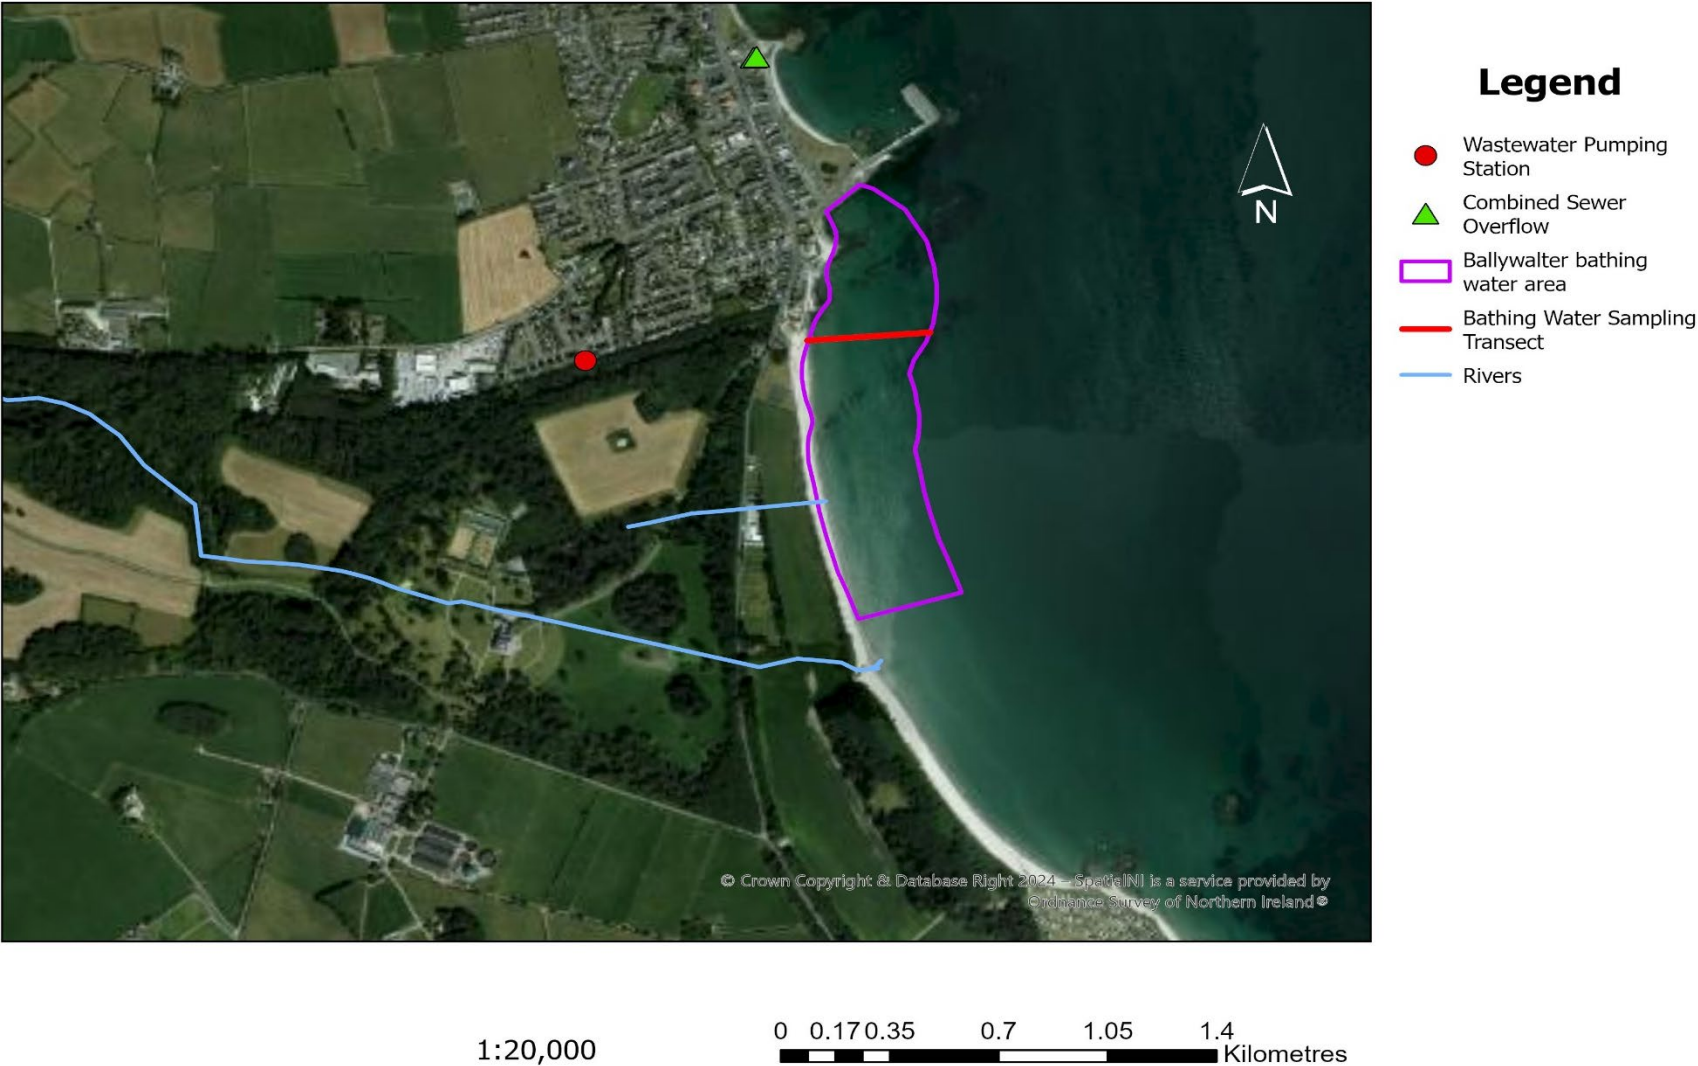
Map 1 Ballywalter Bathing Water

The collection and treatment of wastewater has the potential to cause pollution as all combined collection systems are designed to overflow in periods of extreme wet weather or following failure of the system. This prevents overflows into residential properties. Within the Ballywalter area there are a number of combined sewer overflows (CSO) and wastewater pumping stations with associated emergency overflows, highlighted on Map 1.
