Millisle – Bathing Water Profile

Millisle beach, County Down, Northern Ireland

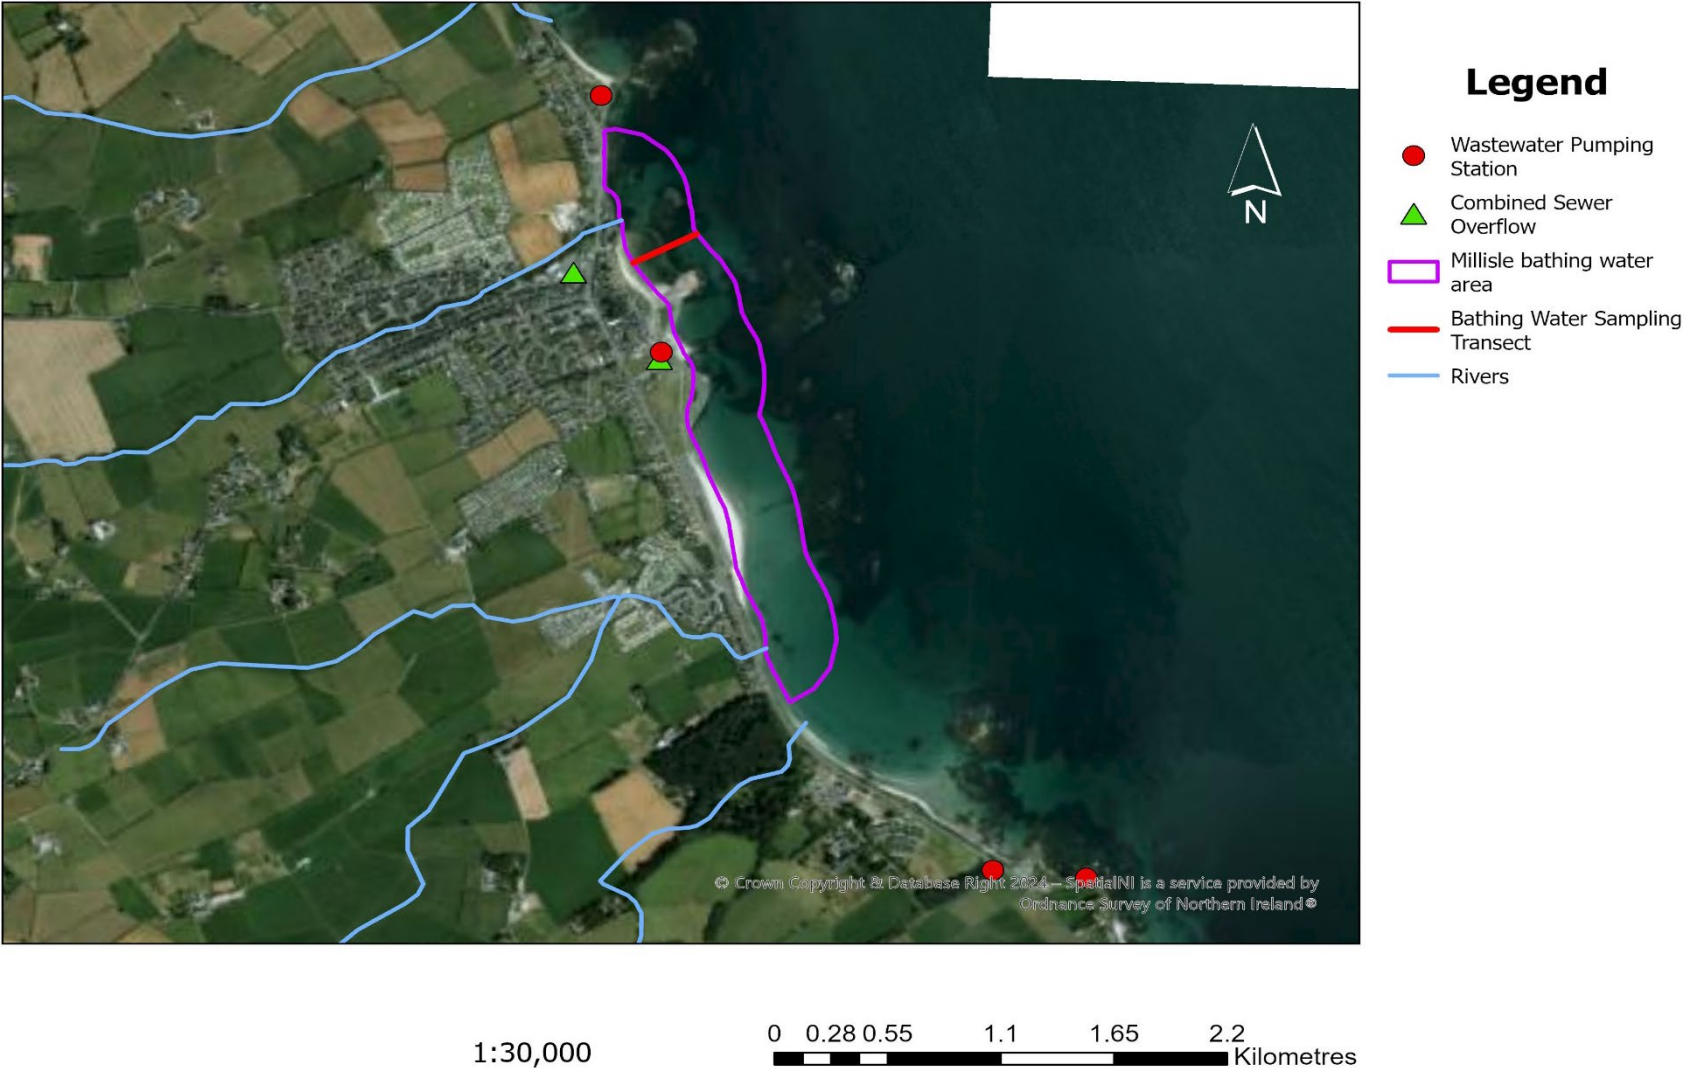
Map 1 Millisle Bathing Water

The collection and treatment of wastewater has the potential to cause pollution as all combined collection systems are designed to overflow in periods of extreme wet weather or following failure of the system. This prevents overflows into residential properties. Within the Millisle area there are several wastewater pumping stations with associated emergency overflows, highlighted on Map 1.
