## Murlough (Co Down) – Bathing Water Profile

Murlough beach, County Down, Northern Ireland

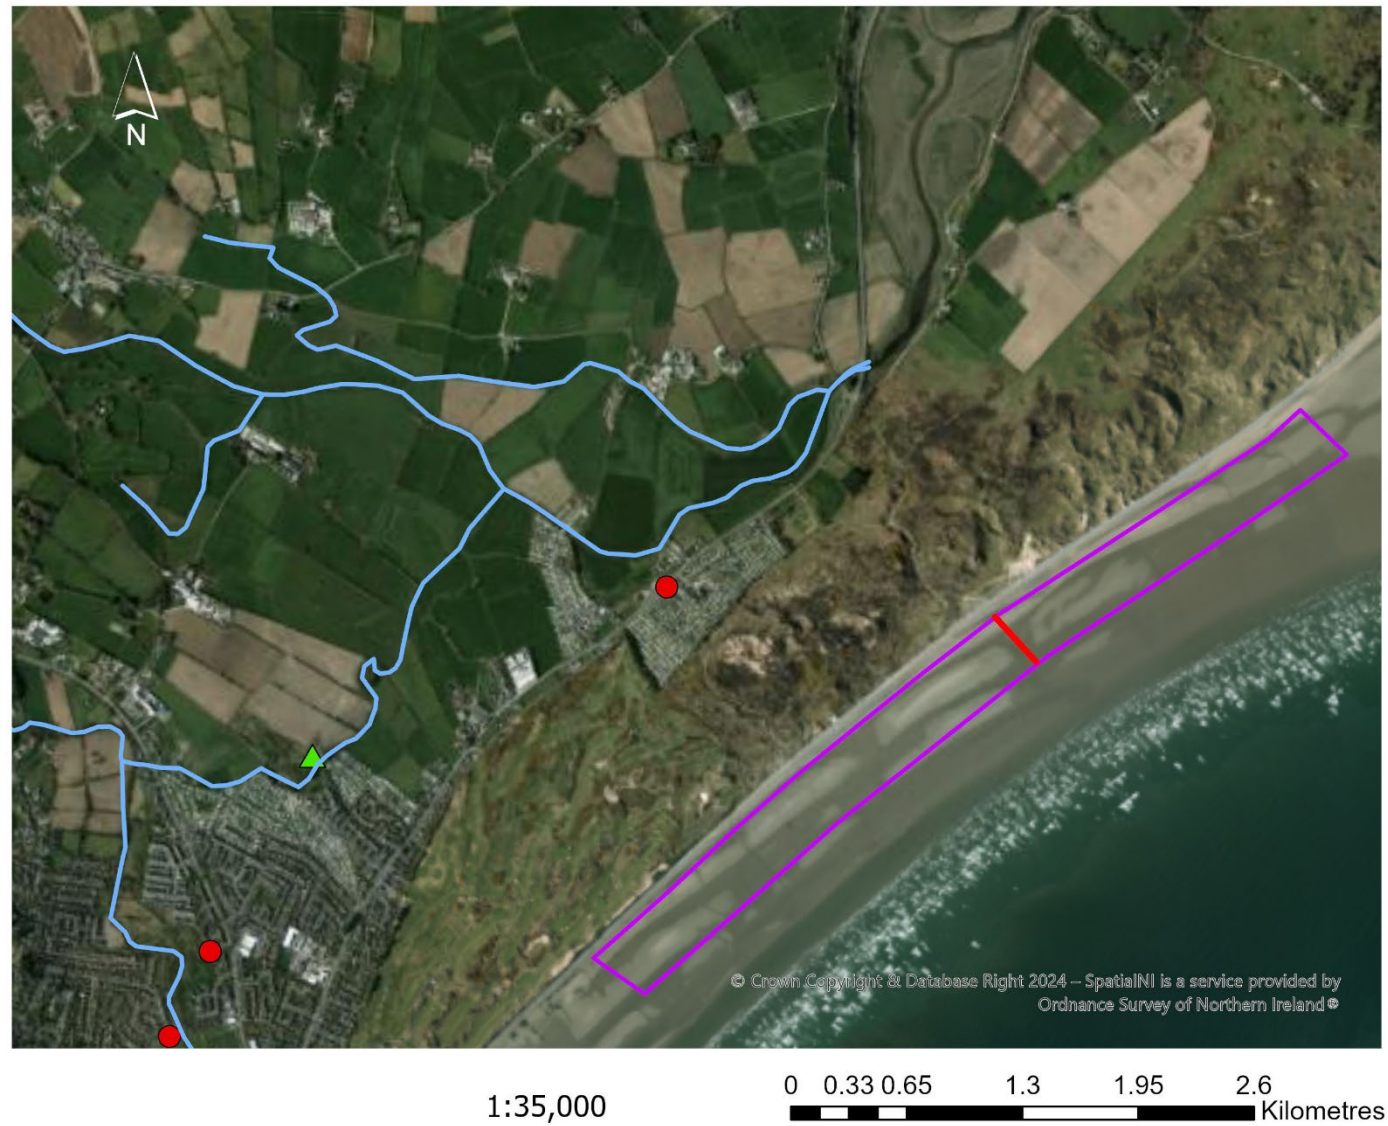
Map 1 Murlough (Co Down) Bathing Water

The collection and treatment of wastewater has the potential to cause pollution as all combined collection systems are designed to overflow in periods of extreme wet weather or following failure of the system. This prevents overflows into residential properties. Within the wider Murlough area there are a number of combined sewer overflows (CSO) wastewater pumping stations and associated emergency overflows, highlighted on Map 1.
