Portstewart – Bathing Water Profile

Portstewart beach, County Londonderry, Northern Ireland

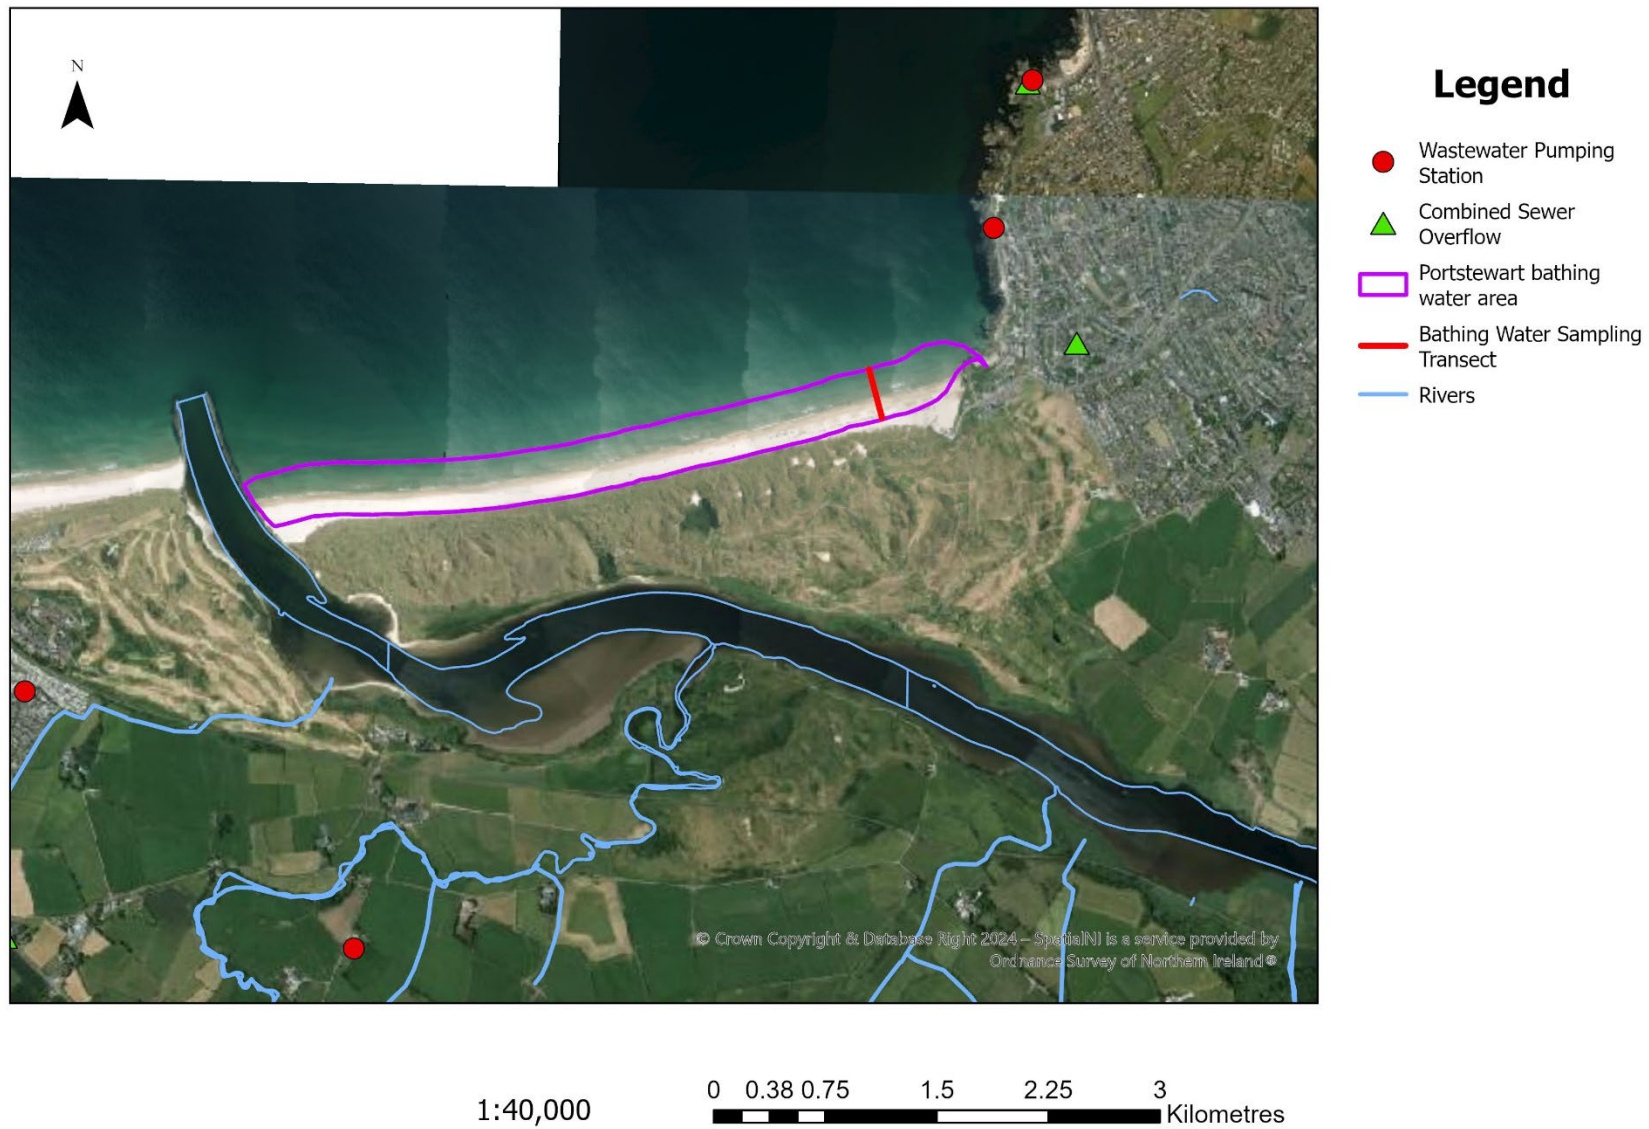
Map 1. Portstewart Bathing Water

The collection and treatment of wastewater has the potential to cause pollution as all combined collection systems are designed to overflow in periods of extreme wet weather or following failure of the system. This prevents overflows into residential properties. Within the Portstewart area there are combined sewer overflows (CSO), emergency overflows and wastewater pumping stations with associated emergency overflows, highlighted on Map 1.
