# Cavity Wall Insulation Research Project 2019

Research study prepared for the  
Northern Ireland Housing Executive

Research study prepared by Consultancy, Investigation and Training (CIT)  
for the Northern Ireland Housing Executive

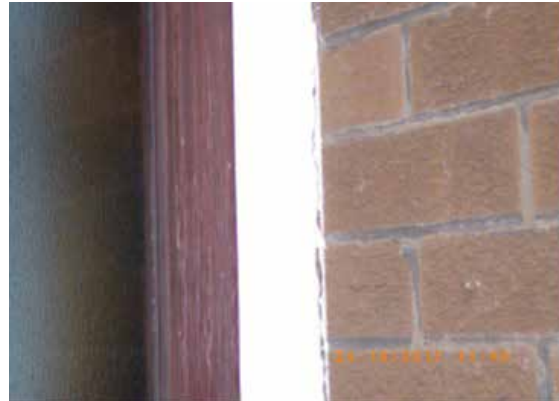
Figure 6.21 Perimeter seals (door)

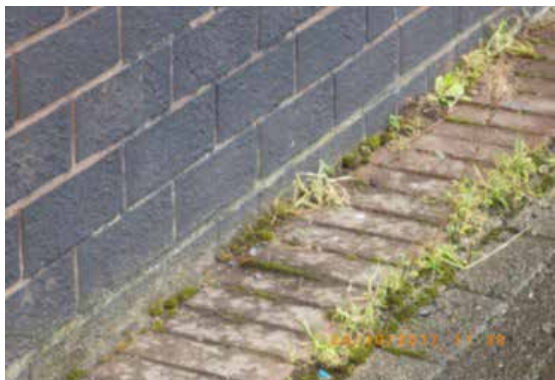
Figure 6.23 DPC below ground level

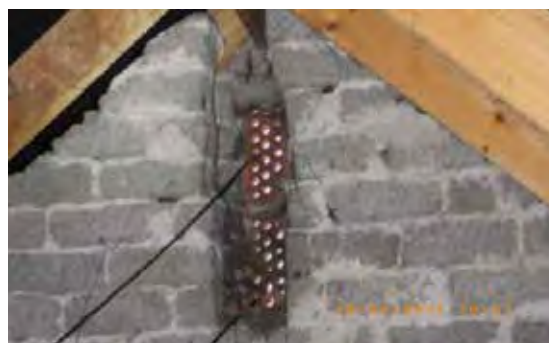
The airbricks in the gable wall have not been sleeved. If this is not remediated, water accessing through the vent is likely to compromise the CWI and may compromise the inner wall areas.

Figure 6.31 Airbrick not sleeved

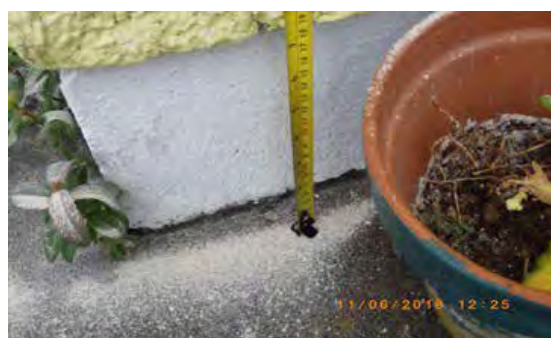
Figure 6.36 DPC level compliant with Building Regulations and CWI industry standards

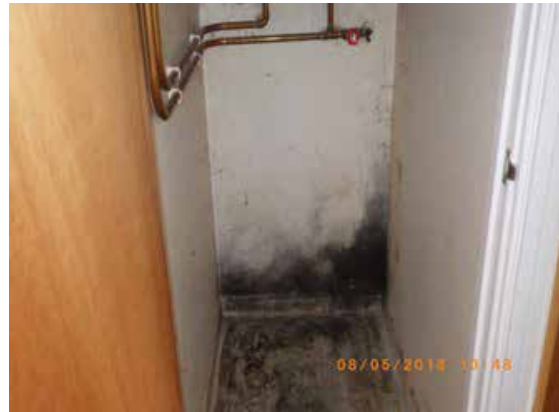
Damp (89%) (ref: figures 7.10 - 7.15). Evidence gathered shows voids and or debris in the CWI installation corresponding with the damp or damp and condensation on the inner walls of the properties.

Figure 7.10 Damp

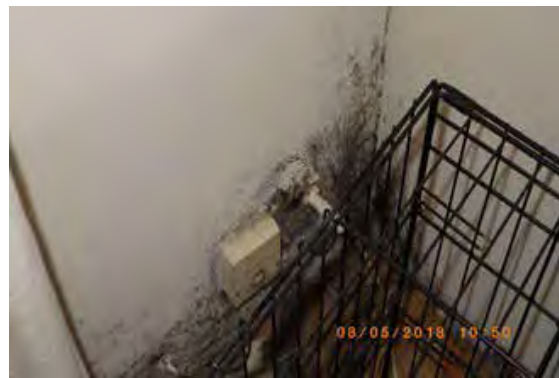
Figure 7.11 Damp

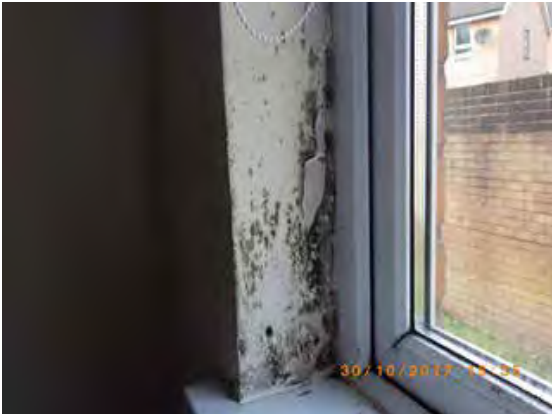
Condensation (33%) (ref: figures 7.12 & 7.13). Evidence gathered highlighted areas of condensation on the inner wall, corresponding with compromised CWI installations, with the voids in the CWI installation promoting cold bridging in the area, and condensation generated as a result.

Figure 7.12 Condensation

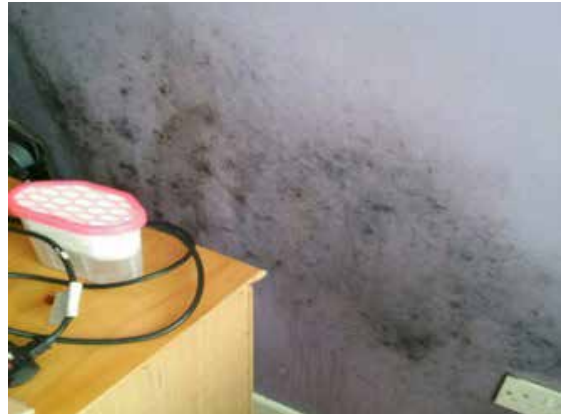
Figure 7.15 Damp and condensation

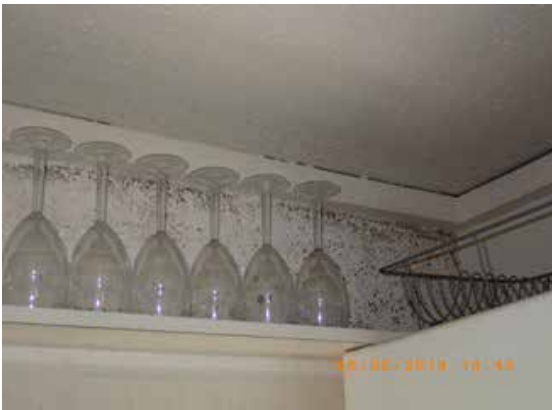
Figure 7.13 Condensation

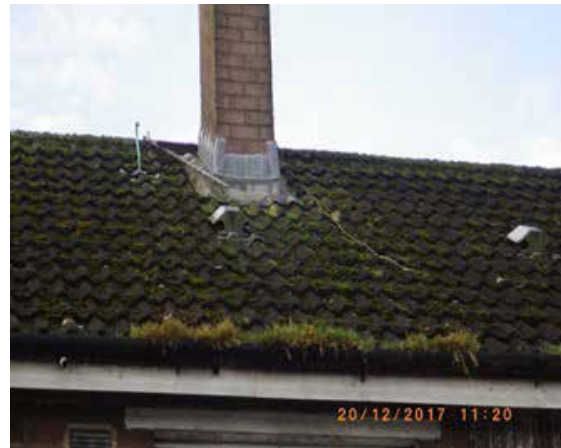
Guttering was the second most common identified issue with almost half of the properties requiring repair or cleaning (47%) (ref: figures 7.25 & 7.26). Defects can allow excess water to flow directly onto the external walls, causing them to become saturated introducing excess water into the cavity, which could increase the risk of water bridging the CWI installation and/or becoming saturated resulting in the formation of damp on the inner walls.

Figure 7.26 Compromised guttering

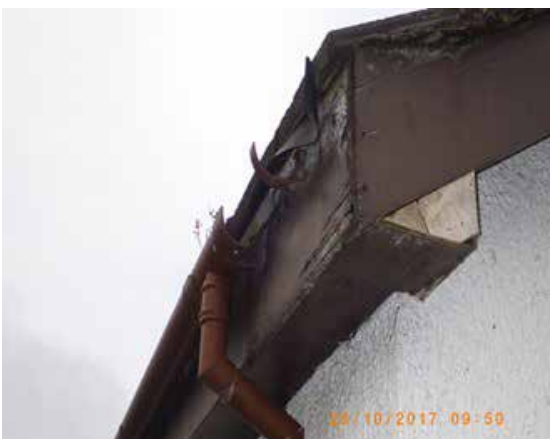
Figure 7.25 Damaged guttering

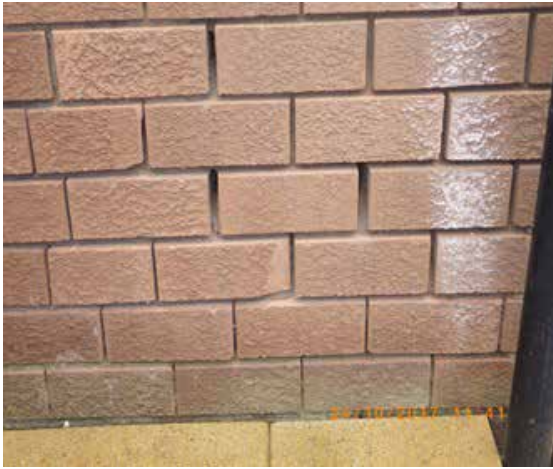
Other defects that could compromise the property external façade are mortar erosion (33%), (ref: figure 7.29), non-compliant DPC level, (27%) (ref: figures 7.27 & 7.28) and compromised verge boards, (20%) (ref: figure 7.30). Compromised mortar (e.g. recessed, missing, damaged or cracked) will weaken the external façade allowing excess water to penetrate the outer wall which may then cause the CWI to become saturated and or water to bridge across the cavity compromising the inner walls. DPC levels and the poor condition of verge boards also have the potential to compromise the external façade's weather resistance to protect the cavity from excess moisture ingress.

Figure 7.29 Compromised mortar

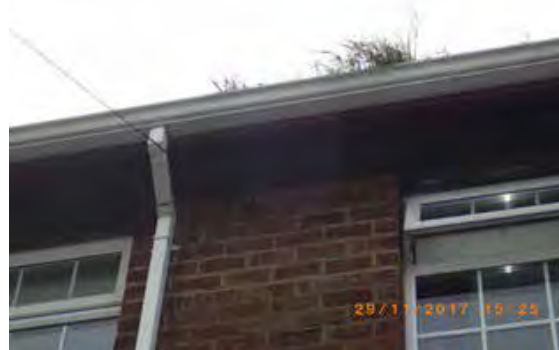
Damaged/blocked guttering (32%) (ref: figures 7.36 & 7.37). Where guttering is either damaged or blocked with foliage growth impeding the dispersal of the rain water, this could soak the outer wall elements (soffit, fascia, brick or render) eventually causing damage to the external façade leading to excessive moisture to access the cavity.

Figure 7.36 Blocked guttering

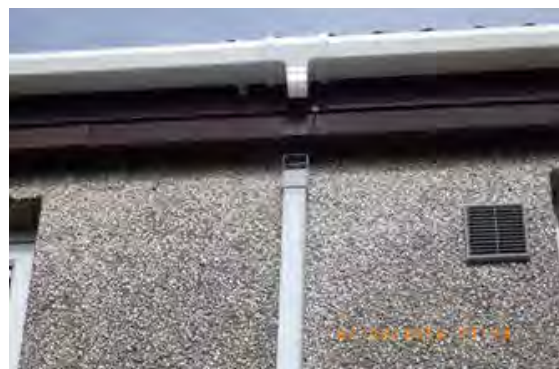
Figure 7.37 Damaged guttering

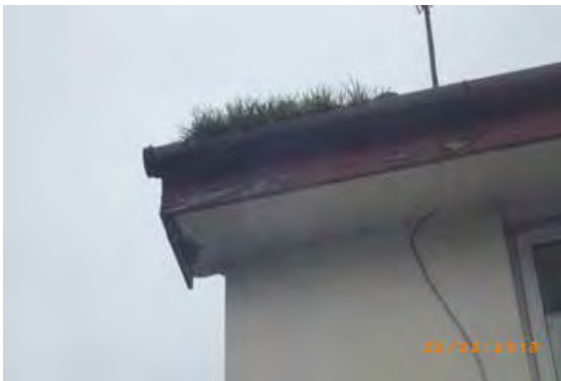
Figure 7.51 Compromised guttering

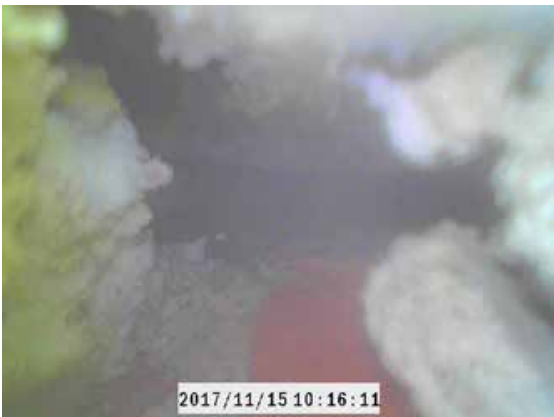
Voids in the CWI and or debris in the cavity (100%) in Class 1, Class 2 – Category A and Class 3 – Category A recommendations) (ref: figures 8.3 - 8.8). All properties within this category exhibited voids in the CWI and or debris in the cavity for all types of CWI systems installed (Foam, Bead and Fibre). The effects of the voids/ debris will be a higher probability of moisture tracking across the cavity compromising the inner walls.

Figure 8.6 Voids and debris in the foam CWI

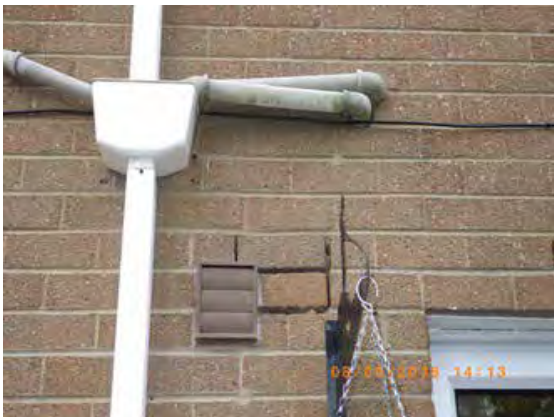
Mortar erosion (33%) (ref: figures 8.9 & 8.10). As can be seen from the photographic evidence, poor making-good and maintenance are also relevant factors. Where the level of exposure to wind driven rain is higher and or because the maintenance of the external façade is poor, moisture is likely to transmit through to the cavity in a CWI installed property and cross the cavity with a high probability of affecting the inner wall.

Figure 8.9 Mortar erosion

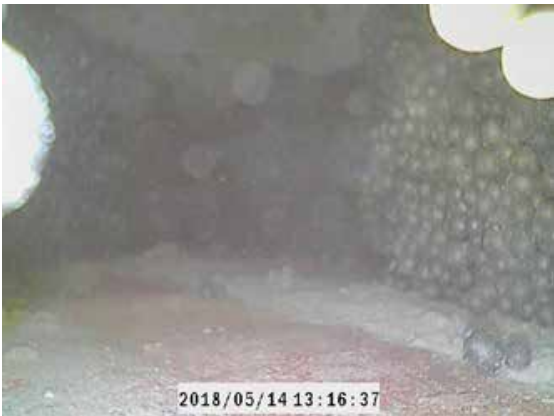
Figure 8.7 Voids in the bead CWI

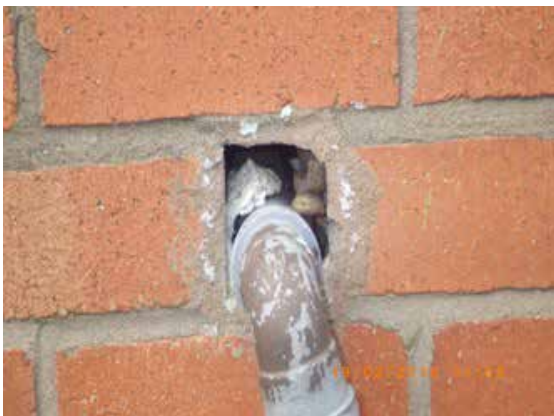
Figure 8.10 Mortar erosion

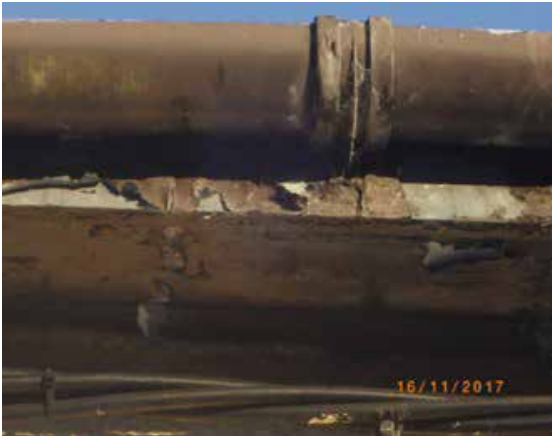
Damaged/blocked guttering (22%) (ref: figures 8.11 & 8.12). When guttering is damaged or blocked with foliage growth that impedes the effective dispersal of rain water, then depending upon the property archetype, water will overflow the guttering and soak the outer wall element (soffit, fascia, brick or render) eventually causing damage to the external façade creating a higher probability of moisture exposure to the inner walls.

Figure 8.11 Damaged/blocked guttering

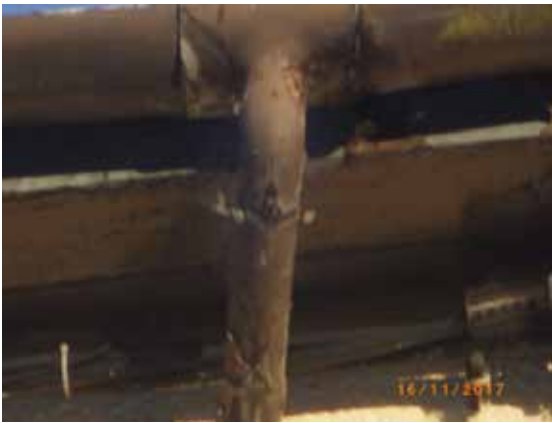
Figure 8.12 Damaged/blocked guttering

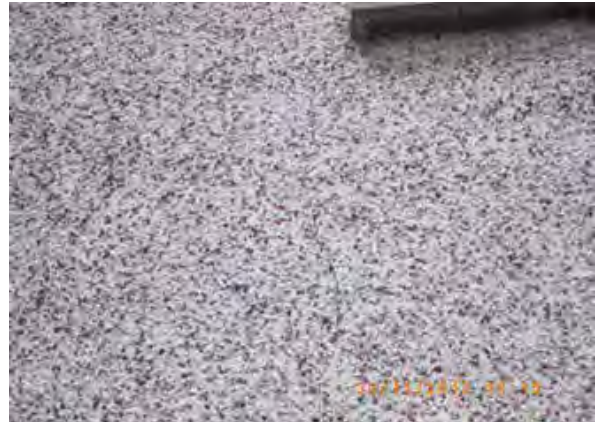
Damaged render/brickwork (33%) (ref: figures 8.15 – 8.18). When render becomes damaged and open, wind driven rain will access behind the render and could eventually detach the render from the wall. Another likely consequence is that water behind the render bridges across the outer wall accessing the cavity in a higher volume with the possibility of compromising the inner walls. Where the brickwork is damaged or not adequately pointed with mortar this could result in the same outcome.

Figure 8.15 Damaged render

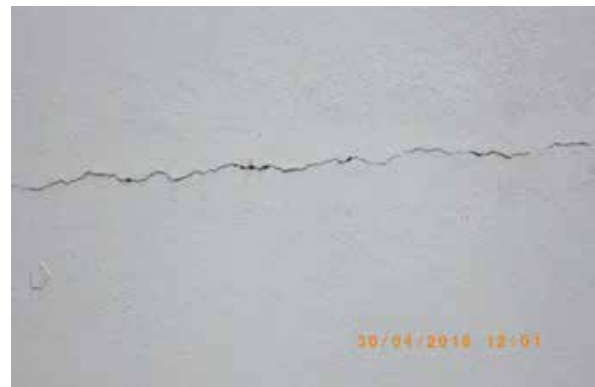
Figure 8.16 Damaged render

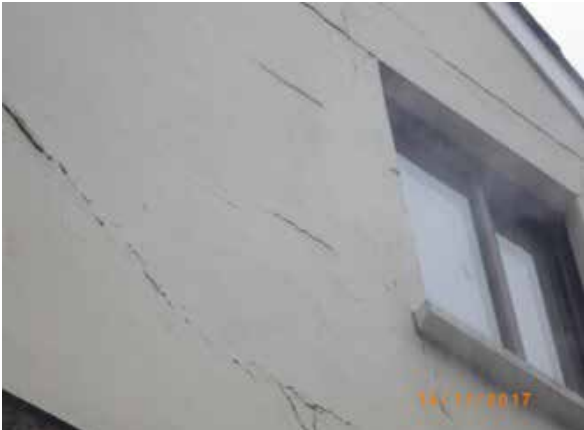
Figure 8.17 Damaged render

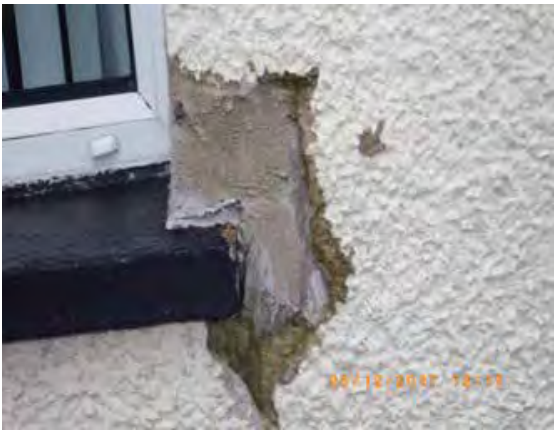
Figure 8.18 Damaged render
